Big Chino Sub-basin Water Monitoring Project Monsoon Season Report: July 1 – September 30

Prepared by: Stephen P. Flora, R.G.
Hydrographic Analyst, SRP Water Measurement

Prepared for: CA1 Monitoring Committee
(Prescott, Prescott Valley, SRP)

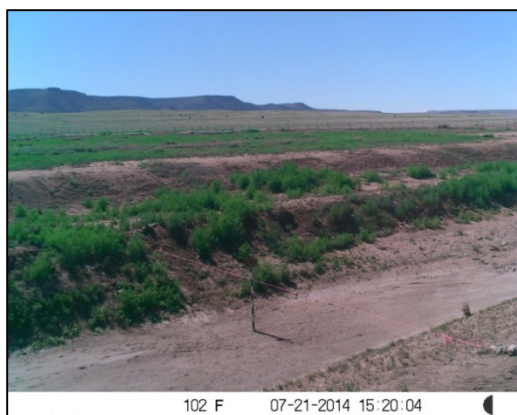
Figure 1. Upper Big Chino Wash tagline reference.

Data processing of stage values and rating curves were completed using Aquarius (version 3.5) time series software. Stage values (feet) collected from the upstream transducer serve as the primary data source (downstream transducer serve as secondary). Offsets to stage values were applied based on the depth of the transducer below stream channel and then compared with visual determination of stage values from flowtophography images. For instances when the event gage was obstructed or missing from the flowtophography images, stage level overlays were created using a tag line reference at each location (see Figure 1 and Figure 2).

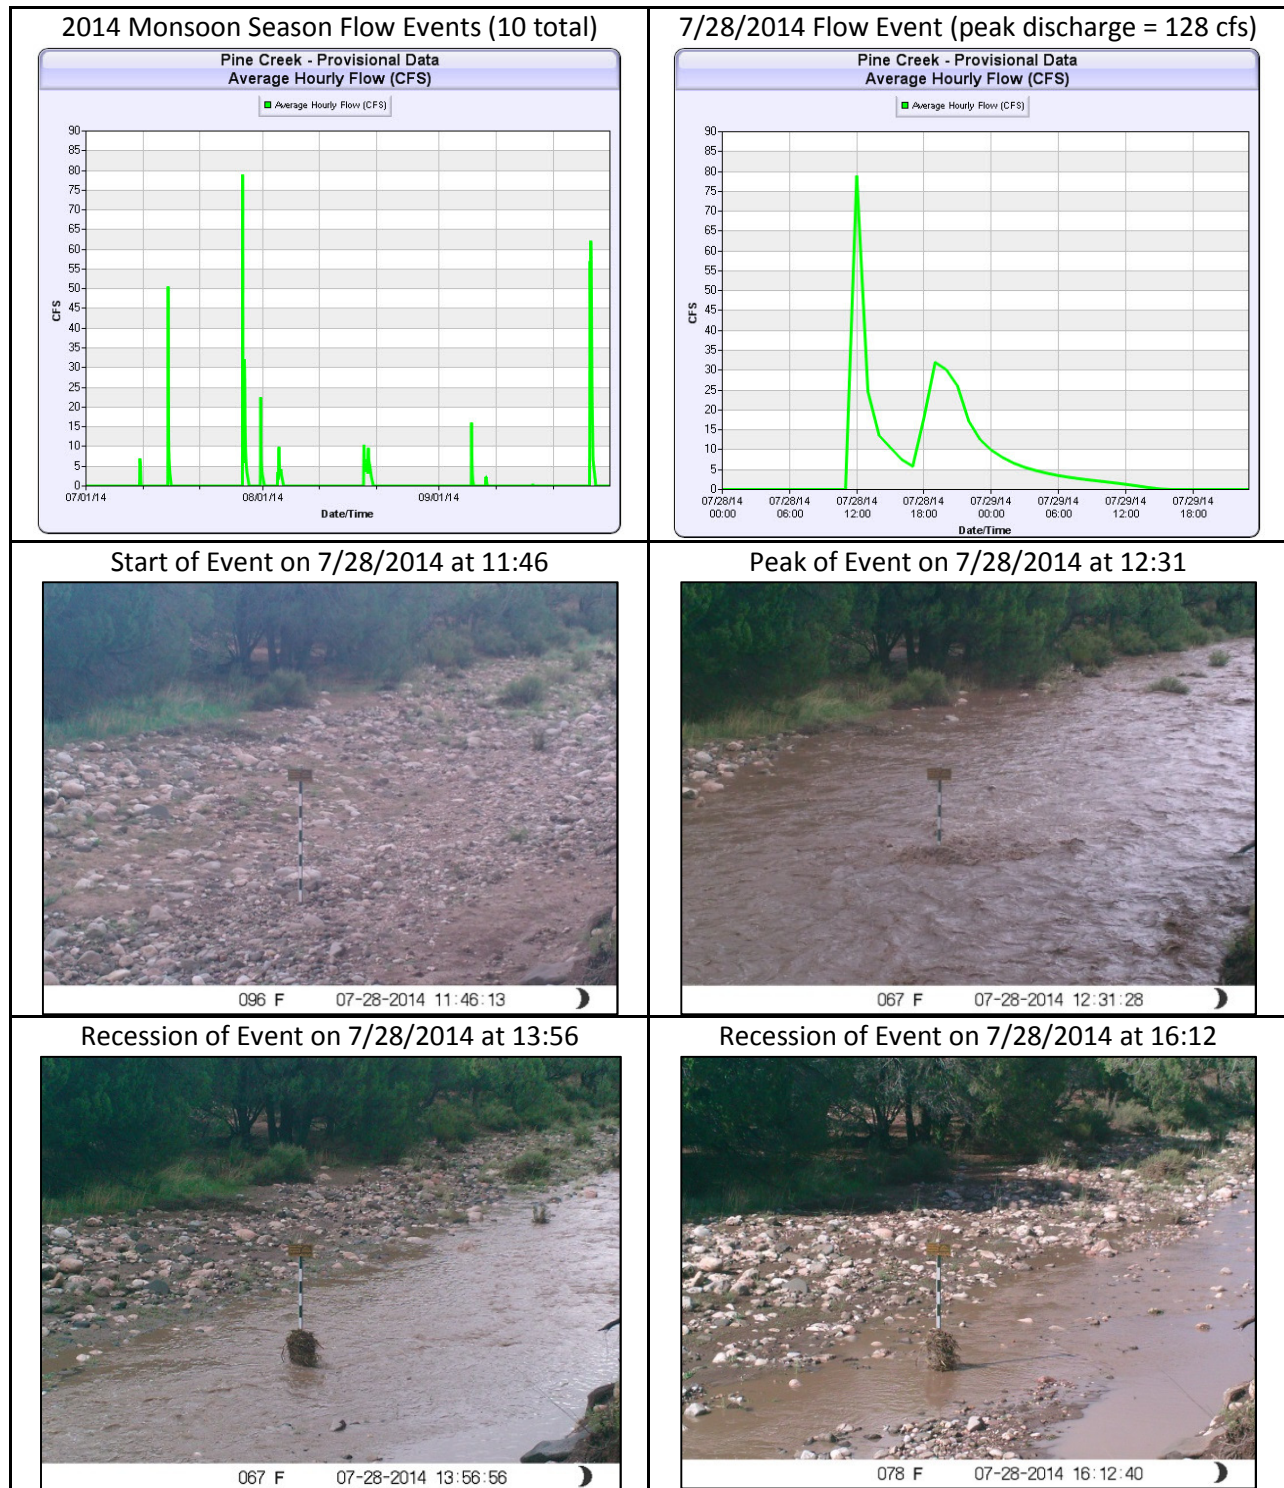
Figure 6: Pine Creek Hydrographs and Flowtopgraphy Flow Event Images

A total of 10 flow events were recorded at Pine Creek (PC) location during the period from July 1, 2014 through September 30, 2014. Peak discharge during events ranged from 0.51 CFS on 9/16/2014 to 84.7 CFS on 9/27/2014. Total volume of each event ranged from 0.05 AF to 46.49 AF, respectively. A total volume of 120.47 AF was estimated to flow through the PC location during the 2014 monsoon season.

Total duration of the events ranged from 1.75 hours on 9/16/2014 to 27.75 hours on 7/28/2014. Average event flow duration was 17.35 hours and total flow duration was 173.5 hours for the 2014 monsoon season. Table 4 below summarizes the flow events at PC location and Figure 6 displays hydrographs and flowtopography images of flow events.

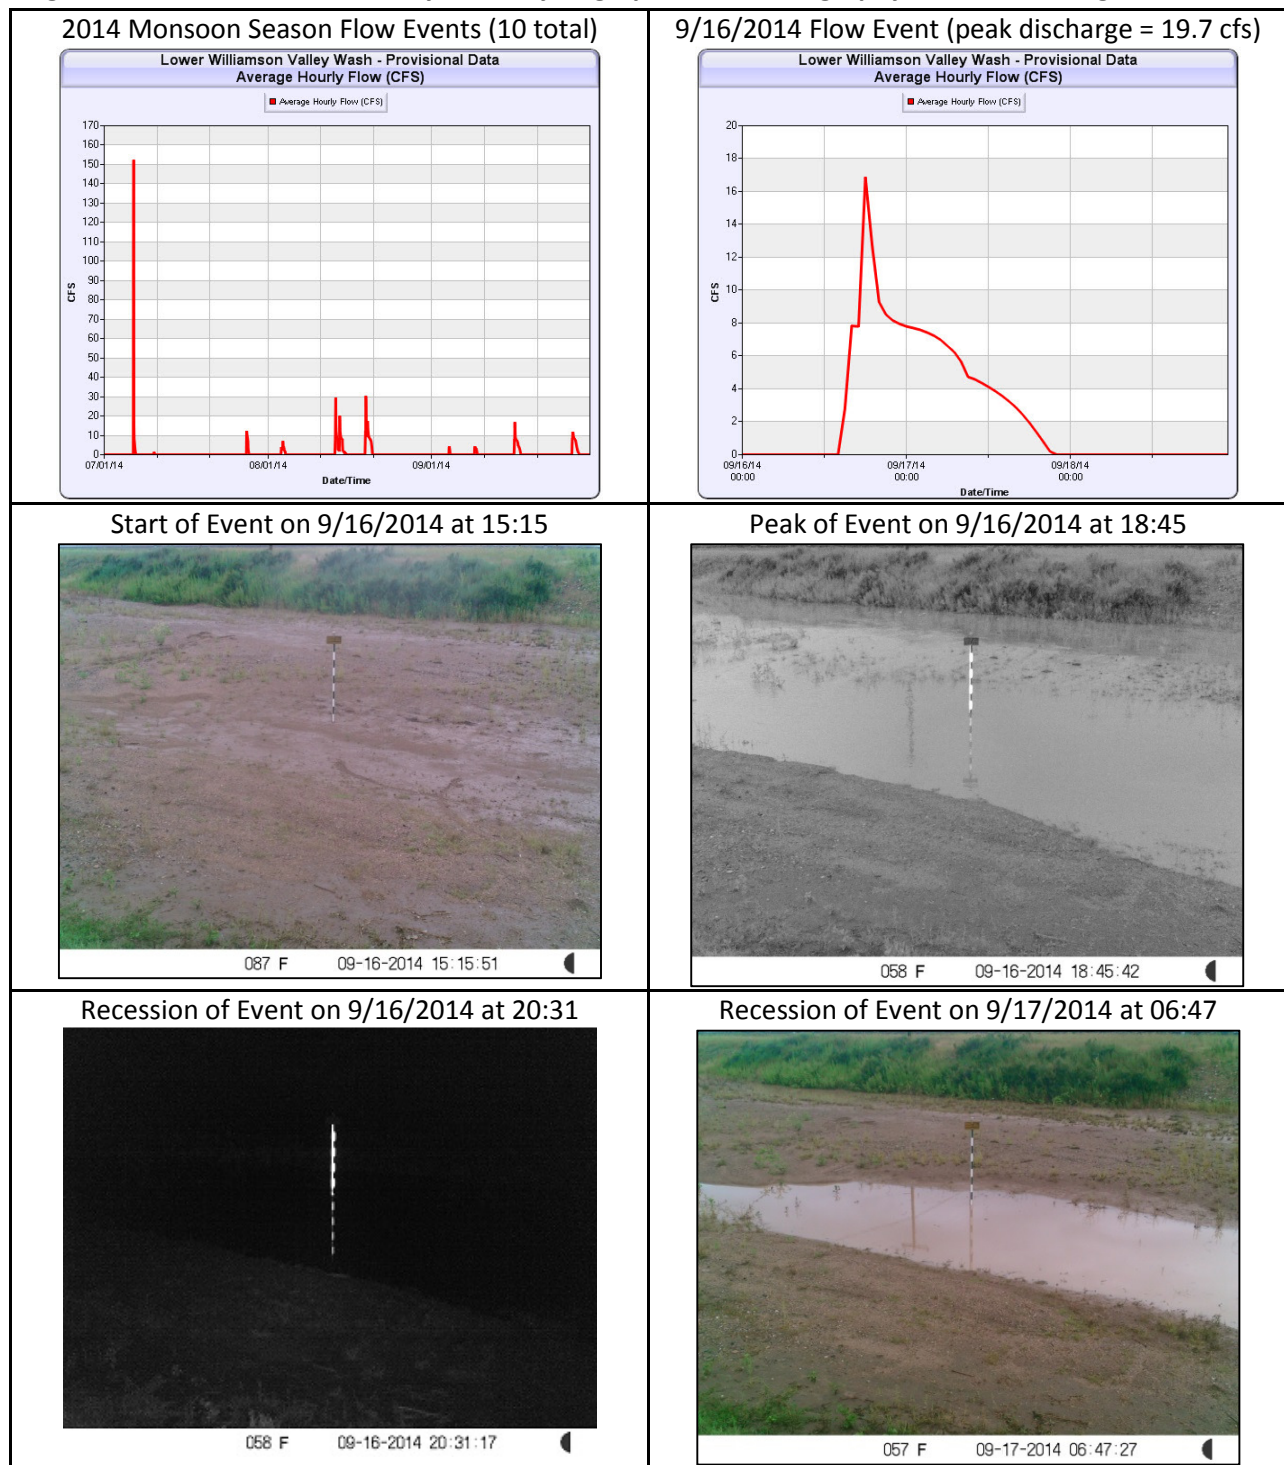
Figure 9: Lower Williamson Valley Wash Hydrographs and Flowtophography Flow Event Images

A total of 10 flow events were recorded at Lower Williamson Valley Wash (LWVW) during the period from July 1, 2014 through September 30, 2014. Peak discharge during events ranged from 4.07 CFS on 7/10/2014 to 281 CFS on 7/6/2014. Total volume of each event ranged from 0.16 AF on 7/10/2014 to 28.1 AF on 8/19/2014. A total volume of 128.23 AF was estimated to flow through the LWVW location during the 2014 monsoon season.

Total duration of the events ranged from 1.0 hour on 7/10/2014 to 53 hours on 8/13/2014. Average event flow duration was 21.6 hours and total flow duration was 216 hours for the 2014 monsoon season. Table 7 below summarizes the flow events at LWVW location and Figure 9 displays hydrographs and flowtopography images of flow events.

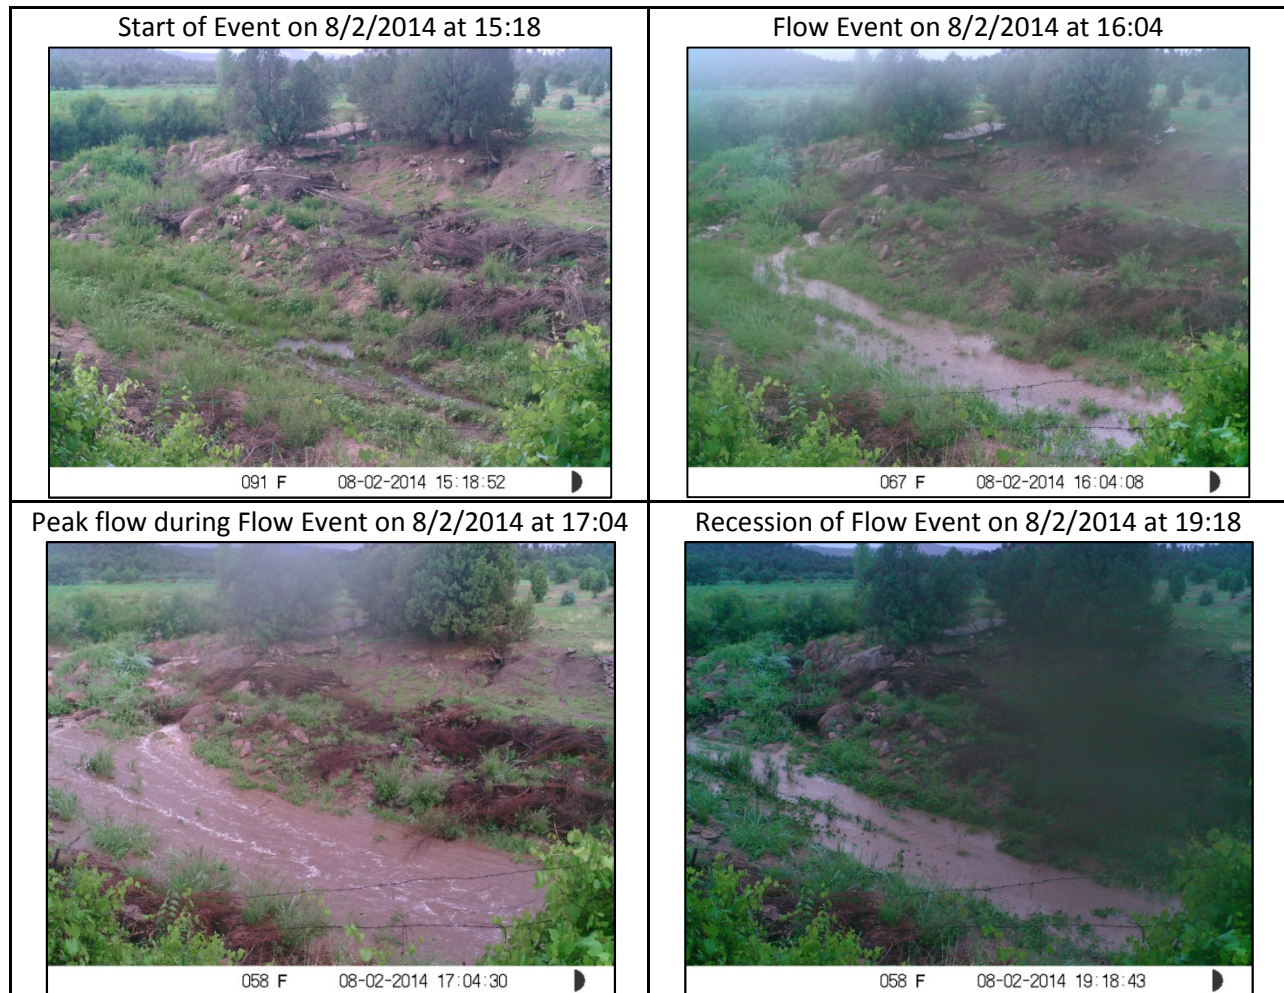
Figure 11 – Upper Walnut Creek at Bridge Flow Event Flowtography Images

Flow events occurred on the following dates and durations: 7/28/2014 (2.25 hours), 8/1/2014 (4 hours), 8/2/2014 (19.25 hours), 8/3/2014 (26 hours), 8/19/2014 (2 hours), and 9/27/2014 (7.5 hours). Average event flow duration was 17.4 hours and total flow duration was 61 hours for the 2014 monsoon season. The UWCB location was not visited during the 2014 monsoon season but was visited before (6/26/2014) and after (10/2/2014) for routine maintenance and flowtography image collection. Figure 11 shows flowtography images during a flow event recorded on 8/2/2014.

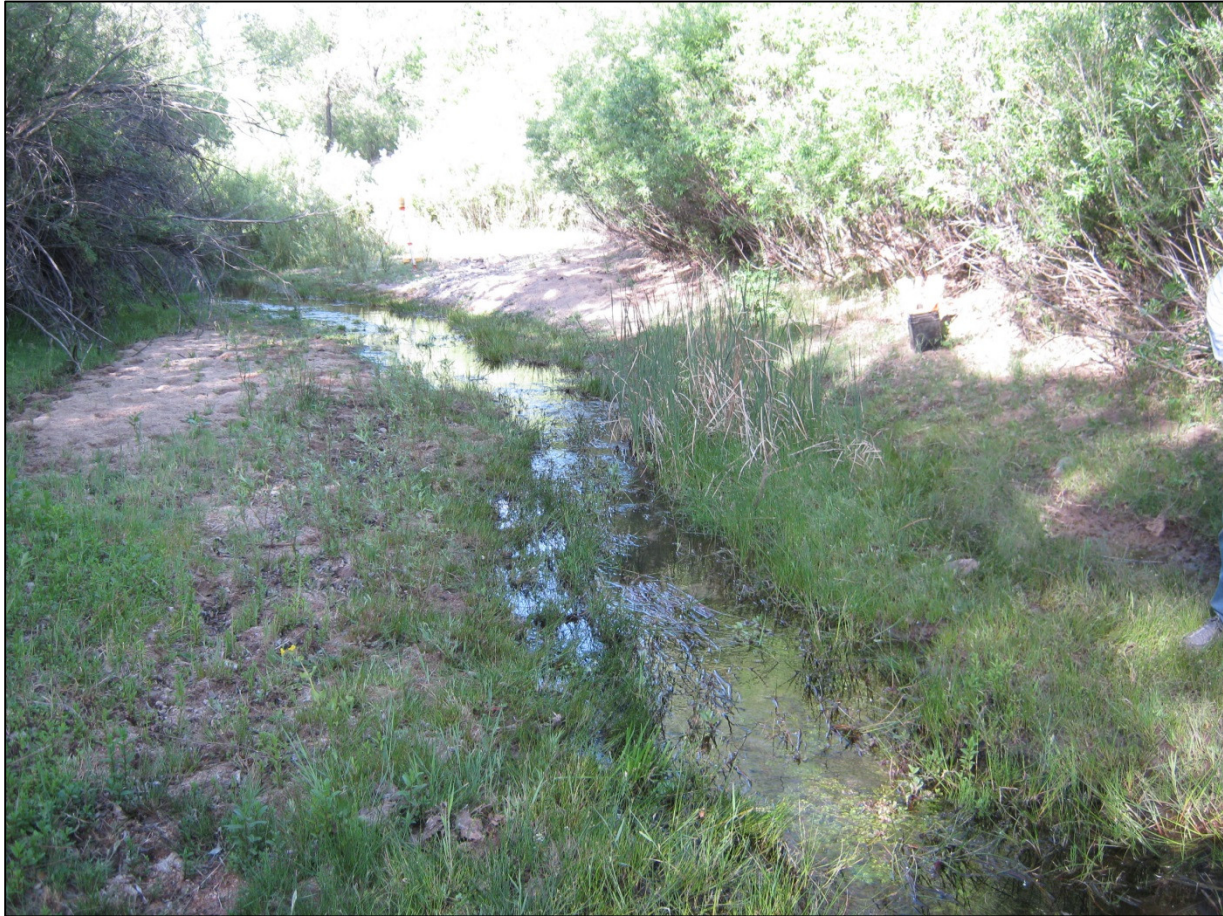
Figure 12 –Upper Walnut Creek at Forest Service Location

The Upper Walnut Creek at Forest Service (UWCFS) location monitoring equipment was not installed prior to the 2014 monsoon season and the site was not visited during this period. Installation of a low flow flume (rated for 2.0 CFS max) and flowtography camera at the site occurred on October 2, 2014. Details on the flume installation and data collected at the UWCFS location will be detailed in the 2014/2015 Winter Season Report. Figure 12 shows the UWCFS location on June 5, 2014.

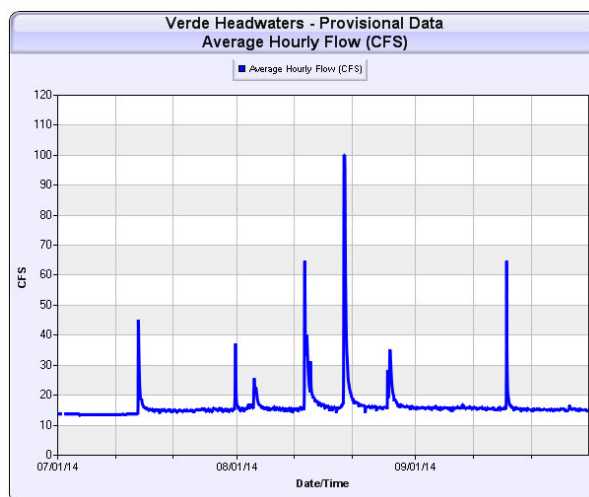
Figure 13 – Verde Headwaters Hydrograph: 2014 Monsoon Season Flow Events (7 total)

During the 2014 Monsoon season a total of 1,000 AF were recorded to flow at the seven SRP Flowtopography™ equipped stream flow monitoring locations recording stage levels within the Big Chino Sub-basin (UWCFS and UWCB excluded). A total of approximately 121 AF were recorded to flow through the LBCW location just upstream of Sullivan Dam near the headwaters of the Verde River. Sullivan Dam was not monitored during this period; therefore it was not determined whether any water recorded at LBCW spilled to the Verde River Canyon (approximately 3 miles upstream of the Verde Headwaters gage location) during the 2014 Monsoon Season. For the five flow events recorded at LBCW, spikes in flow at Verde Headwaters were observed during four of these events on 8/3/2014, 8/12/2014, 8/19/2014, and 9/16/2014 (Figure 13). Without monitoring of Sullivan Dam and Granite Creek, the contributing source of flow seen at Verde Headwaters during events is uncertain. If water did not spill over Sullivan Dam during flow events, it is assumed that surface water flow contributing to spikes in discharge seen at Verde Headwaters would be from Granite Creek and localized runoff below Sullivan Dam.
