## Big Chino Sub-basin Water Monitoring Project Winter/Spring Report: October 1, 2014 – June 30, 2015

Prepared for: CA1 Monitoring Committee  
(Prescott, Prescott Valley, SRP)  
9/15/2015

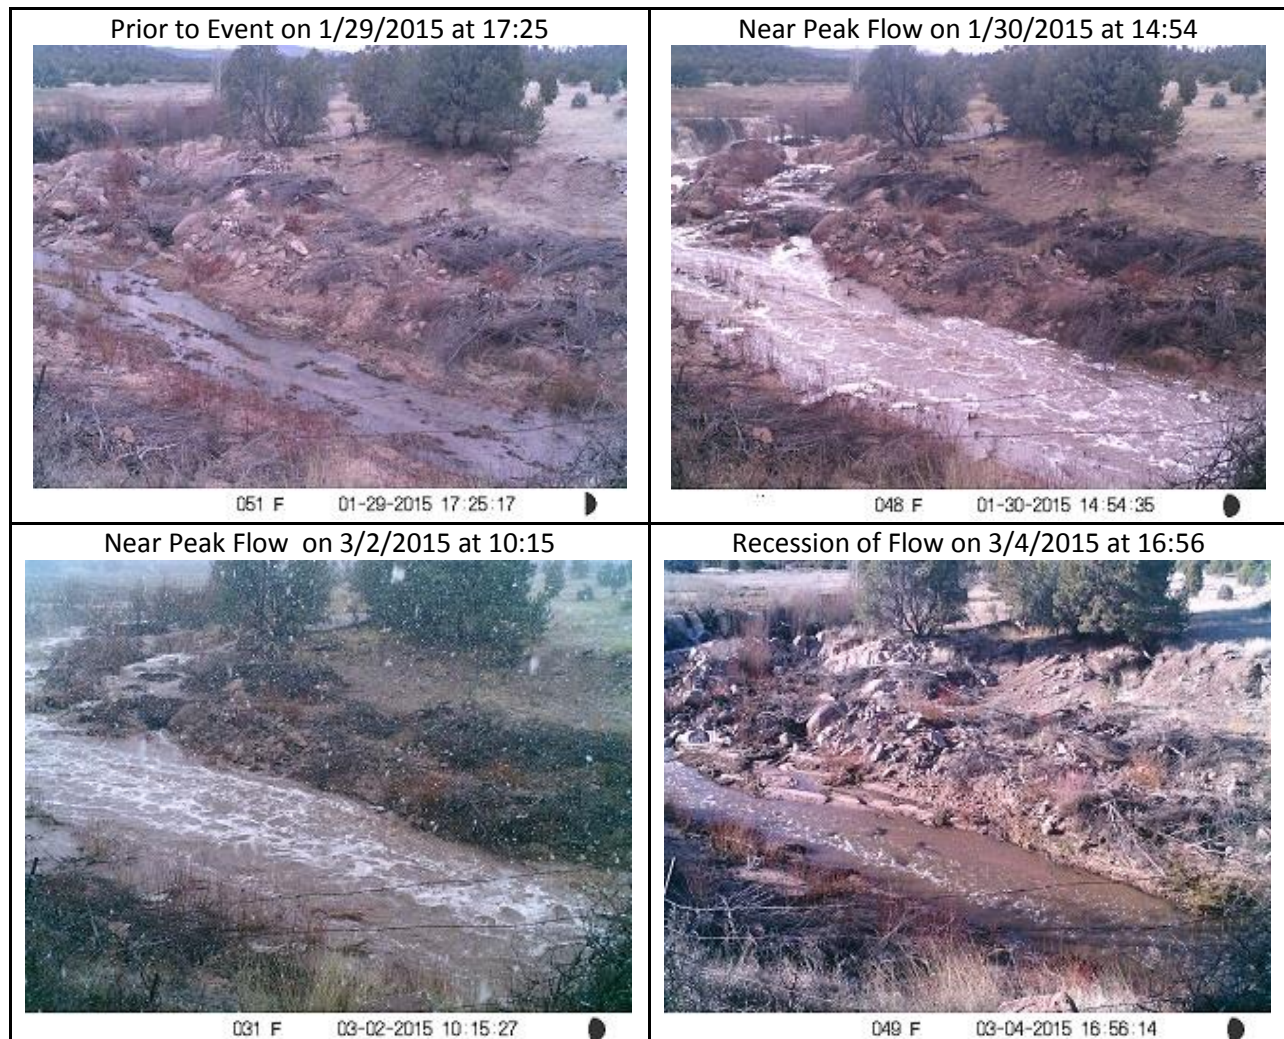
**Figure 6 – Upper Walnut Creek at Bridge Flow Event Flowtopography Images**

High flow events occurred on 1/30/2015 and 3/2/2015 (Figure 6), with duration of approximately 72 to 96 hours, respectively. The UWCB location was visited a total of nine times during the 2014-2015 winter/spring reporting period for routine maintenance and flowtopography image collection. Site visits on 1/7/2015, 2/10/2015, 3/25/2015, and 4/27/2015 also required replacement or repair of batteries or camera due to being inoperative.

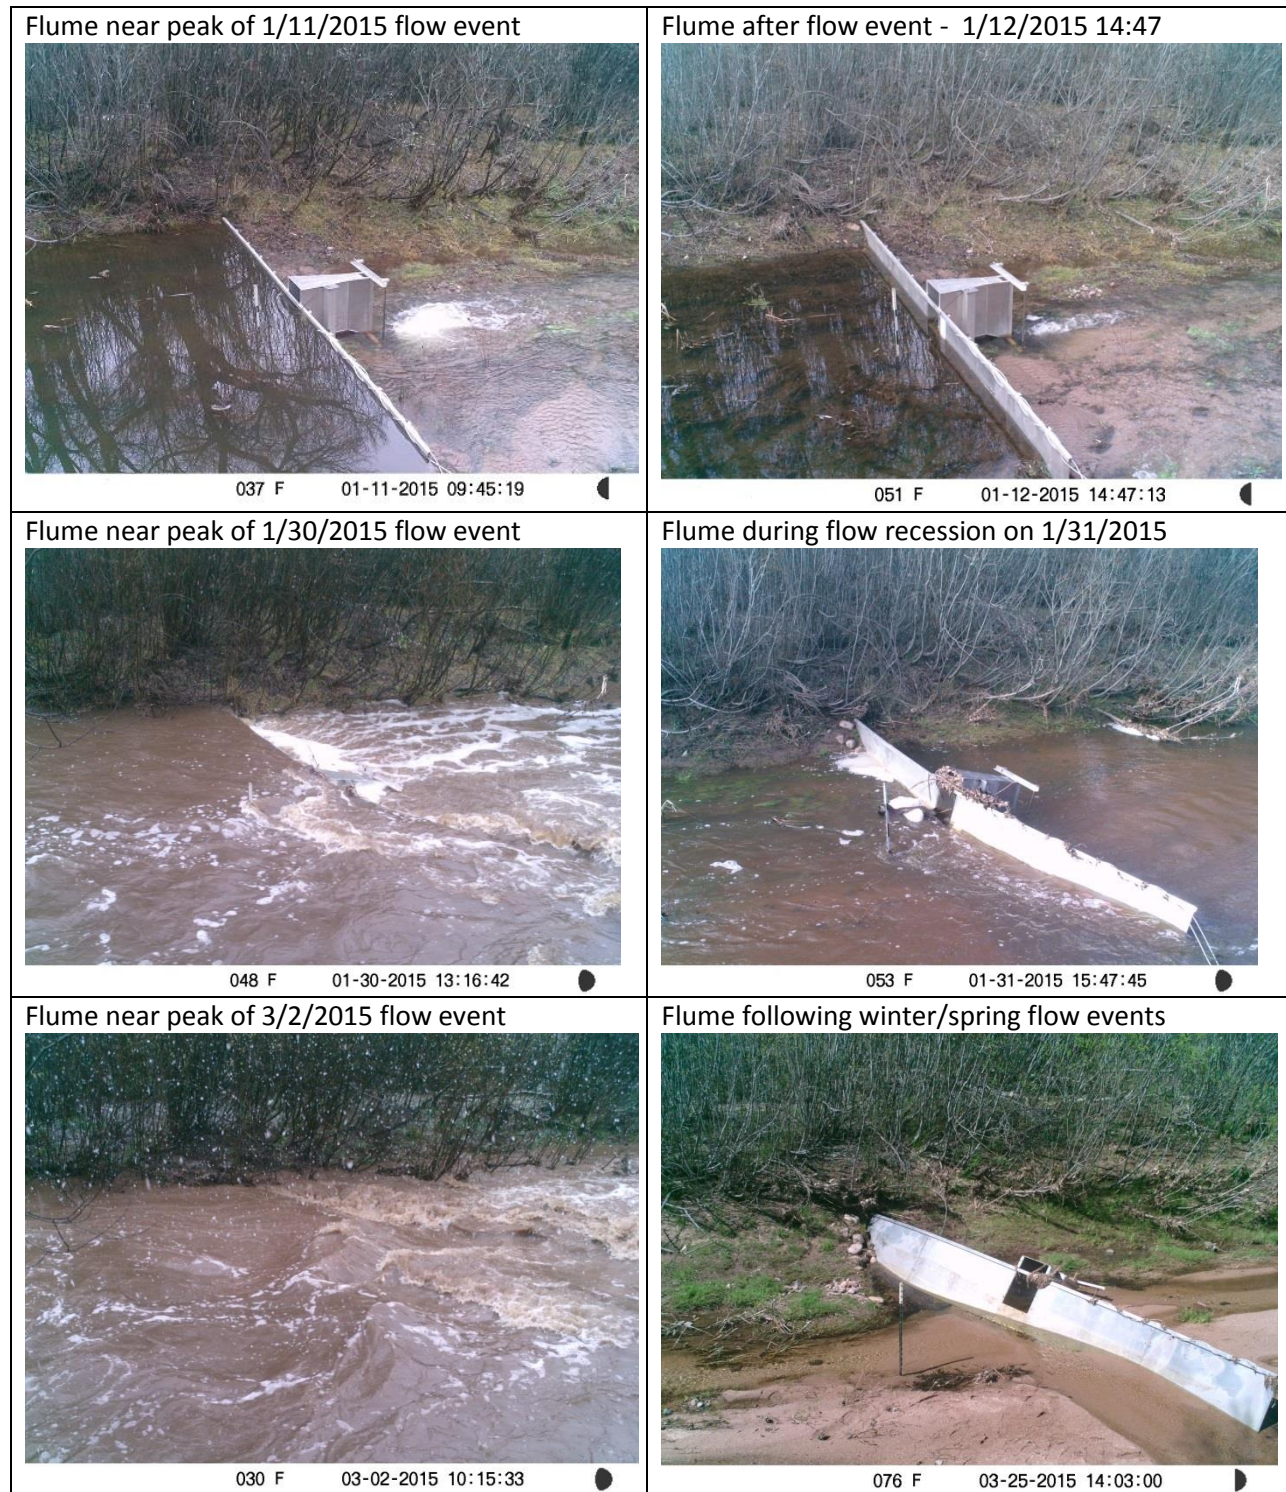
**Figure 9 – Upper Walnut Creek Forest Service Flow Events**

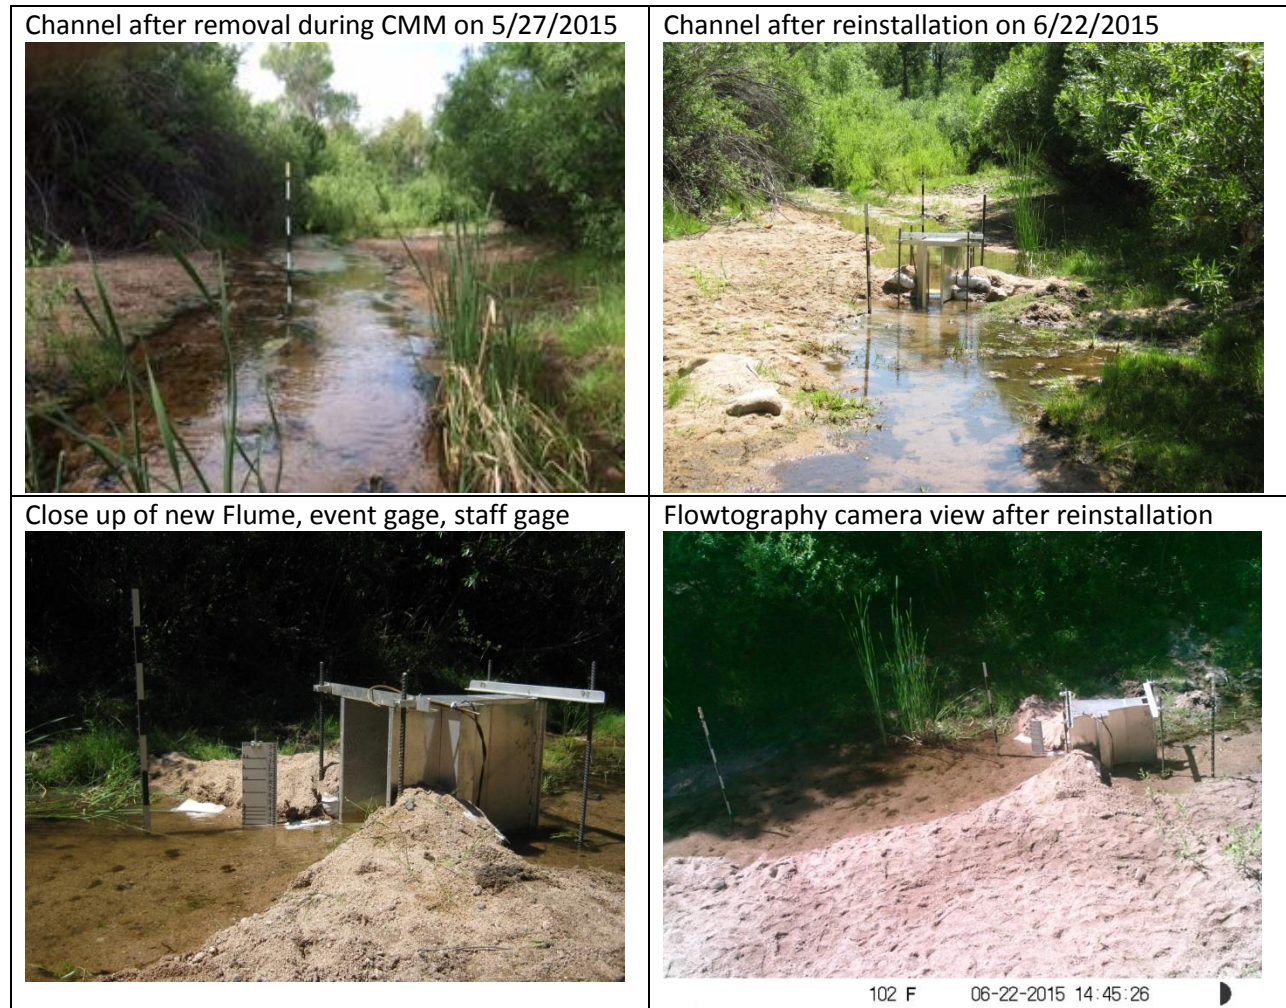
**Figure 10 – Upper Walnut Creek Forest Service Flume Reinstallation**

completed at the UWCFS location during site visits on 5/27/2015 and 6/22/2015. Discharges measured on these dates were 0.42 CFS and 0.13 CFS respectively. A simplified version of the low flow flume was reinstalled on 6/22/2015 approximately 6 feet upstream of the previous flume location in order to measure low flow in the channel. The pressure transducer was moved to the flume stilling well and calibrated to record stage level in the flume. The wing walls that previously crossed the entire channel were not reinstalled in order to allow higher flows to flow around the low flow flume to minimize impact to the site and equipment. Figure 10 shows images of the reinstalled flume at the UWCFS location.

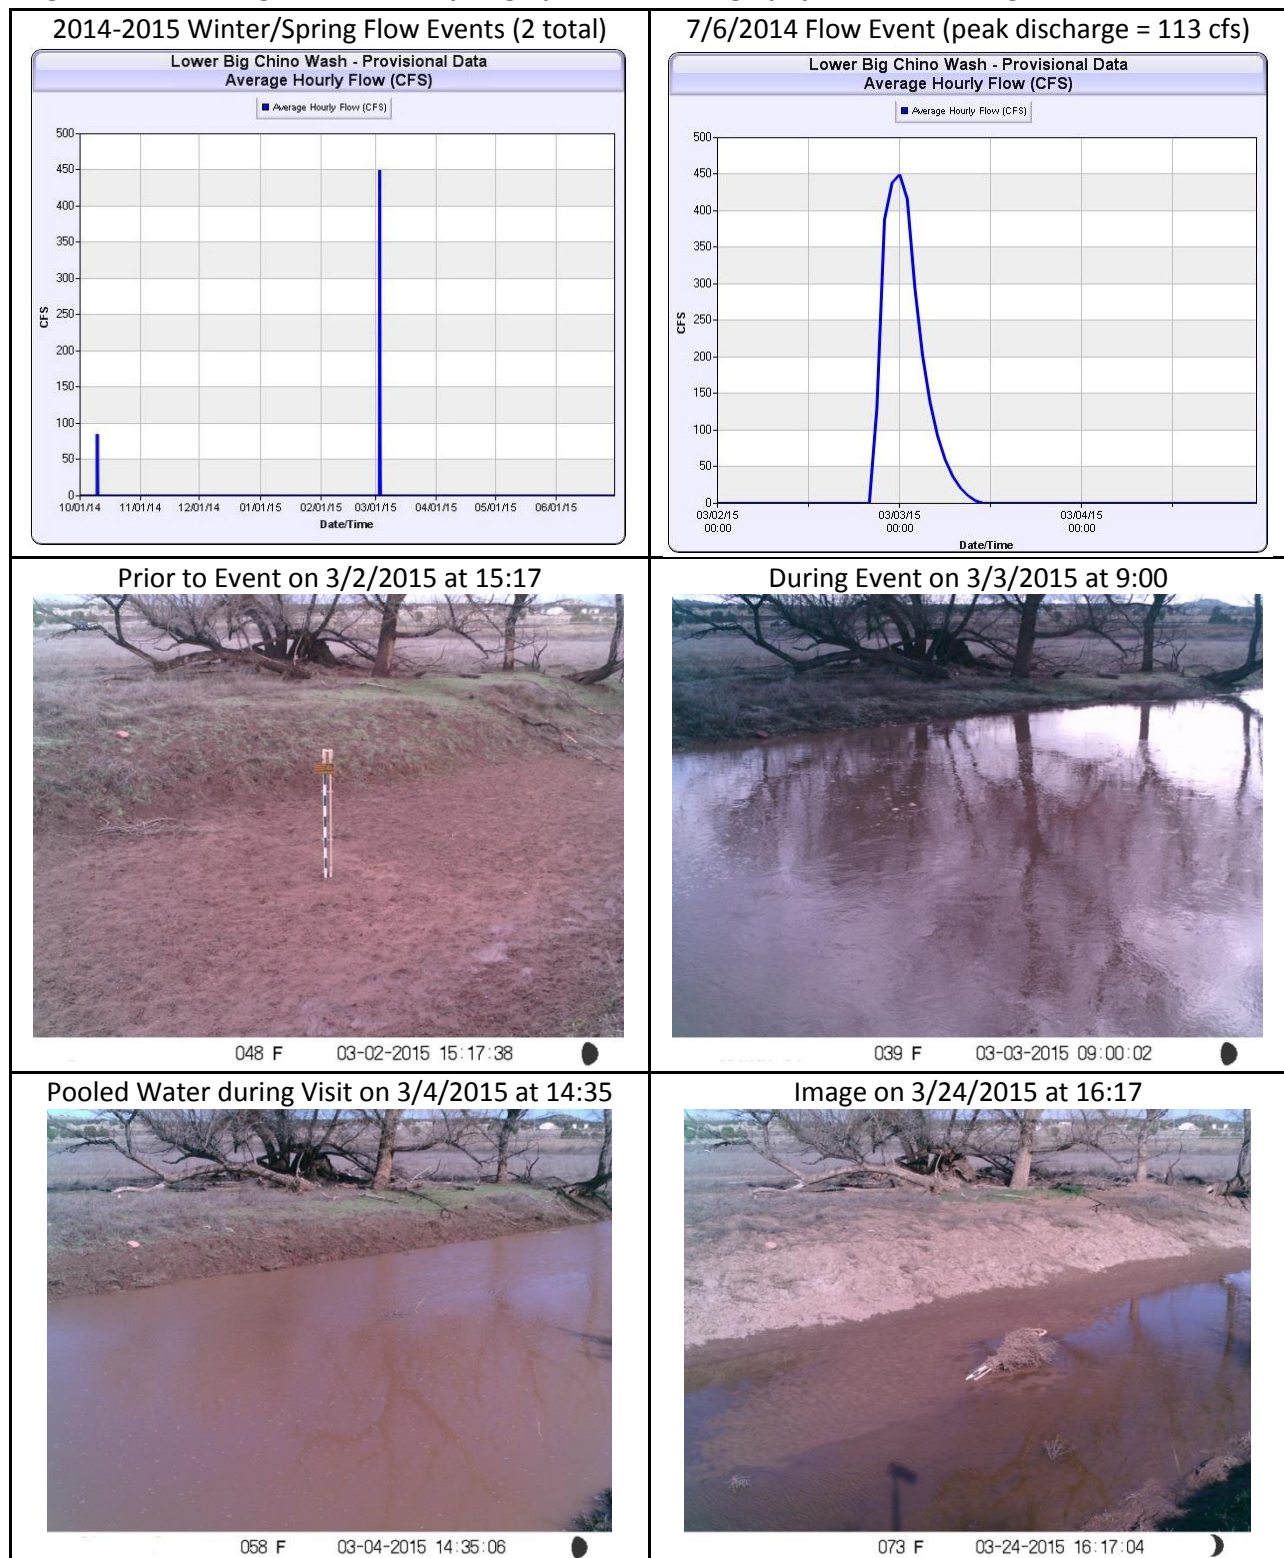
**Figure 14: Lower Big Chino Wash Hydrographs and Flowtopgraphy Flow Event Images**

Two flow events were recorded at Lower Big Chino Wash (LBCW) during the period from October 1, 2014 through June 30, 2015 (Table 8 and Figure 14). Peak discharge during events ranged from 96.8 CFS on 10/9/2014 to 459 CFS on 3/2/2015. Total volume of each event ranged from 26 AF to 222 AF, respectively, for a total volume of 248 AF estimated to flow through the LBCW location during the 2014-2015 winter/spring reporting period.
