ELKS BUILDINGS AND THEATER HISTORIC DISTRICT A PRESCOTT HISTORIC PRESERVATION DISTRICT

12.1 DISTRICT OVERVIEW AND HISTORY

HISTORIC PRESERVATION MASTER PLAN

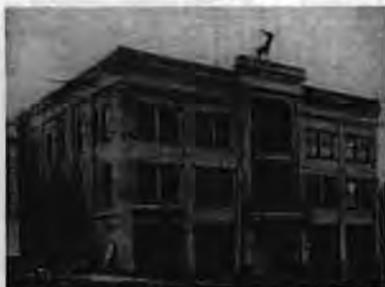
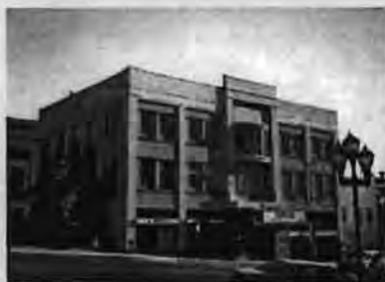
*Elks Building and Theater; 1906
and Today*

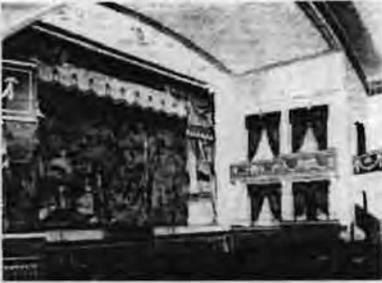
Original Theater Interior

The Elks Building and Theater is a three-story masonry structure of symmetrical massing. Measuring about 95 feet in width by 125 feet in depth, the floor plan is divided into two sections of approximately equal volume. The front portion is divided into rental spaces of various sizes; the rear portion is a theater. On the exterior, few eclectic features were employed. Instead, paired windows and colossal-order pilasters were juxtaposed to create a stark, structural effect. Banks of contrasting masonry above and below the windows accentuate the horizontal thrust.

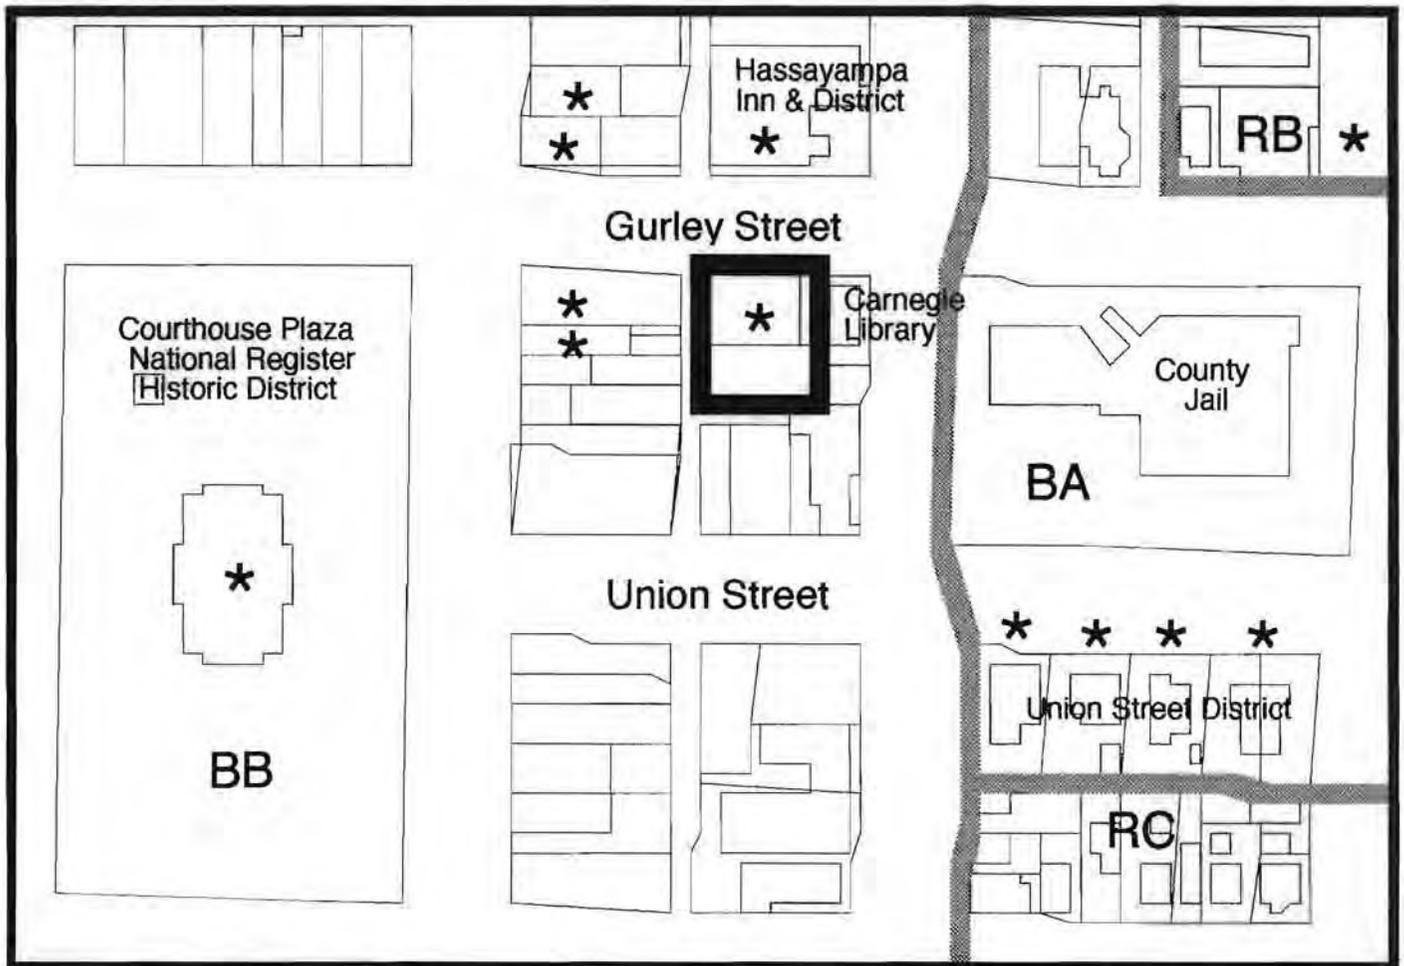
Figure
12-1

Local District Boundary

Elks Building & Theater
Prescott Historic Preservation District
District Boundary & Zoning
Not to Scale

The boundary of the district, along with current zoning, is shown on Figure 12-1.
