**Comprehensive Agreement #1
Prescott/Prescott Valley/SRP
Monitoring/Modeling Committee
FY20 Annual Report
(July 1, 2019 – June 30, 2020)**

Big Chino Sub-basin Water Monitoring Project

July 1, 2019 – June 30, 2020 Annual Report for CA1 Monitoring Committee
City of Prescott, Town of Prescott Valley, and Salt River Project

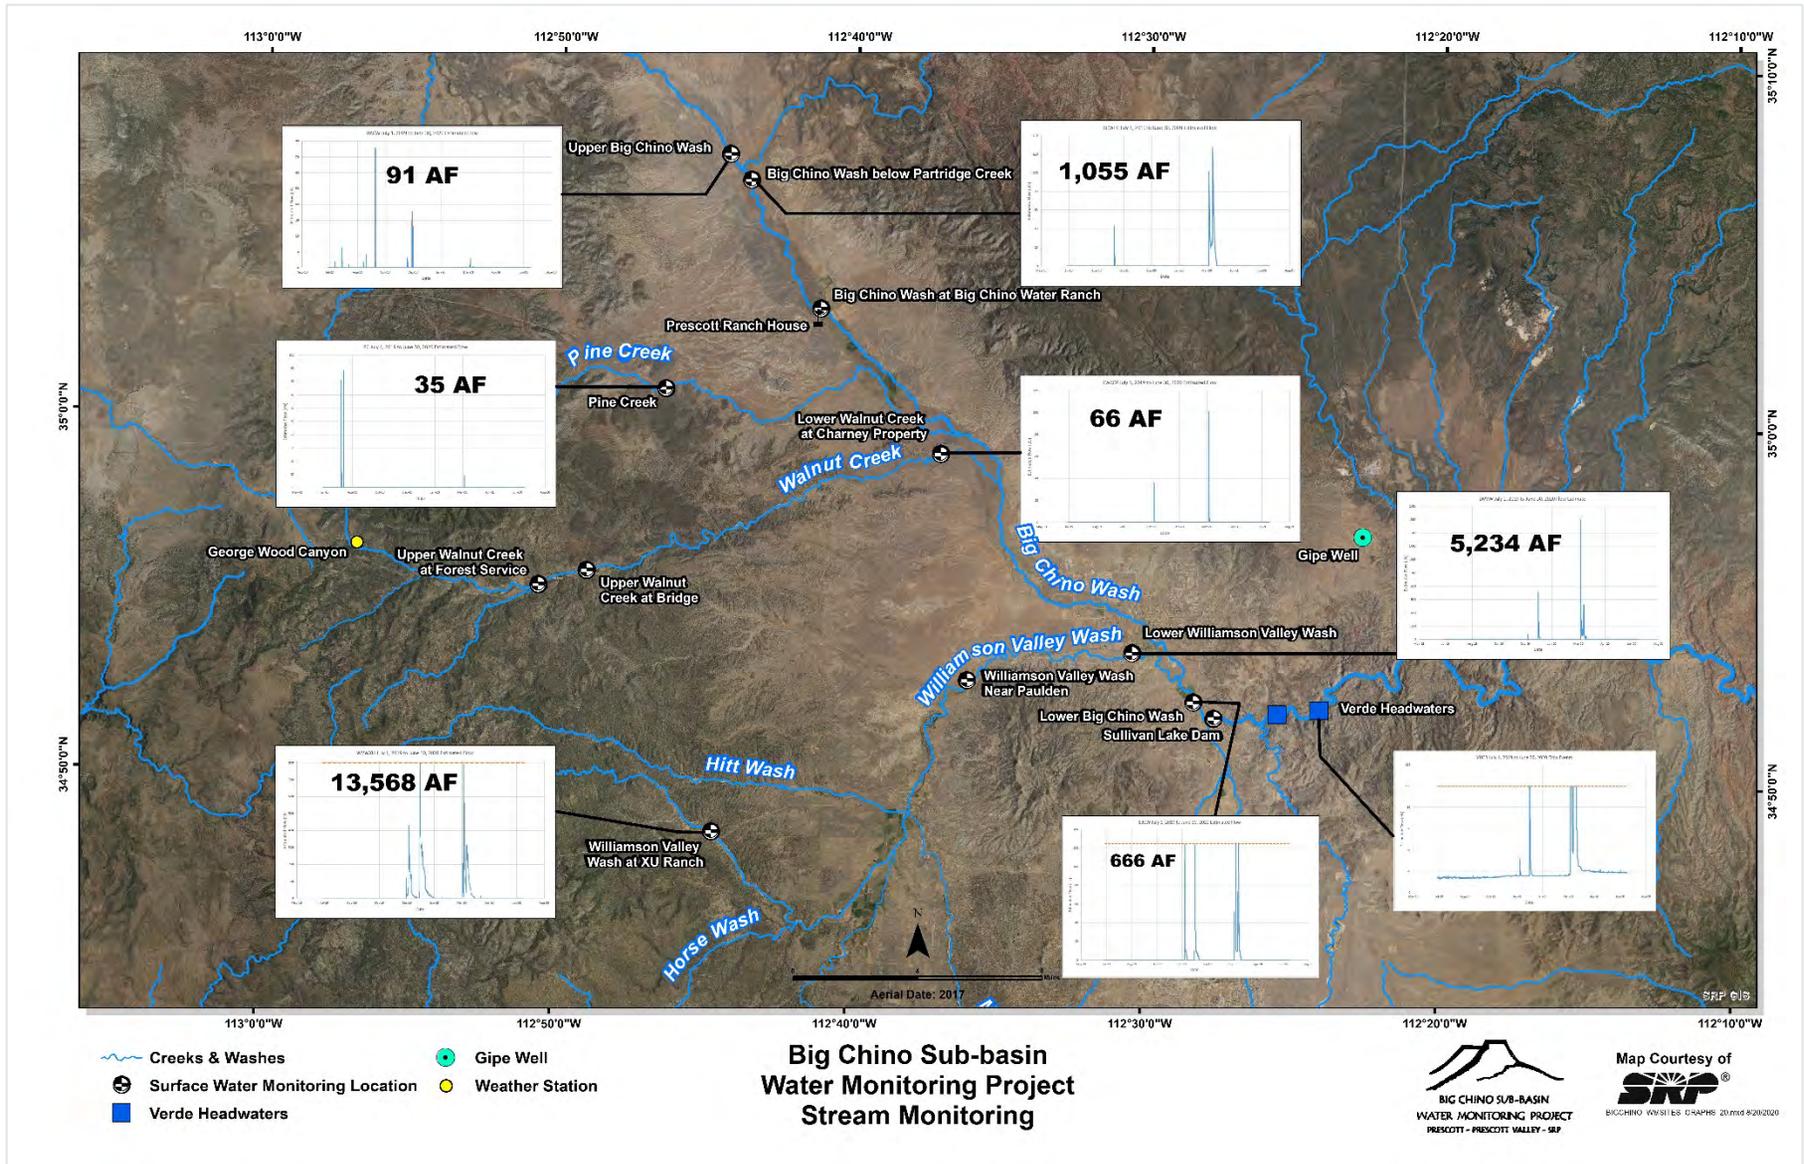
FIGURE 1. BIG CHINO SUB-BASIN MAP

Surface water flow was observed at each SRP Flowtography® site during the 2020 annual reporting period. The flow event start date, an estimate of the magnitude of the flow, and the locations where surface water flow was observed are shown in Table 1 and Figure 1.

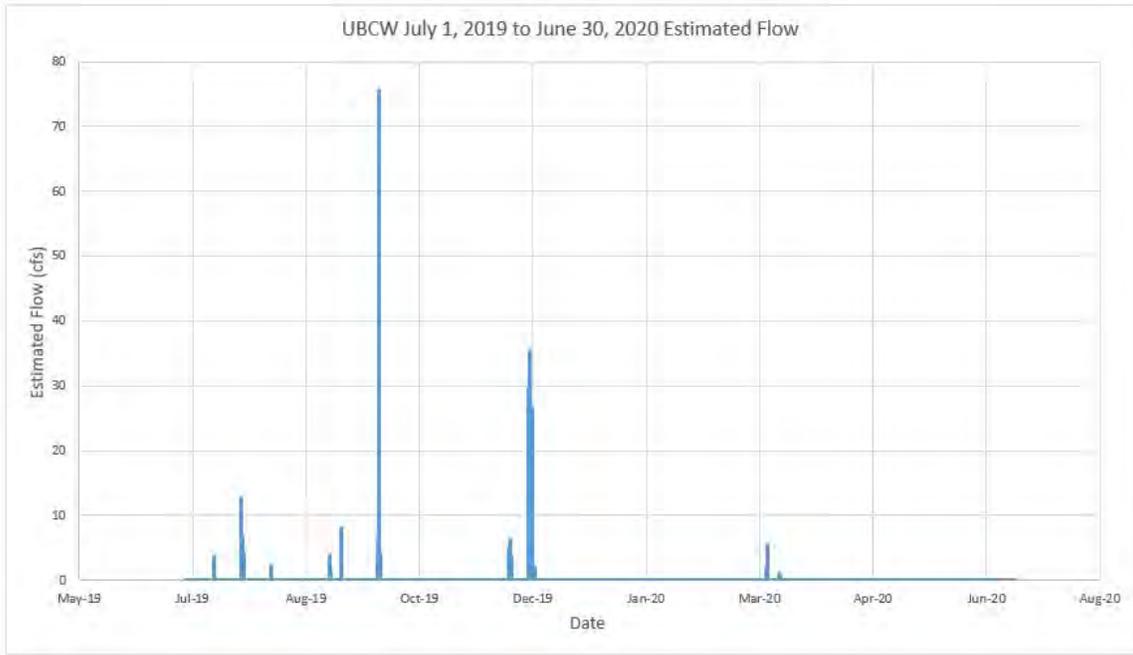
FIGURE 2. UBCW JULY 1, 2019 – JUNE 30, 2020 ANNUAL FLOW EVENTS

Eleven (11) events with measurable ephemeral flow were observed at UBCW during the 2020 annual monitoring period. UBCW responded to monsoon and winter related precipitation events. Peak discharge for the year was an estimated 75 cubic feet per second (cfs) observed on 9/23/2019. The flow event on 11/28/2019 was the longest lasting, with a duration of 78.5 hours, resulting in an estimated total flow volume of 54 AF or 59% of the annual volume at the site. The total estimated volume recorded at the site for the 2020 reporting period was 91 AF. Flow events, durations, and estimated flow volumes for the annual reporting period are outlined in Table 2 and Figures 2-4.

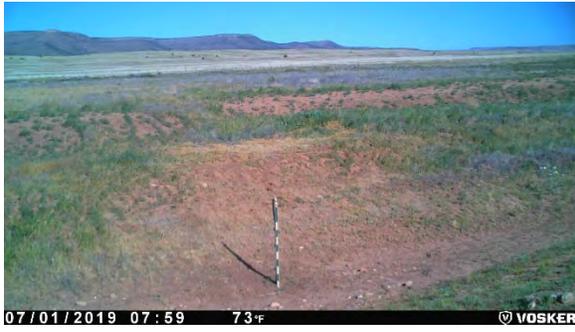
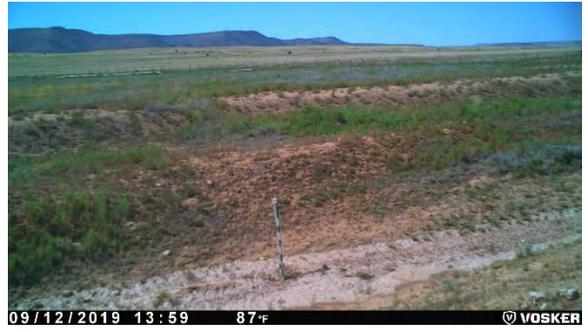
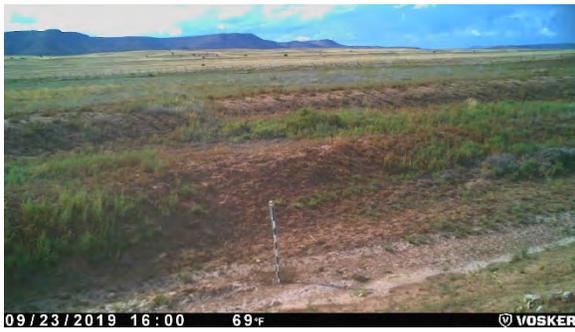
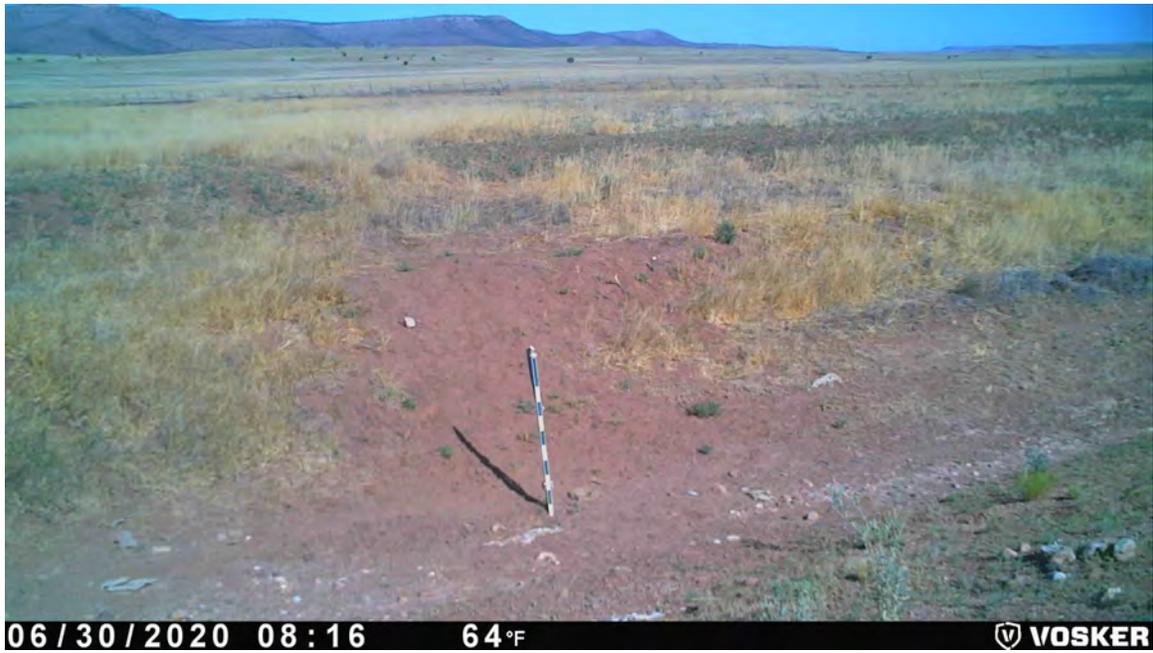
FIGURE 4. UBCW IMAGE DATA

UBCW at the start of the 2020 reporting period:

Greenup after 2019 winter events:

Before Peak of 9/23/2019 flow event:

Peak of 9/23/2019 flow event:

UBCW at the end of the 2020 reporting period:

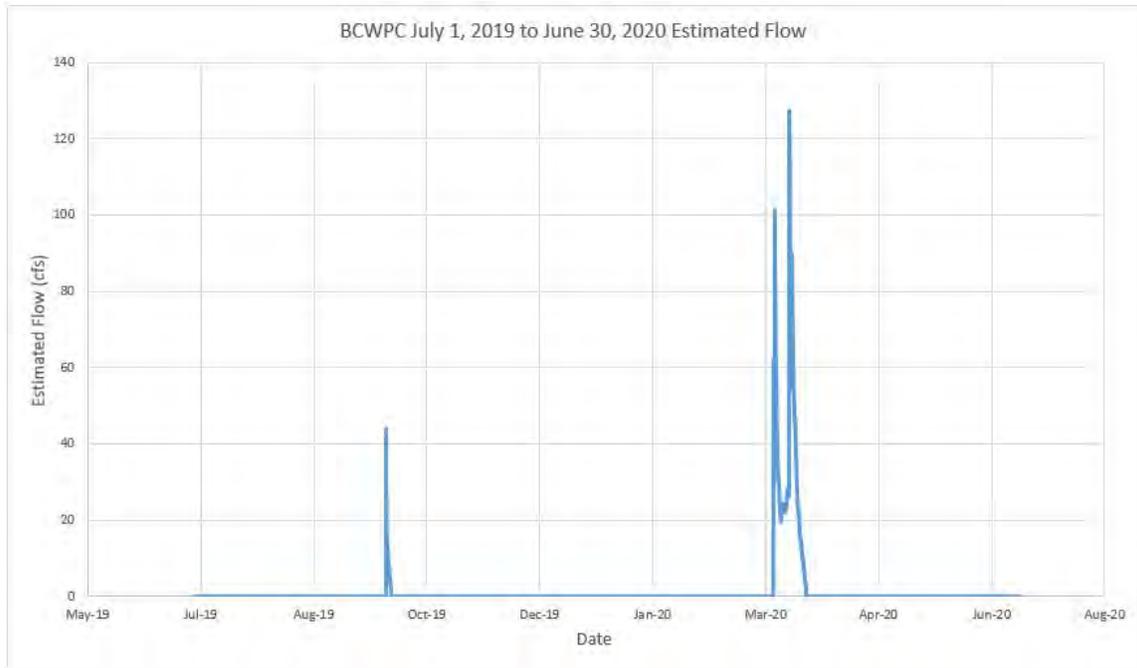
FIGURE 5. BCWPC JULY 2019 – JUNE 2020 ANNUAL FLOW EVENTS

Two (2) events with measurable ephemeral flow were observed at BCWPC during the 2020 annual monitoring period. BCWPC responded to monsoon and winter related precipitation events. Peak discharge for the year was an estimated 127 cfs observed on 3/13/2020. The 3/13/2020 event was the longest lasting event observed at the site for the reporting period with a duration of 361.25 hours, resulting in an estimated total flow volume of 1008 AF or 96% of the annual volume at the site. The 3/13/2020 flow event resulted in the largest estimated flow volume at 1008 AF or 96% of the annual volume at the site. The total estimated volume recorded at the site for the 2020 reporting period was 1,055 AF. BCWPC flow events, durations, and estimated volumes for the 2020 reporting period are outlined in Table 3 and Figures 5-7.

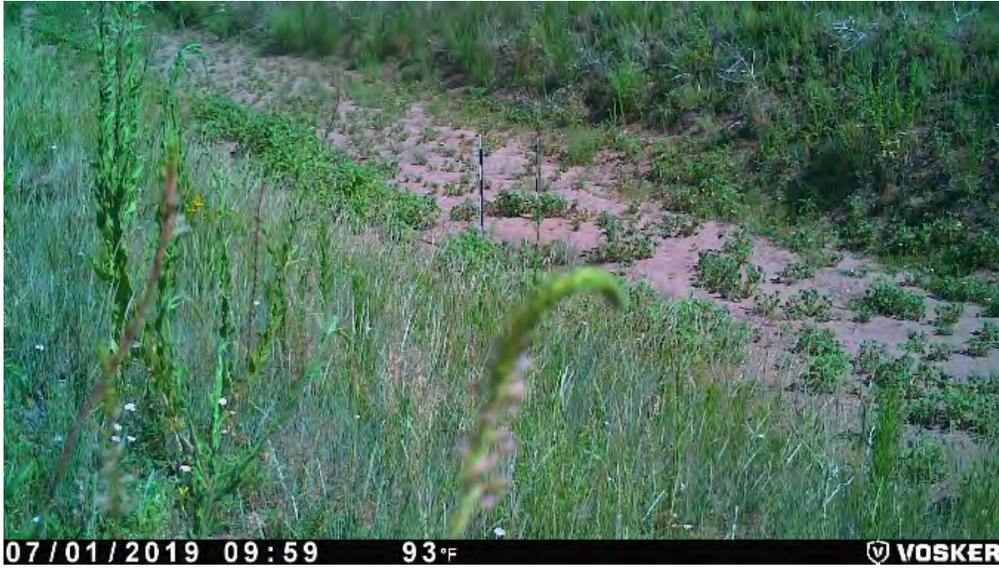
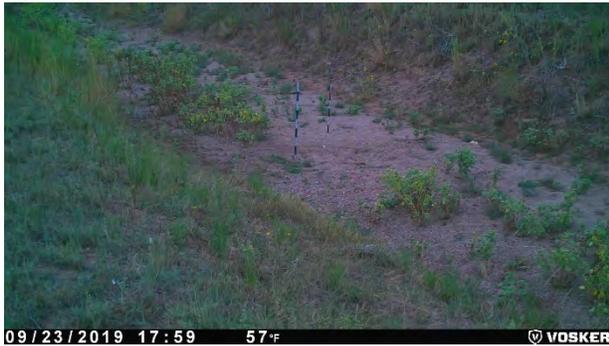
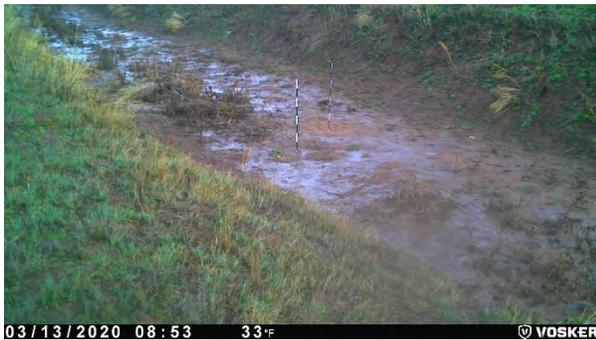
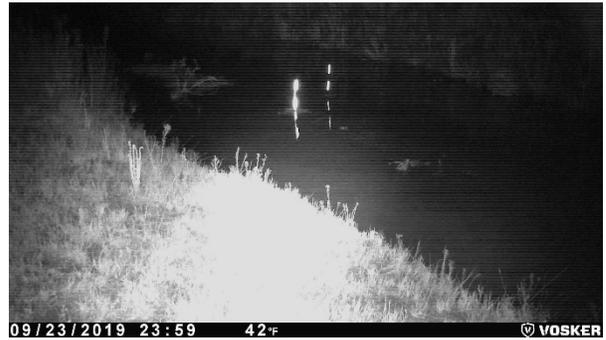
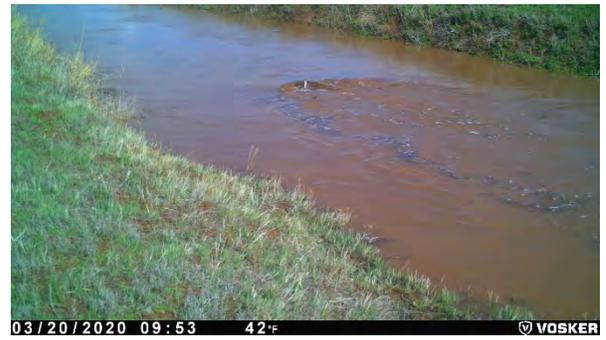
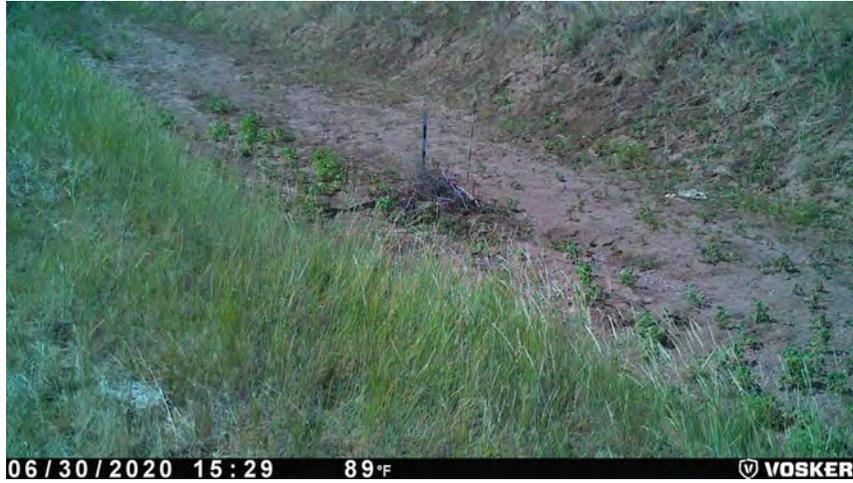
FIGURE 7. BCWPC IMAGE DATA

BCWPC at the start of the 2020 reporting period:

Start of flow event on 9/24/2019:

Flow event on 3/13/2020 before peak:

Peak of flow event on 9/23/2019:

Peak of flow event on 3/20/2020:

BCWPC at the end of the 2020 reporting period:

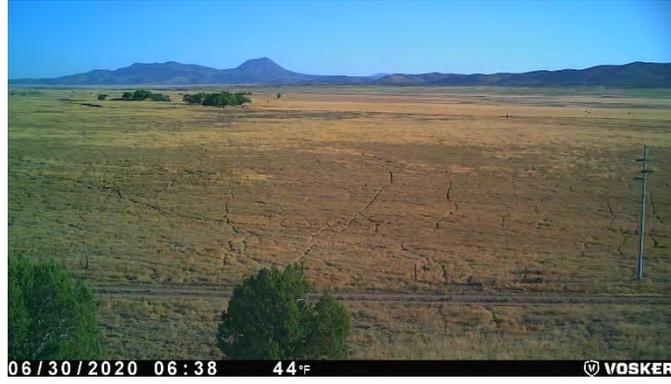
FIGURE 8. BCWR IMAGE DATA

BCWR at the end of the 2020 reporting period:

Precipitation was observed at BCWR on seventy-two (72) days during the 2019 annual monitoring period. Snow accumulation was visible on Five (5) of those days. None of the observed events resulted in water pooling at the surface. BCWR site images for the annual reporting period can be seen in Figure 8 below.

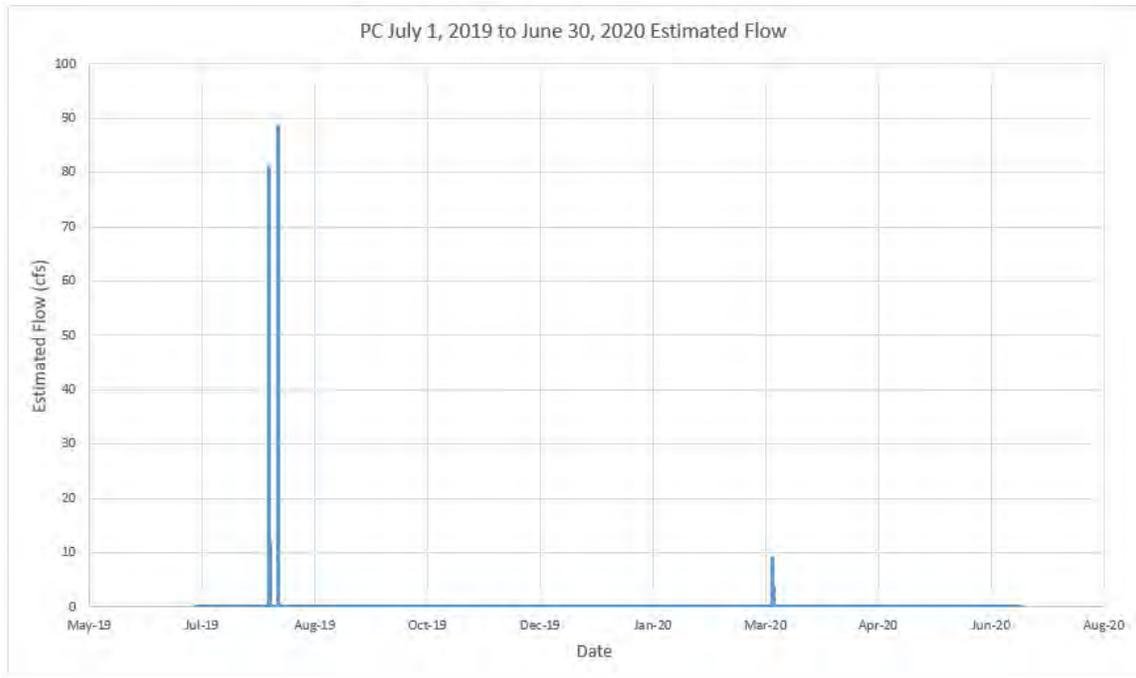
Figure 9. PC July 2019 – June 2020 Annual Flow Events

Three (3) events with measurable ephemeral flow were observed at PC during the 2020 annual monitoring period. PC responded to monsoon and winter related precipitation events. The flow event on 8/06/2019 lasted for 10.75 hours and had an estimated peak stage of 1.25 feet; the peak discharge was 88 cfs. The 3/13/2020 flow event was the longest lasting event observed at the site for the reporting period with a duration of 13.5 hours, resulting in an estimated total flow volume of 4 AF or 11% of the annual volume at the site. The total estimated volume recorded at the site for the 2020 reporting period was 35 AF. PC flow events, durations, and estimated flow volumes for the annual reporting period are outlined in Table 4 and Figures 9-11.

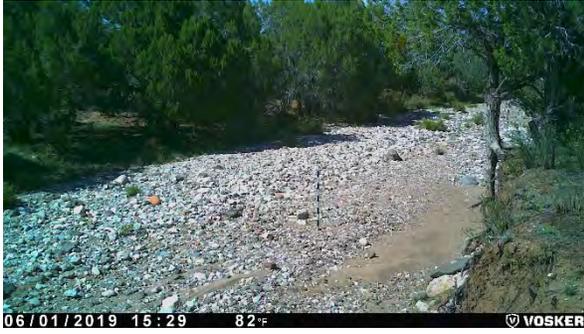
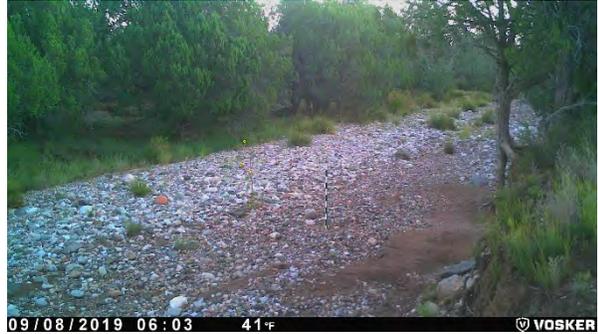
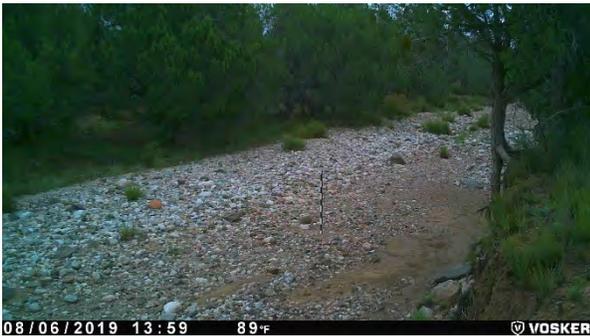
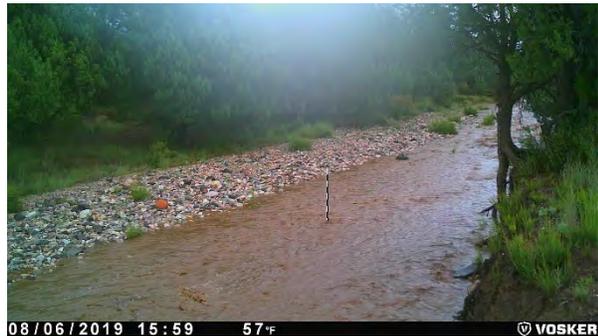
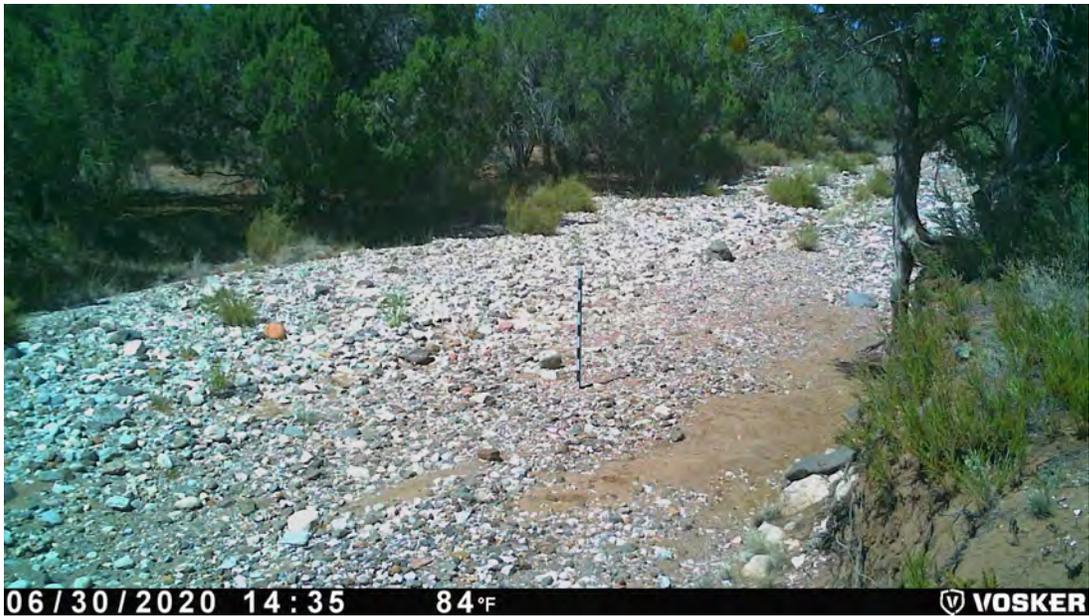
FIGURE 11. PC IMAGE DATA

PC at the start of the 2020 reporting period:

Greenup after 2019 monsoon events:

Start of flow event on 8/6/2019:

Peak of flow event on 8/6/2019:

PC at the end of the 2020 reporting period:

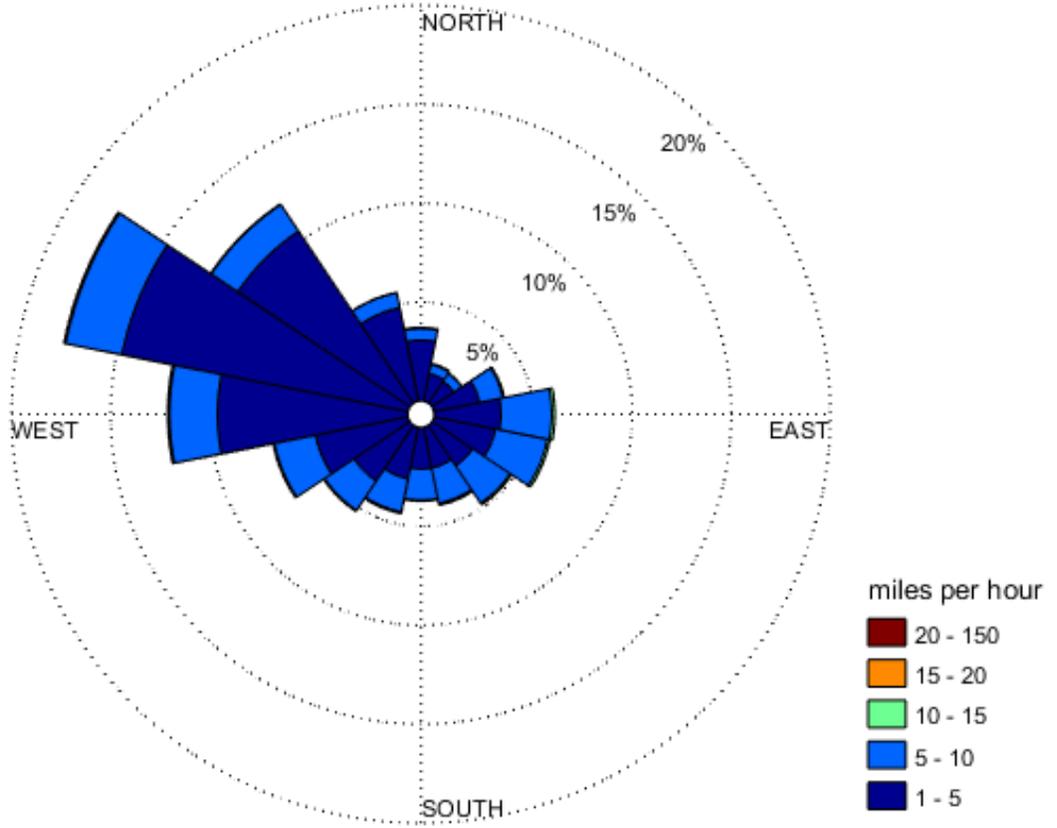
FIGURE 12. GWC JULY 2019 – JUNE 2020 WIND ROSE

- 15.09" of precipitation was observed during the 2020 reporting period
- The predominant wind direction was WNW with a peak gust of 28.3 mph on 4/8/2020
- Air temperature ranged from a maximum of 93.2°F in August 2019 to a minimum of 12.2°F in February 2020

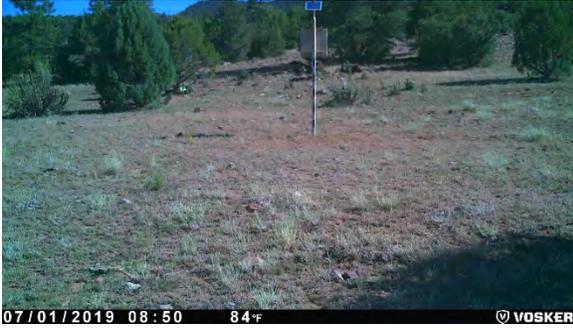
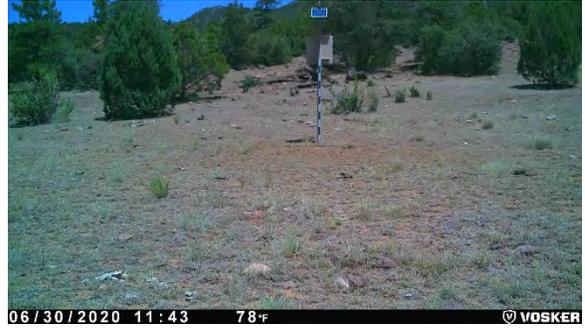
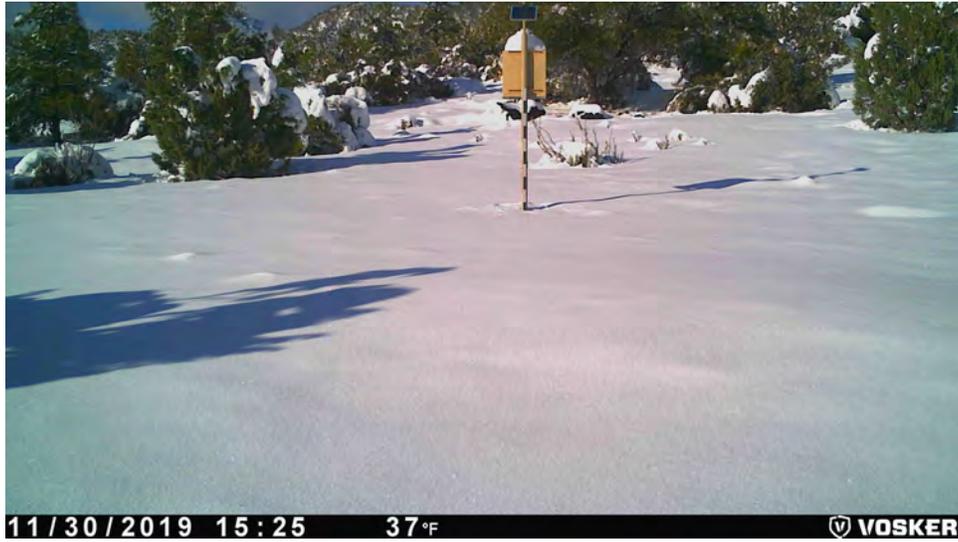
FIGURE 19. GWC IMAGE DATA

GWC at the beginning of the 2020 reporting period:

GWC at the end of the 2020 reporting period:

Snow event on 11/29/19 - 12/4/2019:

Seven (7) snow events were observed during the 2020 reporting period. For five (5) of the observed events, snow depth never surpassed 0.1 feet (see Table 5). Two (2) events produced measurable snow, 11/29/2019, with a peak around 0.7' (see Figure 19) and the final event of the year on 3/18/2019, with accumulations near 0.3'. The 11/29/2019, and 12/26/2019, events each last six days. The latter event produced far less snow accumulations, but lasted multiple days to an extended period of cold temperatures.

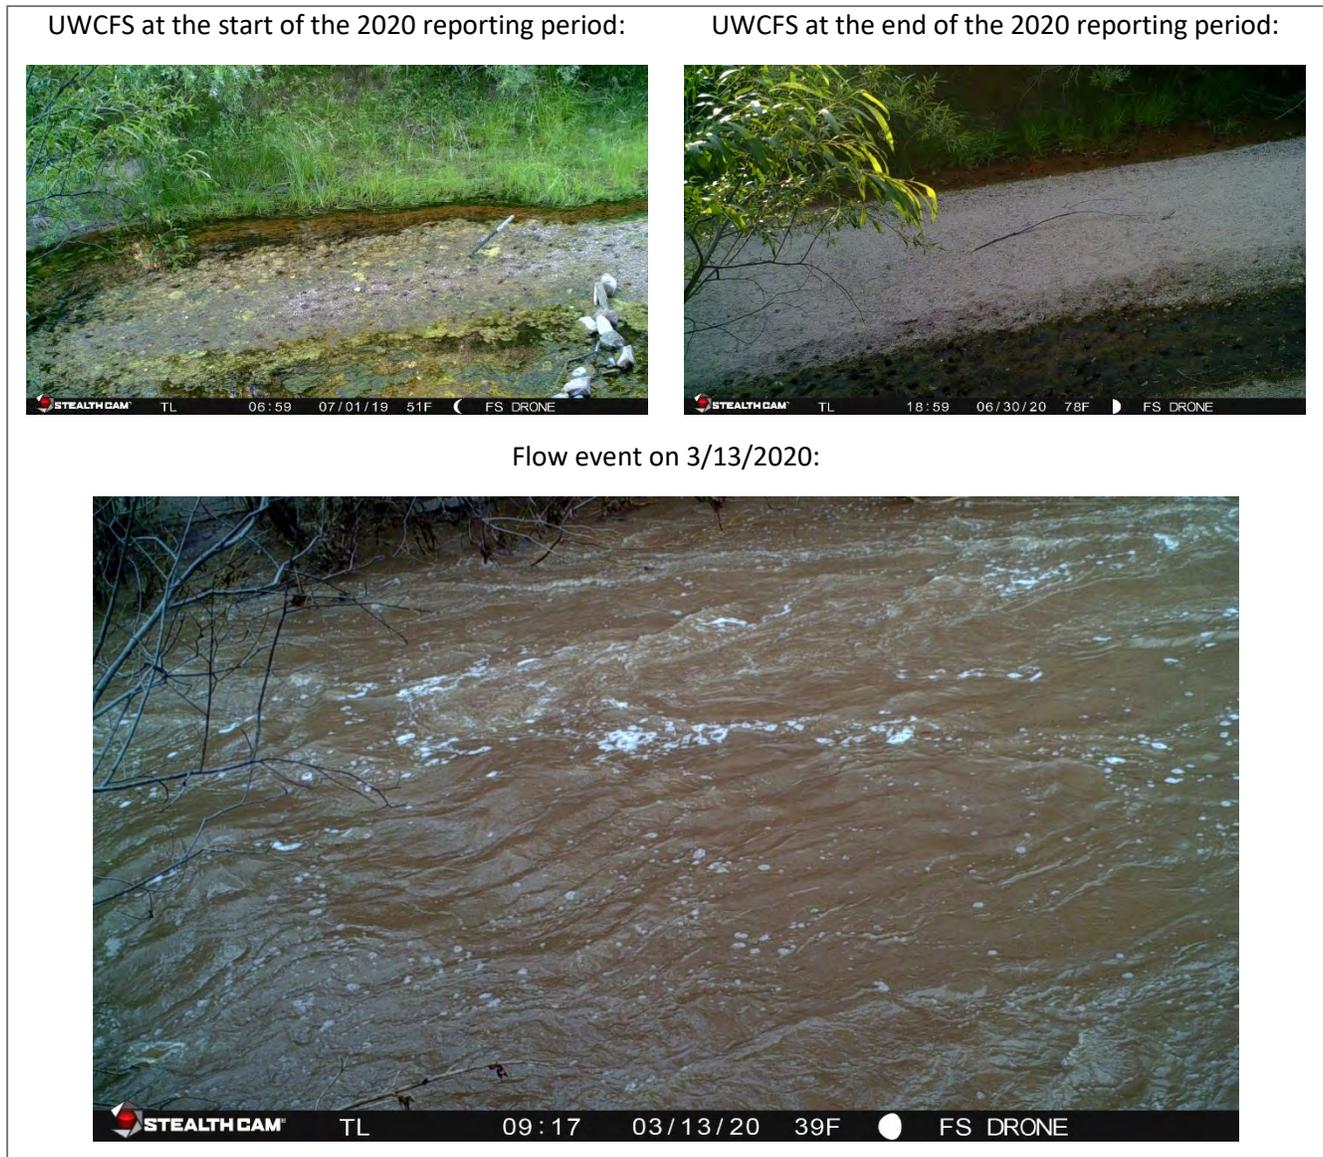
FIGURE 20. UWCFS IMAGE DATA

There are no estimates of flow at this site following the removal of the flume on December 22, 2016, other than visual wet/dry conditions. UWCFS site images are shown in Figure 20 below. UWCFS was dry (the site had no surface flow) from 7/28/2019 through 11/21/2019.

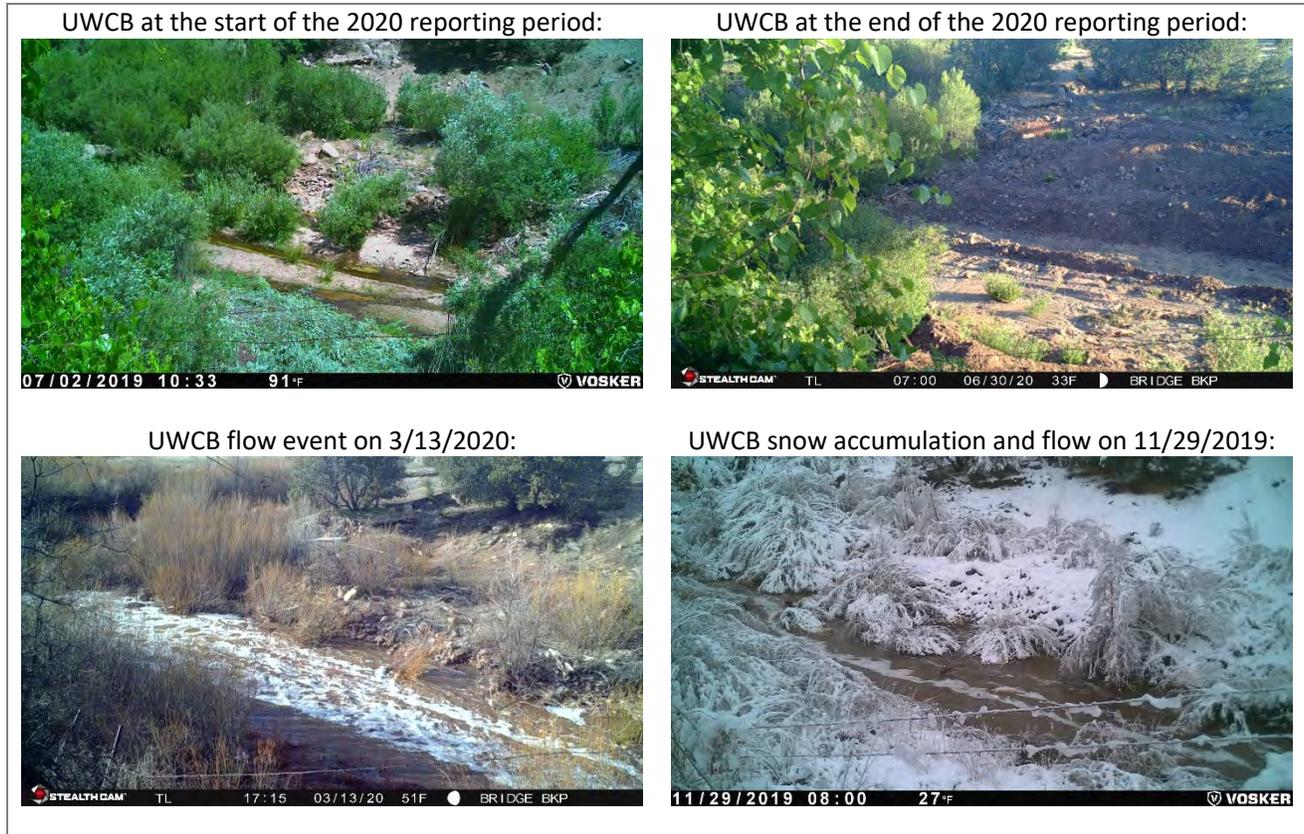
FIGURE 21. UWCB IMAGE DATA

No surface water is visible at the start or the end of the 2020 annual monitoring period (see Figure 21). Maturing plant and vegetation growth block a clear view of the channel at both of these times, and for much of the reporting period.

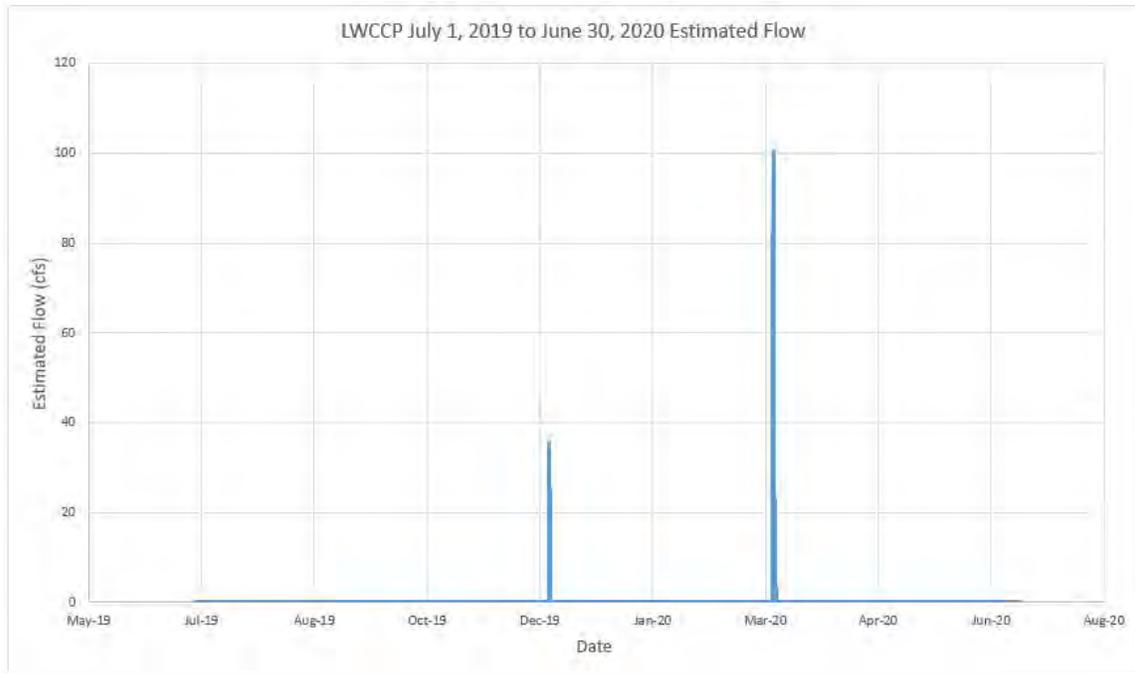
FIGURE 22. LWCCP JULY 2019 – JUNE 2020 ANNUAL FLOW EVENTS

Two (2) events with measurable ephemeral flow were observed at LWCCP during the 2020 annual monitoring period. LWCCP responded to monsoon and winter precipitation events. The flow event on 3/13/2020 lasted for 35.5 hours and had an estimated peak stage of 1.06 feet; the peak discharge was greater than 100 cfs. The total estimated volume recorded at the site for the 2020 reporting period was greater 66 AF. LWCCP flow events, durations, and estimated flow volumes for the annual reporting period are outlined in Table 6 and Figures 22-24.

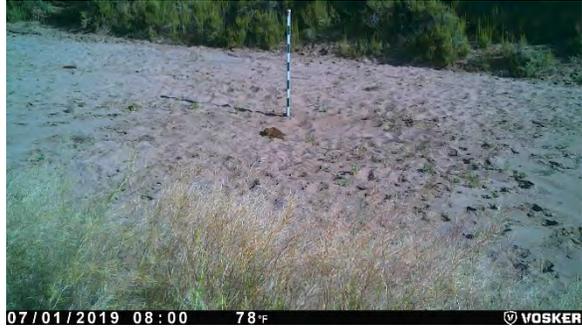
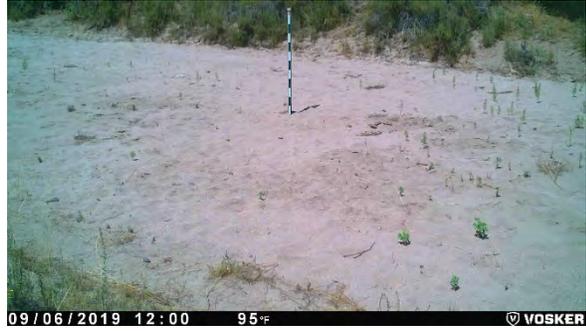
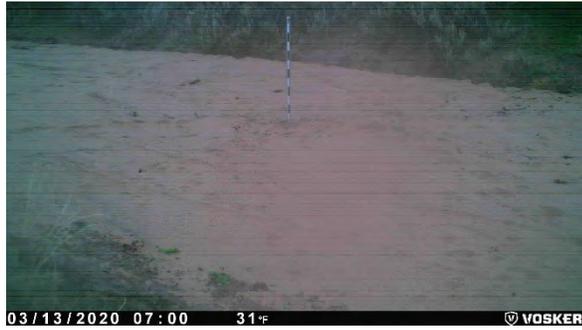
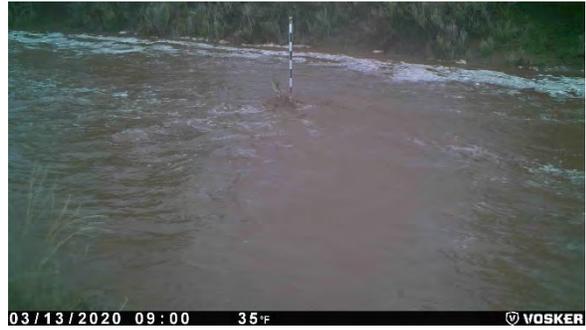
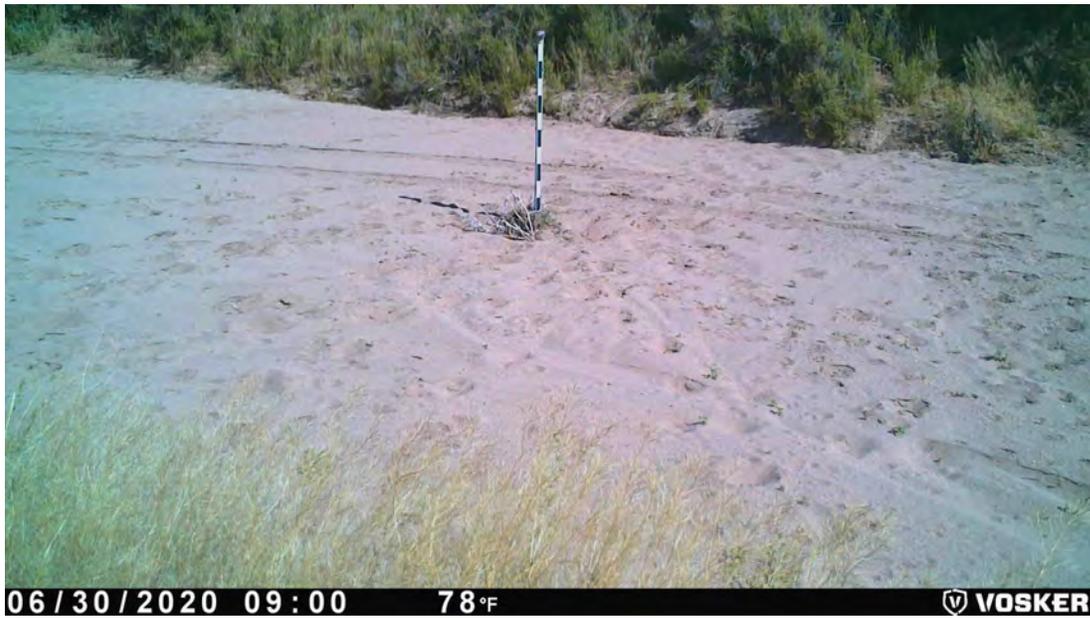
FIGURE 24. LWCCP IMAGE DATA

LWCCP at the start of the 2020 reporting period:

Greenup after 2019 monsoon events:

Before the flow event on 3/13/2020:

Aftermath of peak of flow event on 3/13/2020:

LWCCP at the end of the 2020 reporting period:

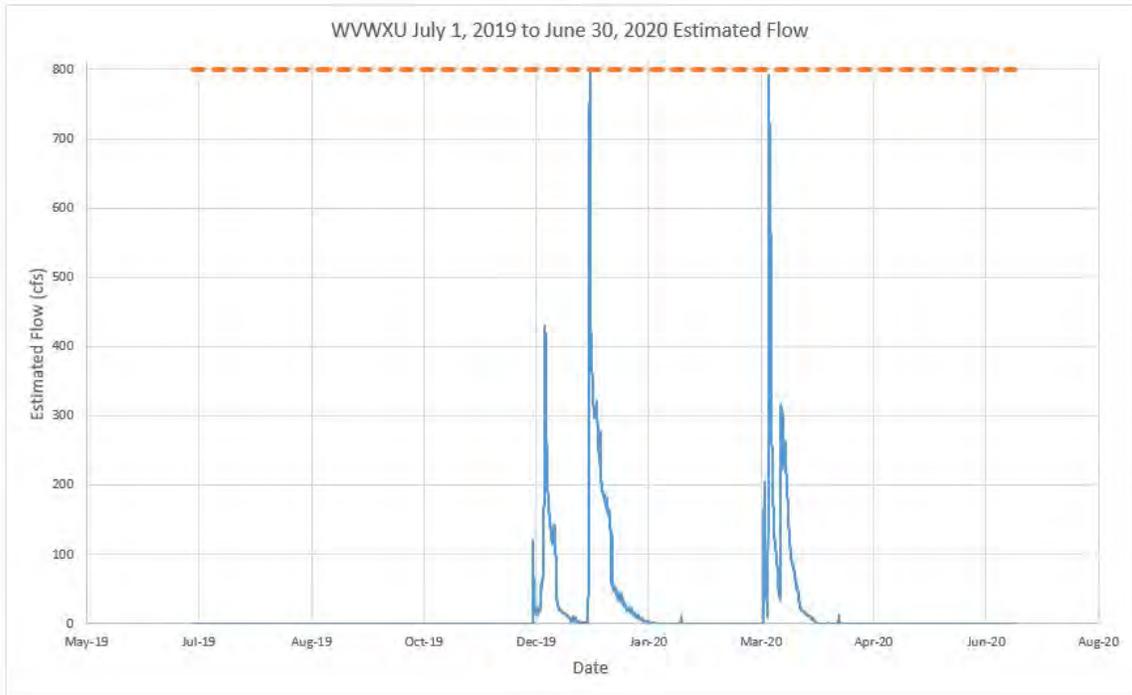
FIGURE 25. WVWXU JULY 2019 – JUNE 2020 ANNUAL FLOW EVENTS¹⁹

Three (3) events with measurable ephemeral flow were observed at WVWXU during the 2020 annual monitoring period. WVWXU responded to monsoon and winter related precipitation events. Peak discharge for the year was an estimated 800¹⁹ cfs, observed on 11/29/2019. That event produced the largest estimated flow volume of 8,473²⁰ AF, or 62% of the annual volume at the site. The total estimated volume observed at the site for the 2019 reporting period was 13,568¹⁹ AF. WVWXU flow events, durations, and estimated flow volumes for the annual reporting period are outlined in Table 7 and Figures 25-27 below.

¹⁹ The peak discharge noted is the maximum calculated discharge for the site according to the existing discharge rating. Actual peak discharge may be greater than this.

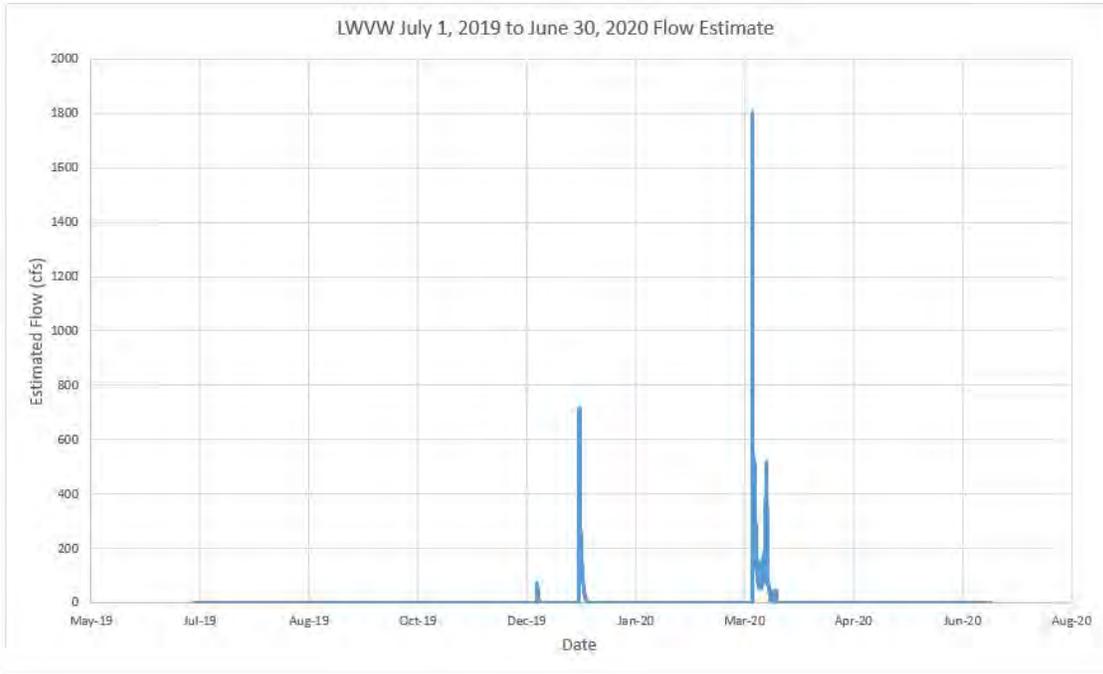
FIGURE 28. LWVW JULY 2018 – JUNE 2019 ANNUAL FLOW EVENTS

Three (3) events with measurable ephemeral flow were observed at LWVW during the 2020 annual monitoring period. LWVW responded to monsoon and winter related precipitation events. The event on 3/13/2020 was the longest lasting with a duration of 264 hours and an estimated peak stage of 4.09 feet; the peak discharge was 1,804 cfs. This event was also the highest estimated stage. The total estimated volume recorded at the site for the 2020 reporting period was greater than 5,234 AF. LWVW flow events, durations, and estimated flow volumes for the annual reporting period are outlined in Table 8 and Figures 28-30 below.

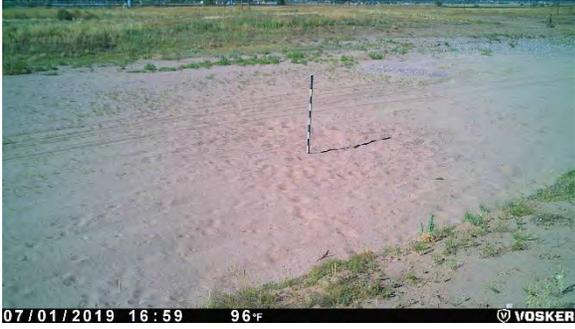
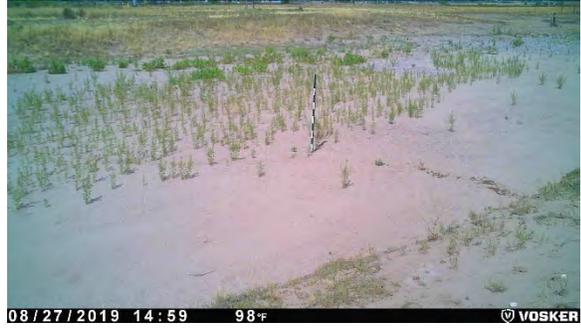
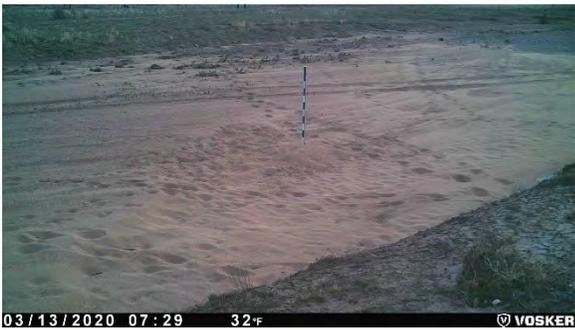
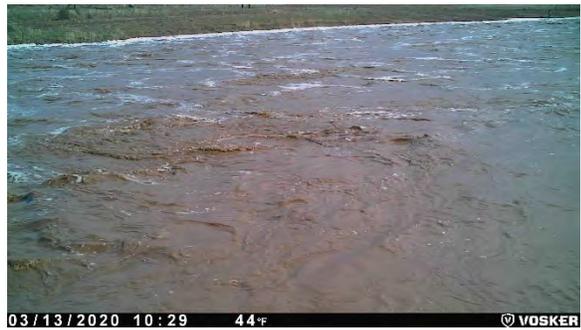
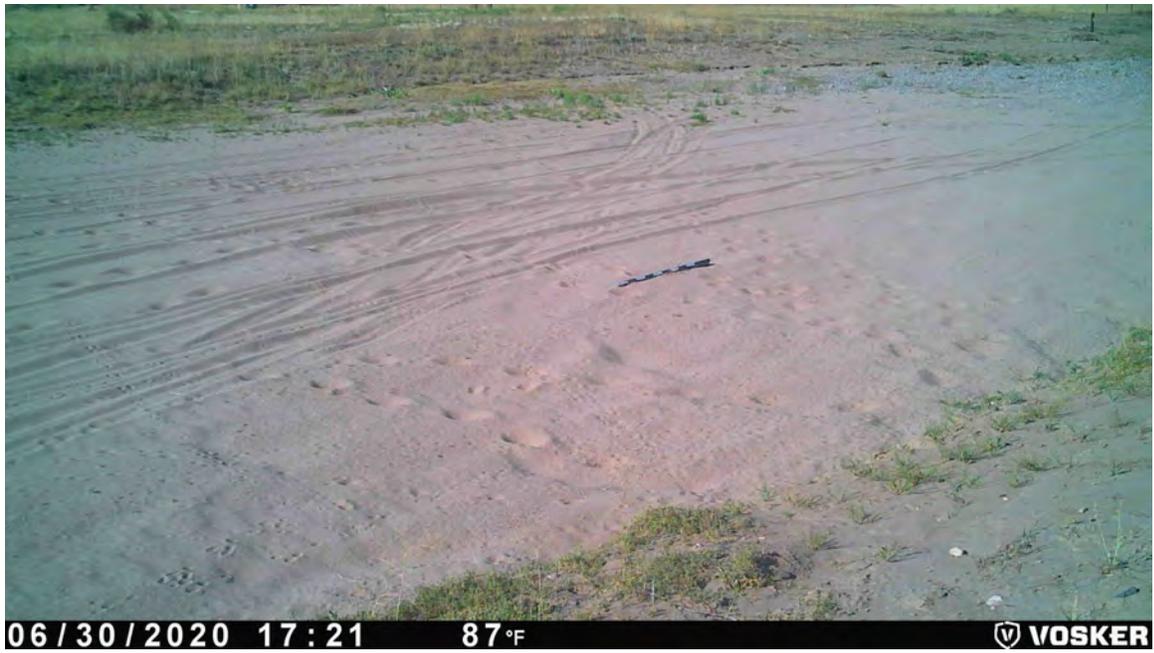
FIGURE 30. LWVW IMAGE DATA

LWVW at the start of the 2020 reporting period:

Greenup after 2019 monsoon events:

Start of flow event on 3/13/2020:

LWVW on 3/13/2020 with flow above bank full conditions:

LWVW at the end of the 2020 reporting period:

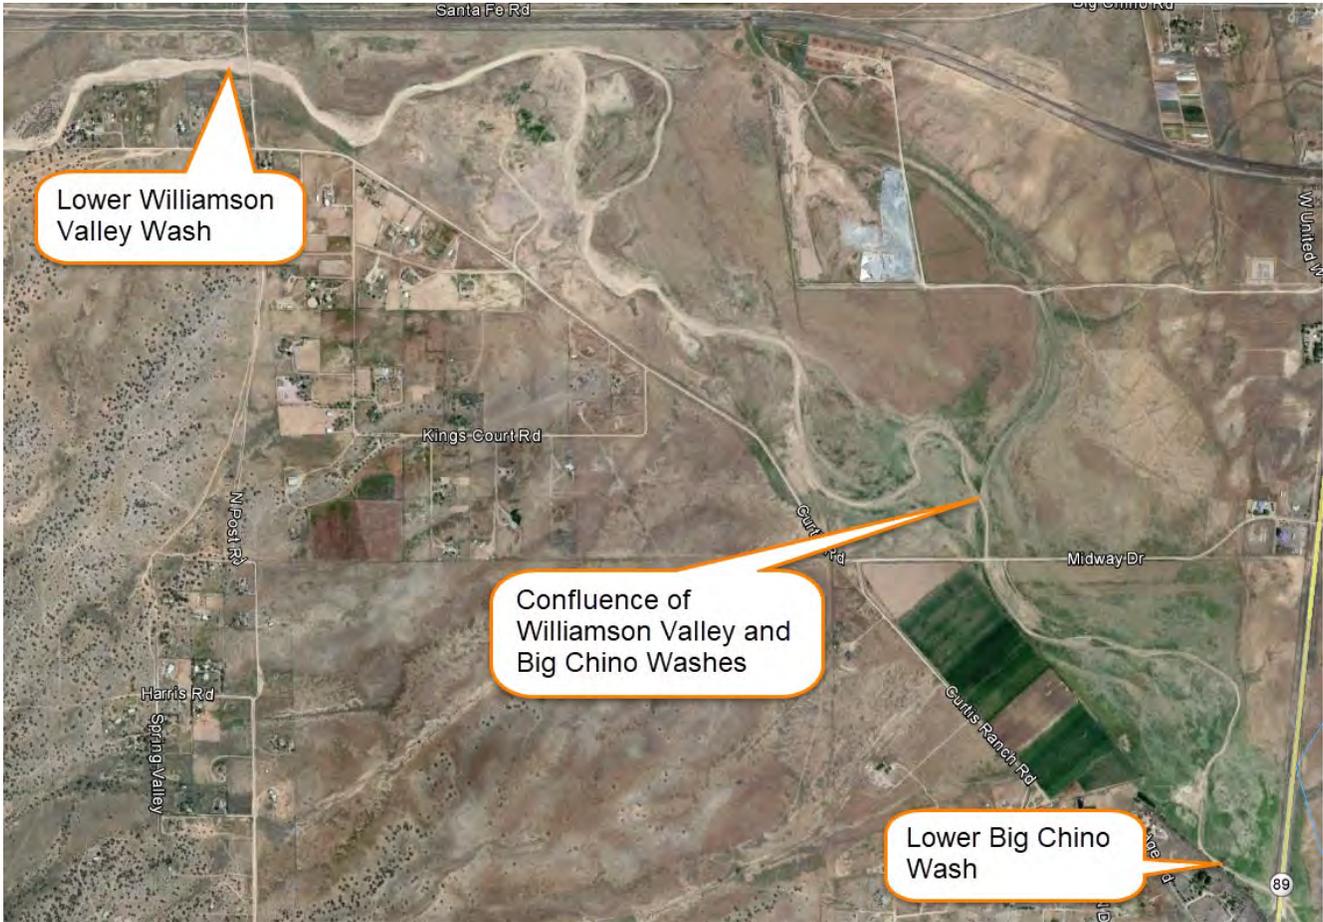
The LBCW is located ~ 2.5 miles southeast and ~ 3.8 river miles downstream of LWVW. Between the two sites are a series of meandering bends. The flow relationship between the two sites has behaved as it has in the past several years, where larger accumulated flows were observed at LWVW than at LBCW. The LBCW has a much smaller flow area than at the LWVW, so many times the site experiences flows that exceeds its rating. See Figure 31 below for an aerial image of the sites.

FIGURE 31. AERIAL IMAGE OF WILLIAMSON VALLEY WASH CONFLUENCE WITH BIG CHINO WASH BETWEEN LWVW AND LBCW

As of this report, the wetted area and its infiltration rate between the the two locations is not defined, see Figure 31. The accumulated flow differences between the two sites are detailed in Figure 32 which provide aerial imagery coupled with flow details of the largest magnitude event. In addition to the CA1 Monitoring locations, the accumulated flows as defined at the USGS gage sites at Lower Williamson Valley Wash (upstream) and the USGS Big Chino Wash at Paulden, AZ gage (downstream of the LBCW) are shown.
