**Comprehensive Agreement #1
Prescott/Prescott Valley/SRP
Monitoring/Modeling Committee
FY20 Annual Report
(July 1, 2019 – June 30, 2020)**

Big Chino Sub-basin Water Monitoring Project

July 1, 2019 – June 30, 2020 Annual Report for CA1 Monitoring Committee
City of Prescott, Town of Prescott Valley, and Salt River Project

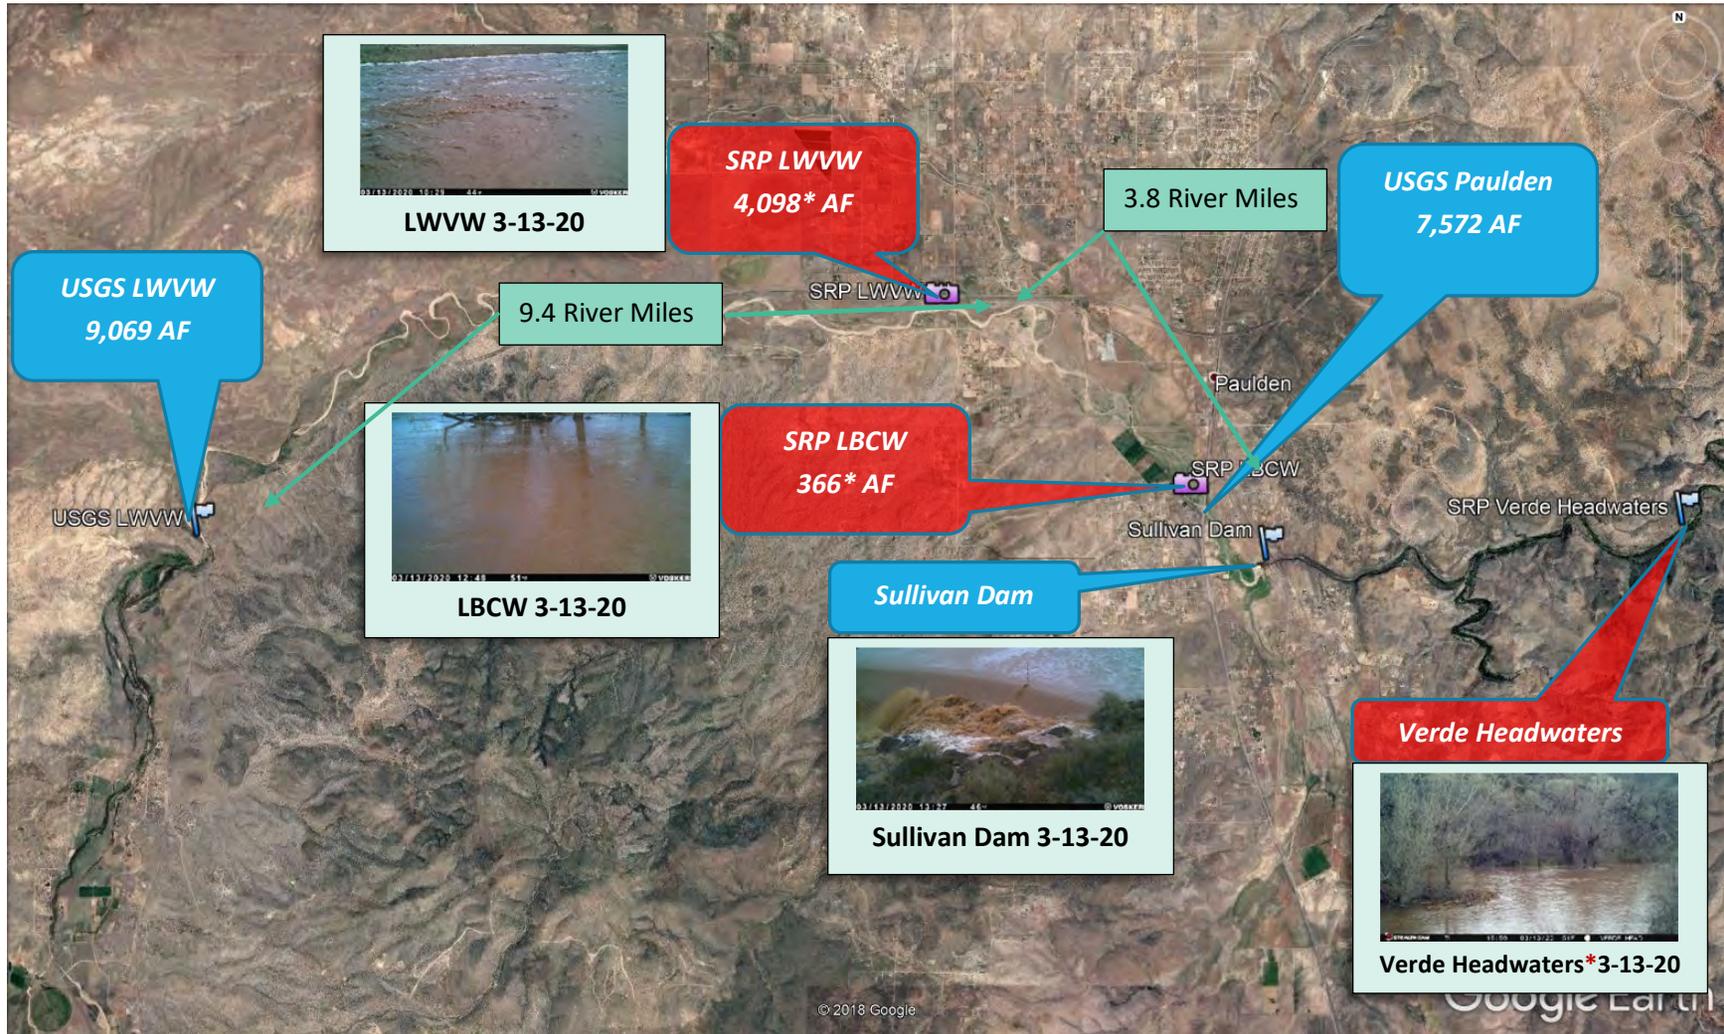
FIGURE 32. AERIAL IMAGE OF WILLIAMSON VALLEY WASH CONFLUENCE WITH BIG CHINO WASH - TOTAL ACRE FEET FOR 3/13/2020 EVENT (13 DAYS)

USGS LWVW AF was obtained from the USGS website.
 USGS Paulden AF was obtained from the USGS website.
 Sullivan Dam is not measured.

SRP LWVW* Estimated flow volumes for flow events where the flow exceeded the site discharge ratings may be lower than the actual flow.
SRP LBCW* Estimated flow volumes for flow events where the flow exceeded the site discharge ratings may be lower than the actual flow.
Verde Headwaters* Estimated flow volumes for flow events where the flow exceeded the site discharge ratings may be lower than the actual flow.

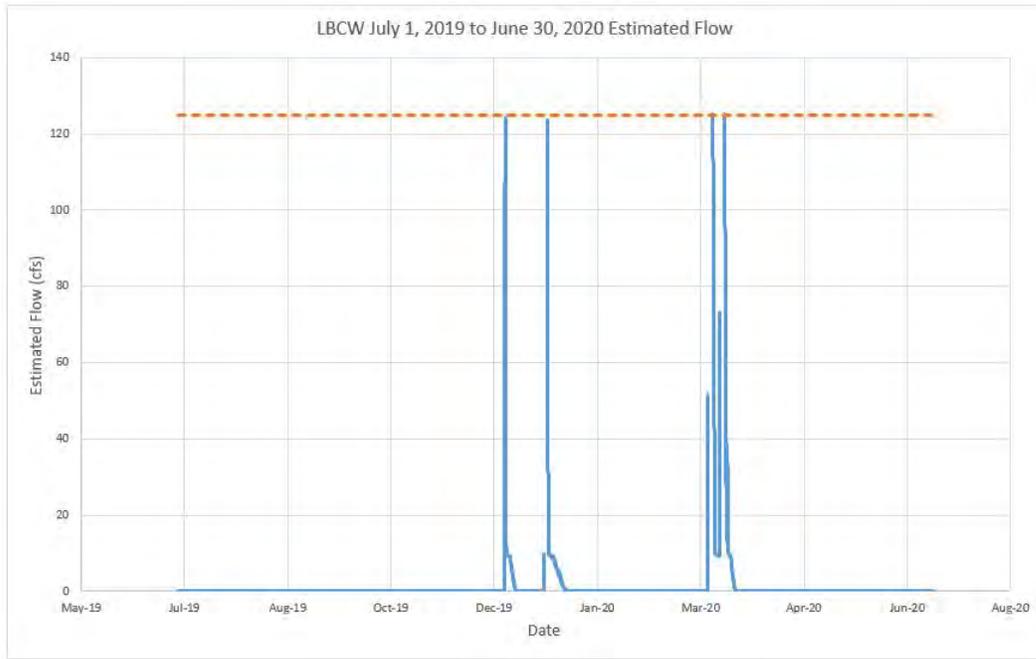
FIGURE 33. LBCW JULY 2019 – JUNE 2020 ANNUAL FLOW EVENTS²⁷

Three (3) flow events that exceeded the site rating were observed at LBCW during the 2020 annual monitoring period. LBCW responded to monsoon and winter related precipitation events. The event on 2/25/2020 was the longest lasting with a duration of 413.5 hours and an estimated peak stage of 6.97 feet; the peak discharge was greater than 124²⁵ cfs. The total estimated volume recorded at the site for the 2020 reporting period was greater than 666 AF²⁶. LBCW flow events, durations, and estimated flow volumes for the annual reporting period are outlined in Table 9 and Figures 31-37 below.

²⁷ Discharge is not calculated when flow exceeds the existing site rating. Flow was above the discharge rating for 114 hours.

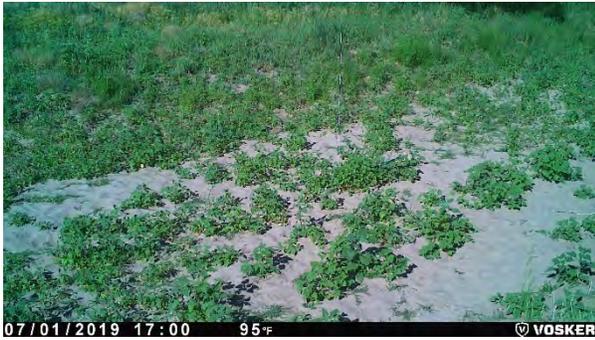
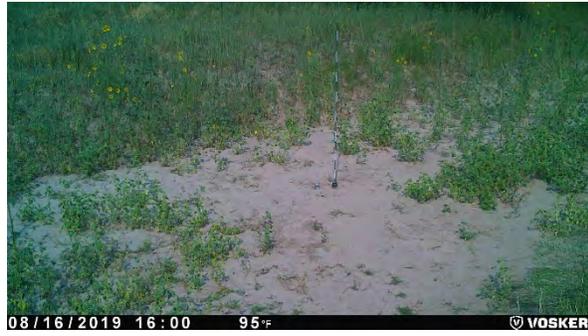
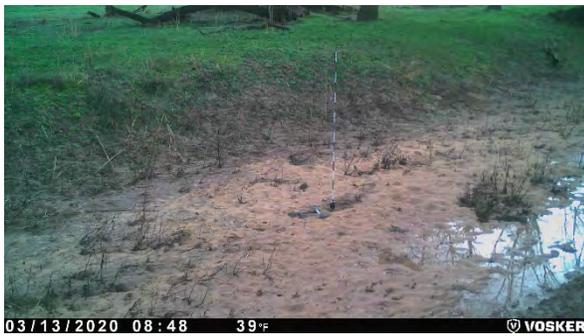
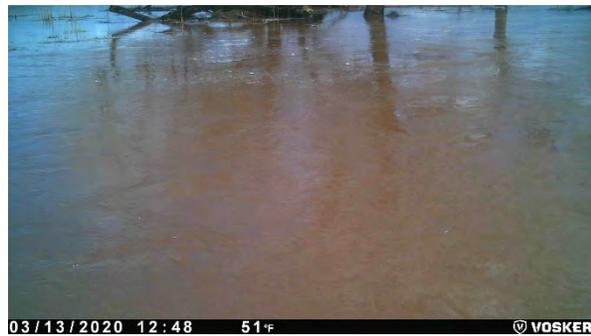
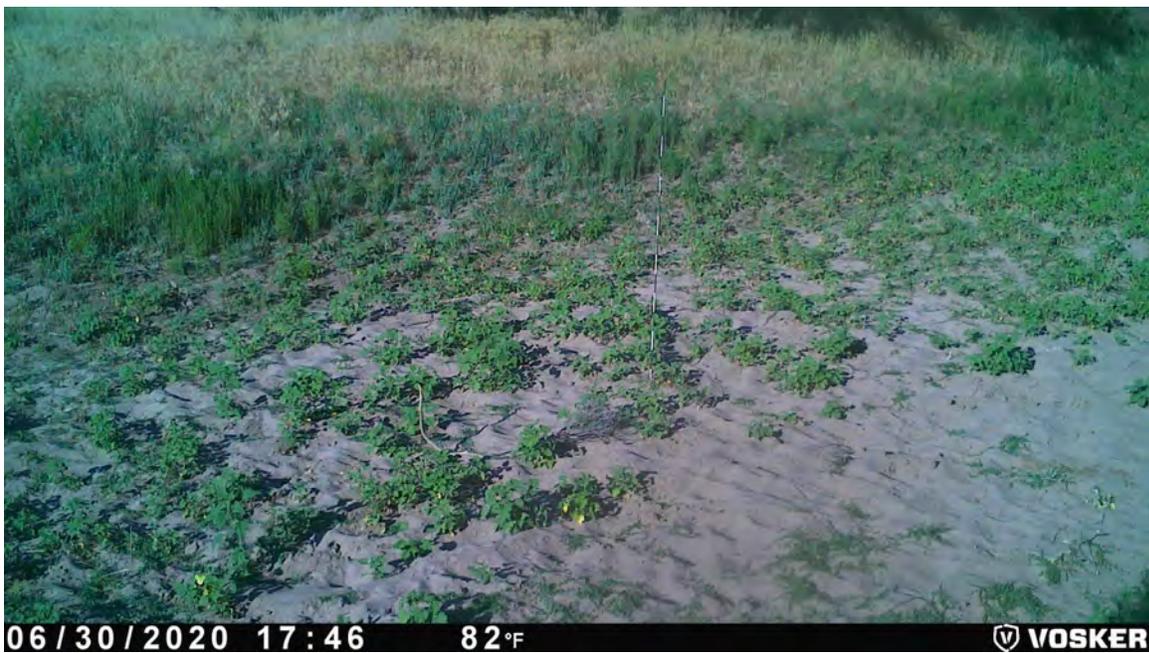
FIGURE 35. LBCW IMAGE DATA

LBCW at the start of the 2019 reporting period:

LBCW green up after early winter events:

Morning before the peak flow event 3/13/2020:

Peak of flow event on 3/13/2020:

LBCW at the end of the 2020 reporting period:

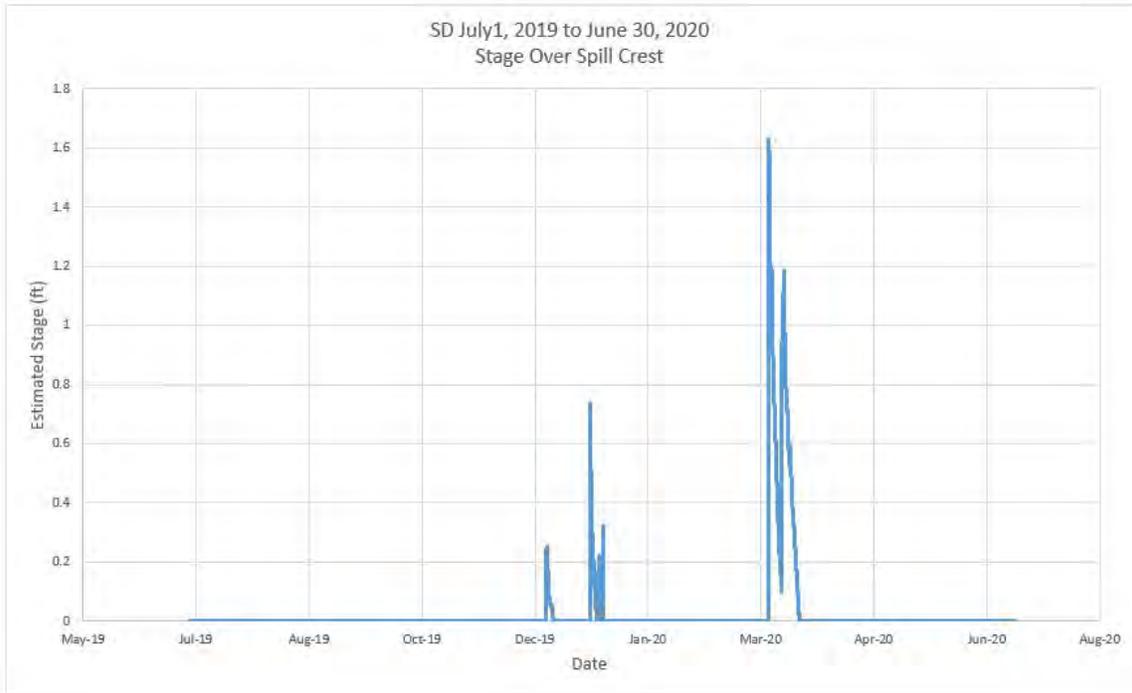
FIGURE 36. SD JULY 2019 - JUNE 2020 STAGE DATA

Six (6) events were observed at SD during the 2020 annual monitoring period. SD responded to winter related precipitation events. Standing surface water was visible behind the dam starting from 7/1/2019 to 8/8/2019. Standing surface water was again visible behind the dam starting 8-28-2019 to the end of the 2020 reporting period. Stage represents the water depth of water spilling over the SD structure crest. There is no stage to discharge relation for the site, therefore no flow data is assumed. SD events, durations, and peak stages for the annual reporting period are outlined in Table 10 and Figures 38-40.

²⁹ Stage event duration is based on stage data, no discharge data available.

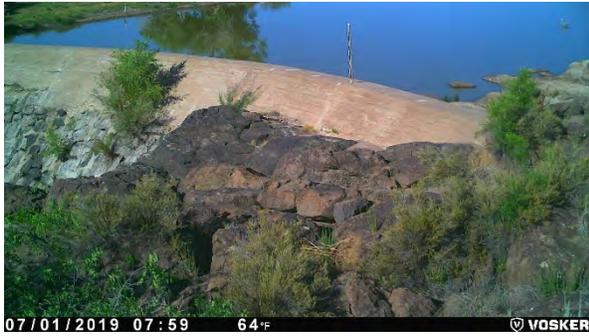
SD at the start of the 2020 reporting period:

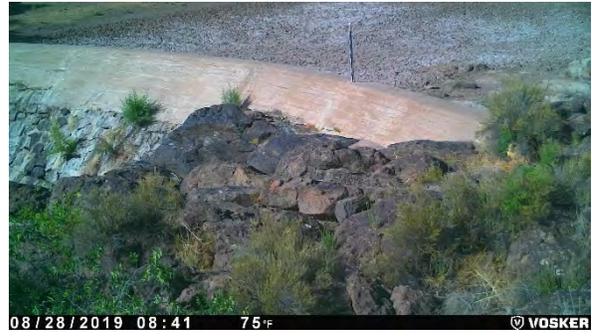
Greenup at SD after monsoon events:

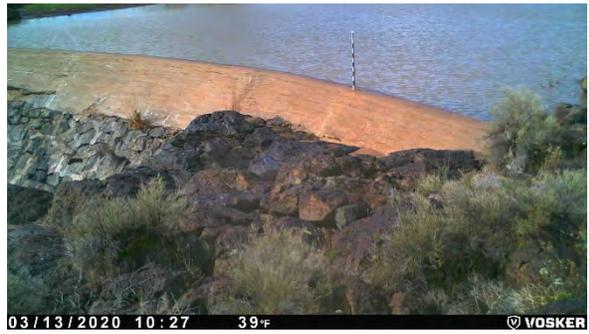
Start of flow event on 3/13/2020:

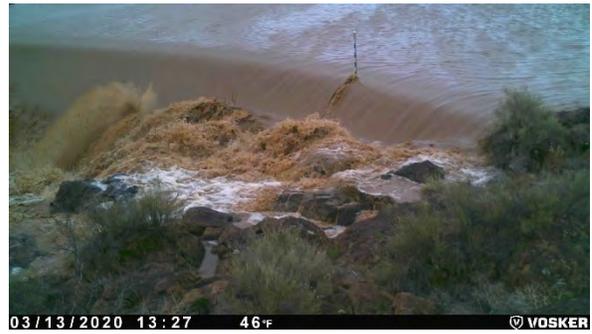
Continued flow event on 3/13/2020:

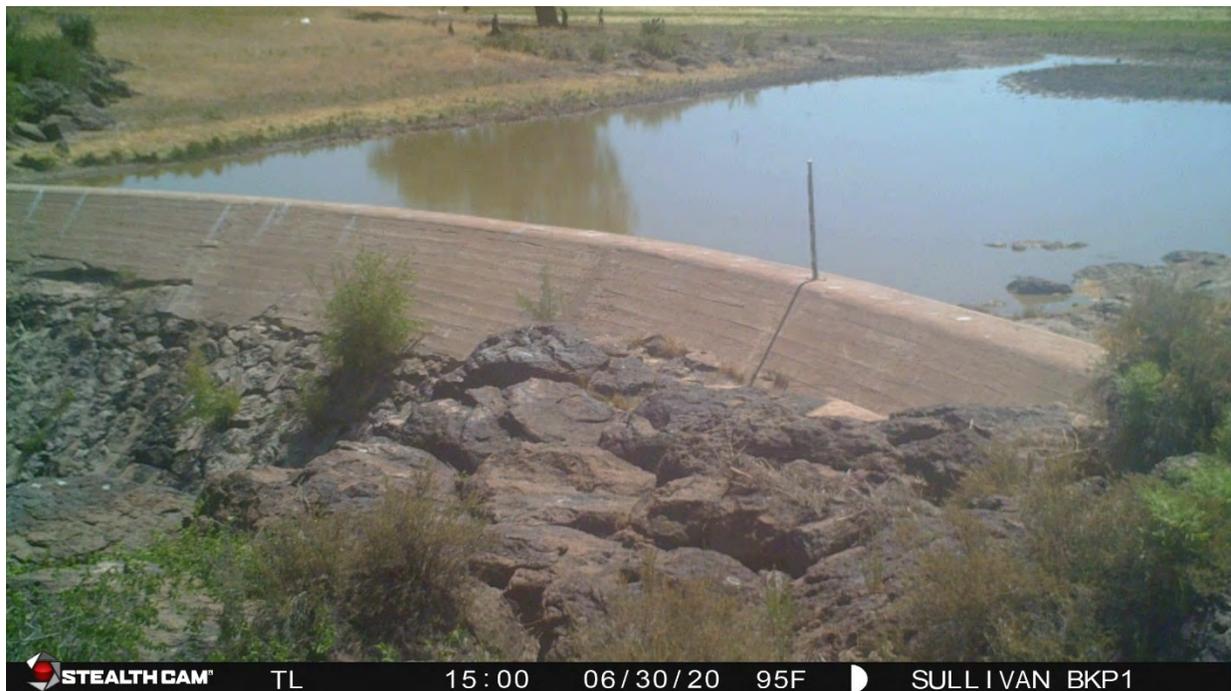
FIGURE 38. SD IMAGE DATA

SD at the end of the 2020 reporting period:

There was no water in storage behind Sullivan Dam at the from August 8, 2019 through August 28, 2019. Water started to pool on 8/29/2019, and the first spill event occurred on 12/6/2019. After the 2019 monsoon precipitation events, the water behind Sullivan Dam was present through the end of the calendar year. Winter precipitation events resulted in six (6) observed spill events over Sullivan Dam. Water remained pooled behind Sullivan Dam for the remainder of the reporting period.

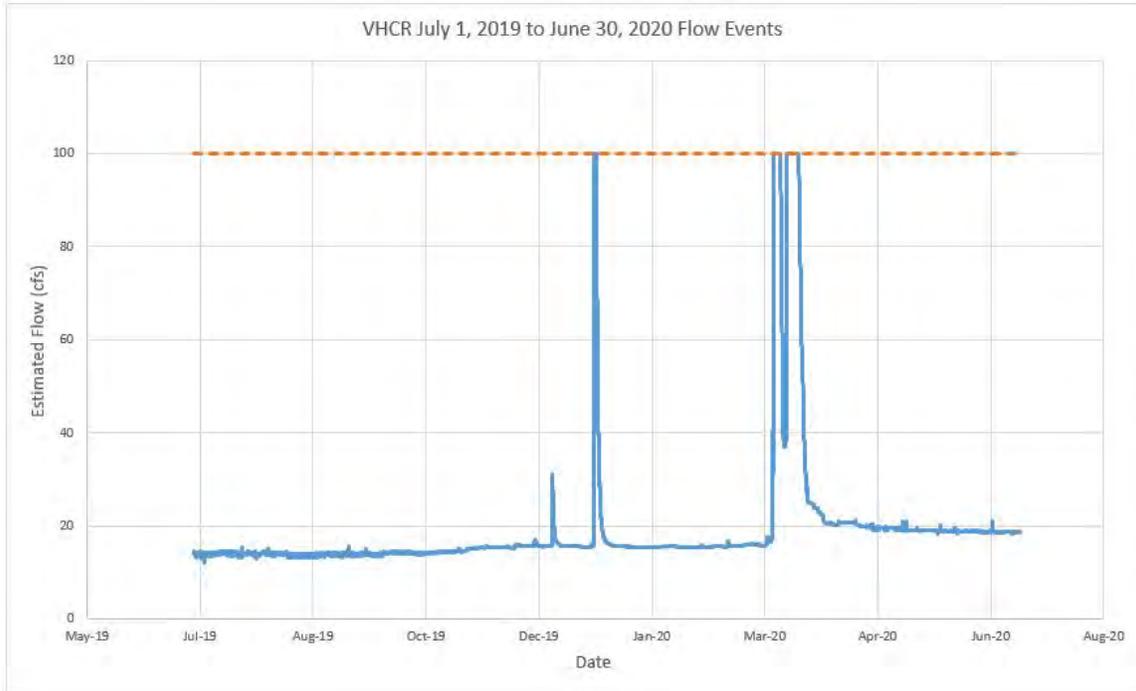
FIGURE 39. VHCR JULY 2019 – JUNE 2020 ANNUAL FLOW EVENTS³⁰

Three (3) events were observed at VHCR during the 2020 annual monitoring period (for this site and report, a flow event was defined as exceeding a flow rate of over 20 cfs). Two (2) flow events exceeded the flume flow design limit of 100 cfs. VHCR flow events for the annual reporting period are outlined in Table 11 and Figures 41-43.

³⁰ Discharge is not calculated when flow exceeds the existing site rating. Flow was above the discharge rating for 223 hours from December 2019 through March 2020.

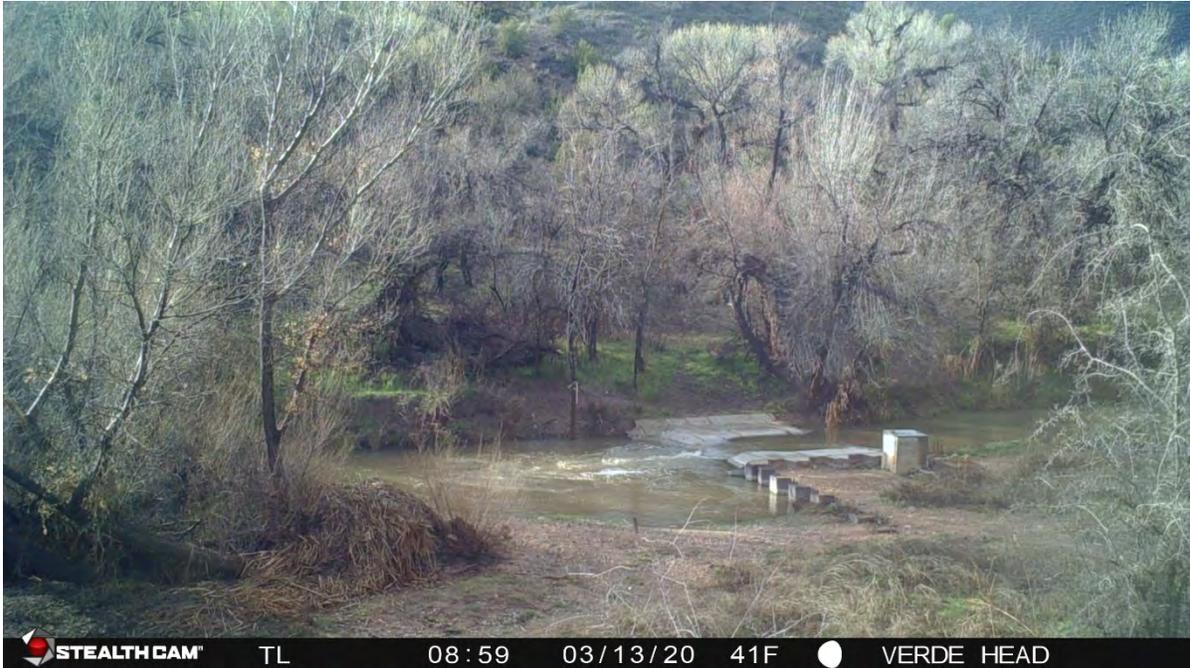
FIGURE 41. VHCR SITE IMAGES

VHCR before flow event on 3/13/2020:

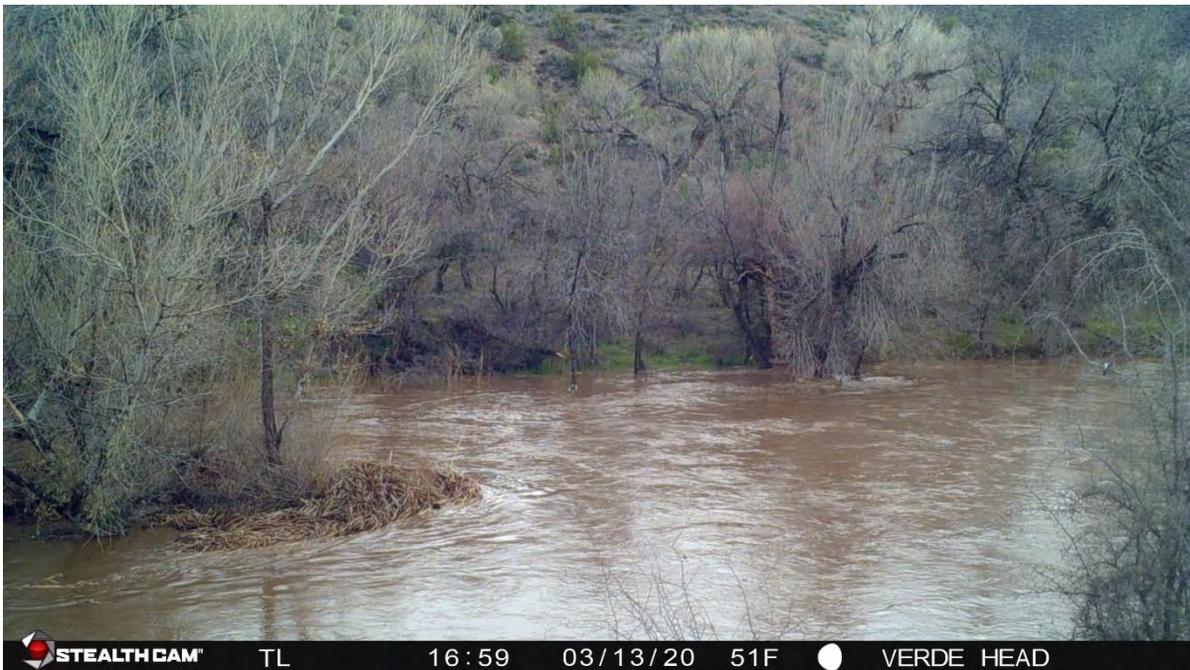
VHCR during flow event on 3/13/2020:

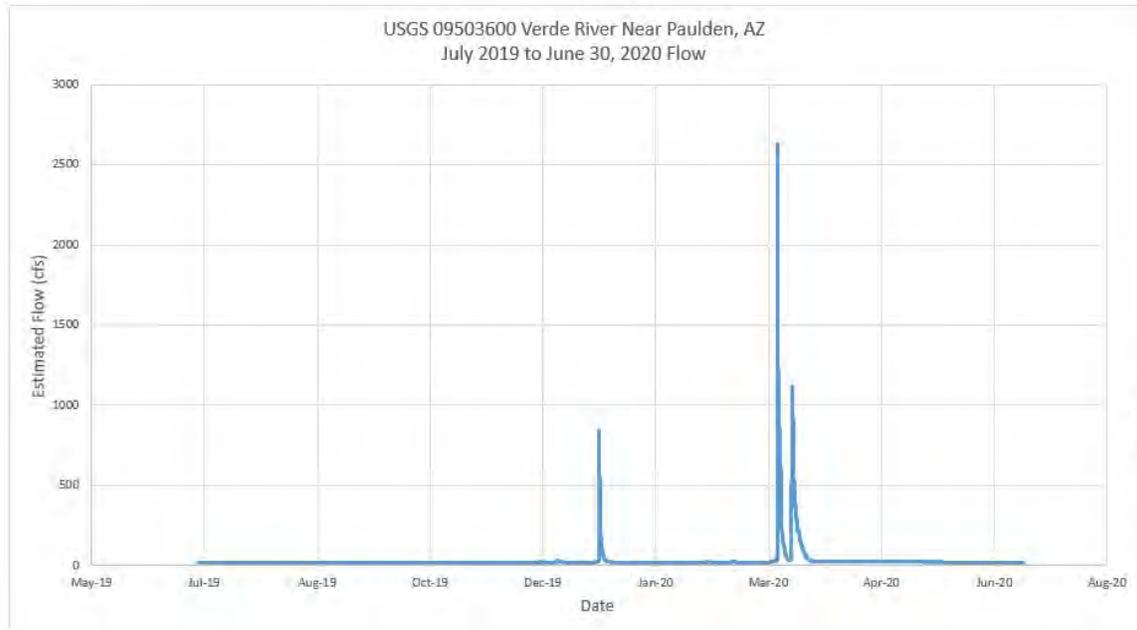
FIGURE 42. USGS VERDE RIVER NEAR PAULDEN, AZ JULY 2019 – JUNE 2020 FLOW EVENTS

The USGS Verde River near Paulden, AZ stream gage is approximately 6 river miles downstream of VHCR. Flow events observed at VHCR were also observed at the USGS gage (see Table 11 and Figure 44 below).

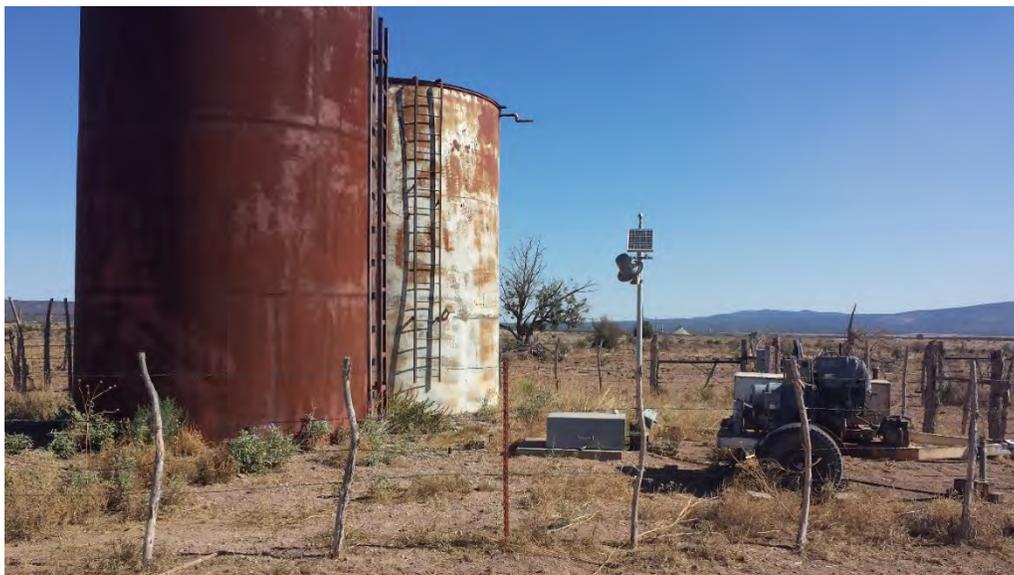
FIGURE 43. GW SITE IMAGE FOR REFERENCE

The GW location records the distance from land to water (stage in feet below land surface). Between July 2019 and June 2020, the overall water level decreased 0.38 feet (see Figures 45-47 below).
