# Comprehensive Agreement No. 1

## Eighth Annual Report

FY21  
(July 1, 2020 – June 30, 2021)

BIG CHINO SUB-BASIN  
WATER MONITORING PROJECT  
PRESCOTT - PRESCOTT VALLEY - SRP

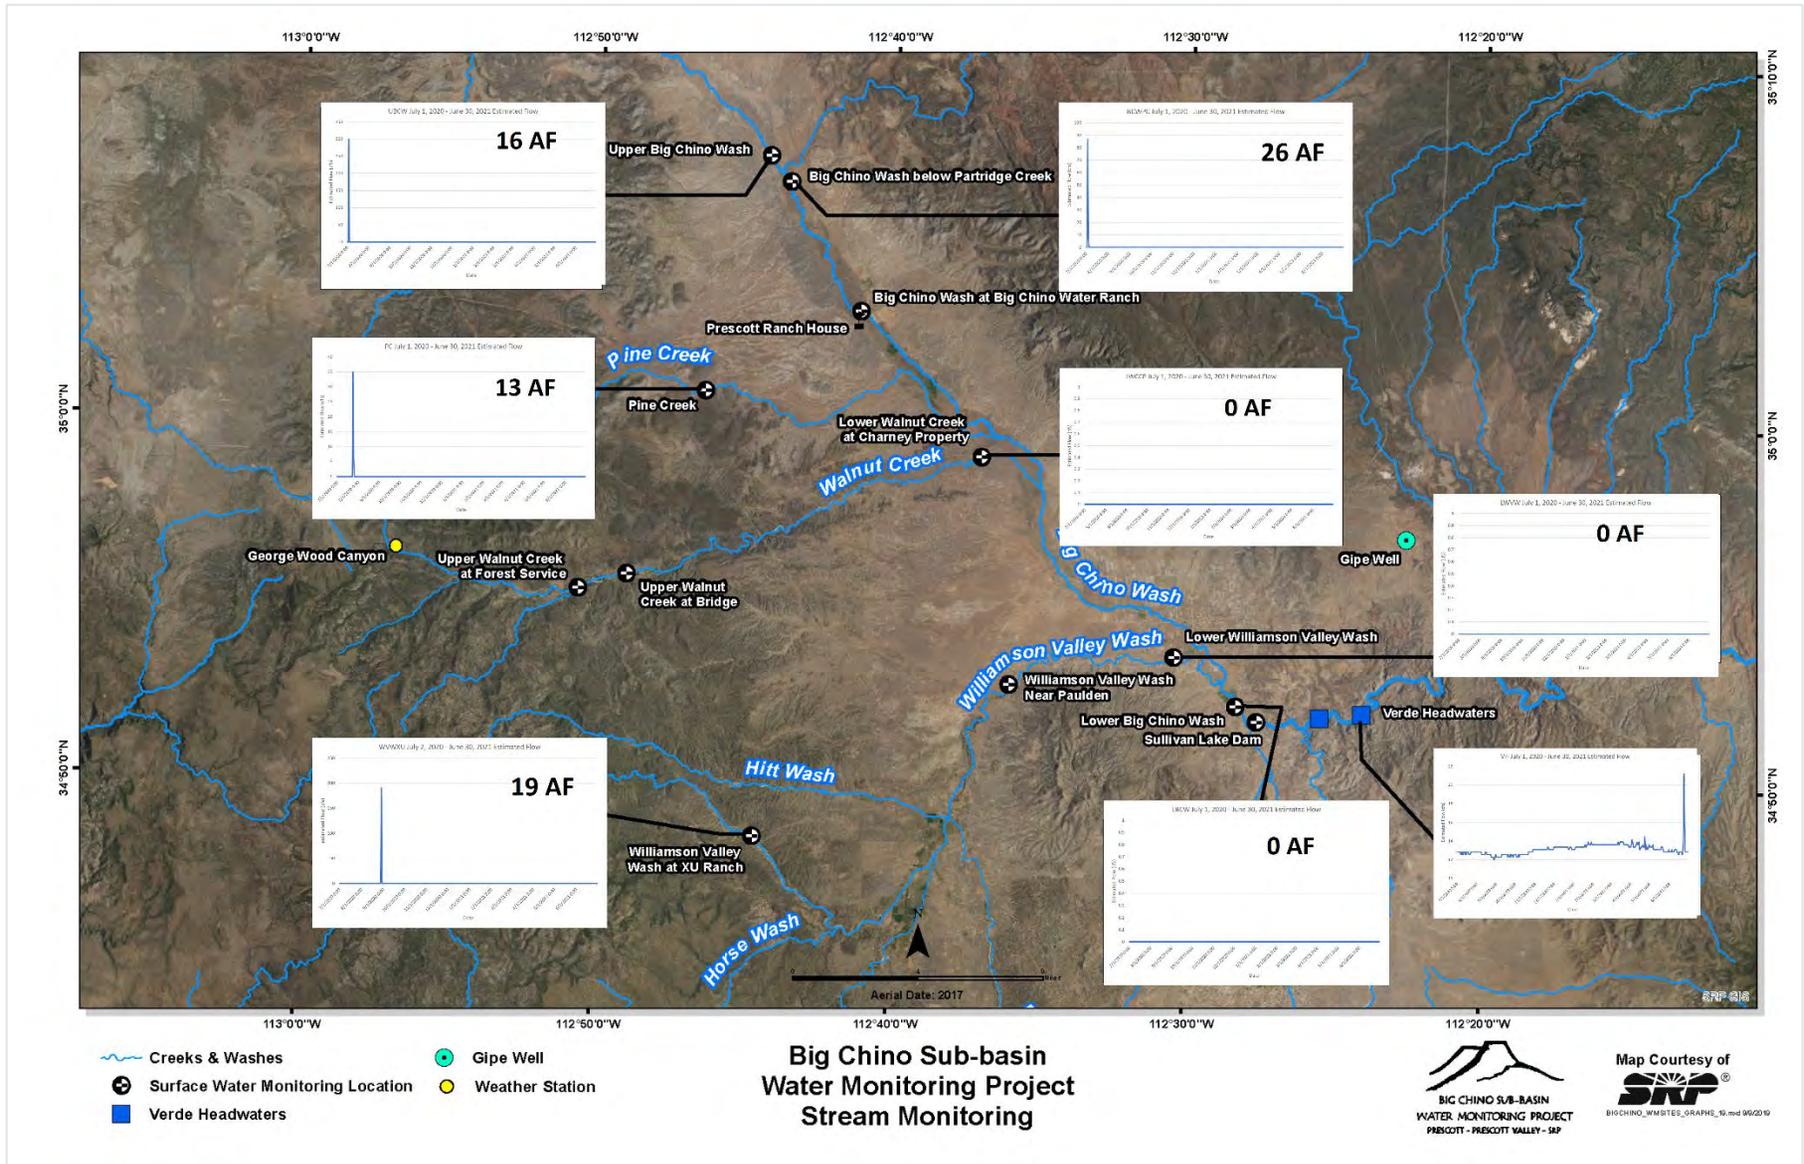
FIGURE 1. BIG CHINO SUB-BASIN MAP

Surface water flow was not observed at each SRP Flowtography® site during the 2021 annual reporting period. The flow event start date, an estimate of the magnitude of the flow, and the locations where surface water flow was observed are shown in Table 1 and Figure 1.

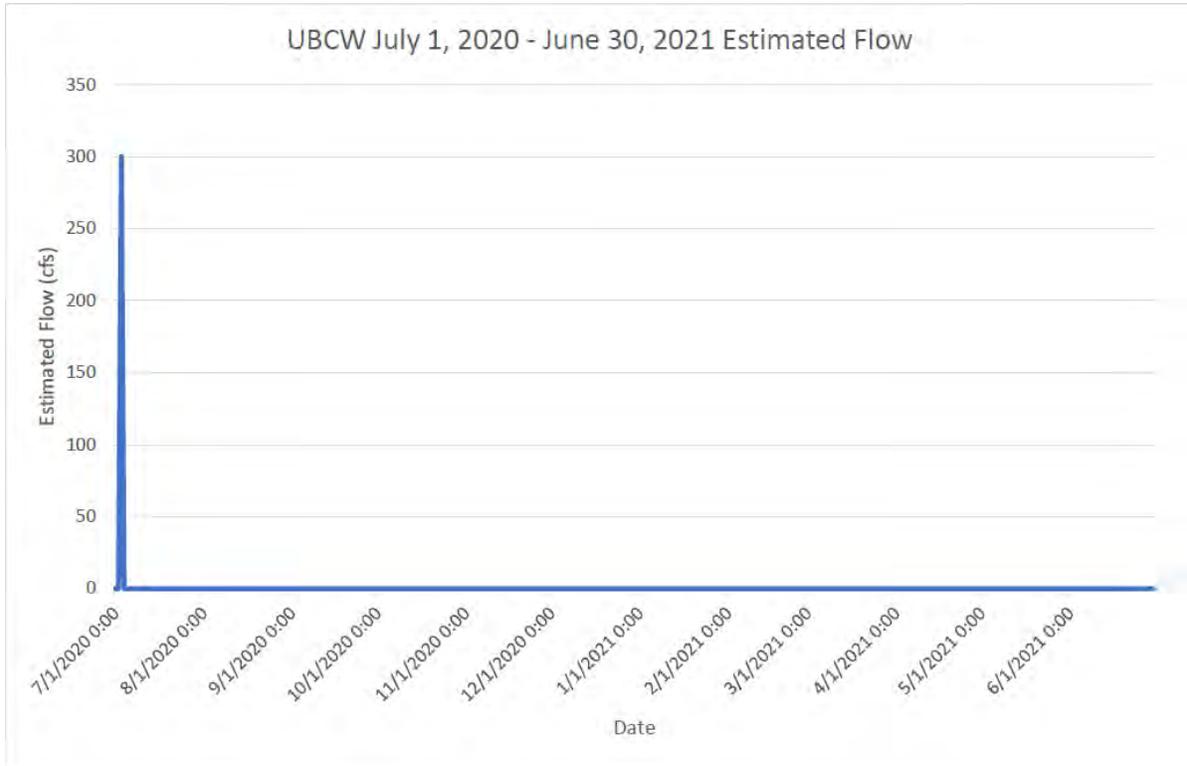
FIGURE 2. UBCW JULY 1, 2020 – JUNE 30, 2021 ANNUAL FLOW EVENTS

One (1) event with measurable flow was observed at UBCW during the 2021 annual monitoring period. UBCW responded to one (1) monsoon related precipitation event. Peak discharge for the event was an estimated 228 cubic feet per second (cfs) observed on 7/3/2020. The event had a duration of 11.25 hours, resulting in an estimated total flow volume of 16 AF. Because this was the only event observed during the year, the 16 AF is also the estimated volume recorded at the site for the 2021 reporting period. Flow event data including duration and estimated flow volume for the annual reporting period are outlined in Table 2 and Figures 2-4.

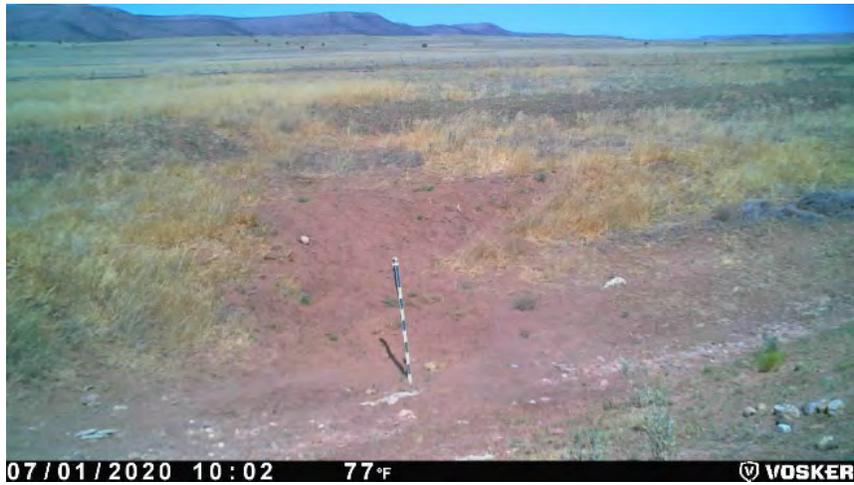
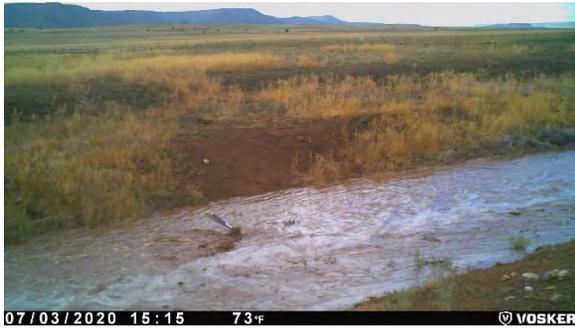
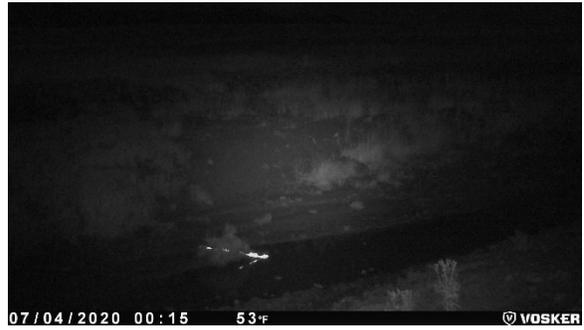
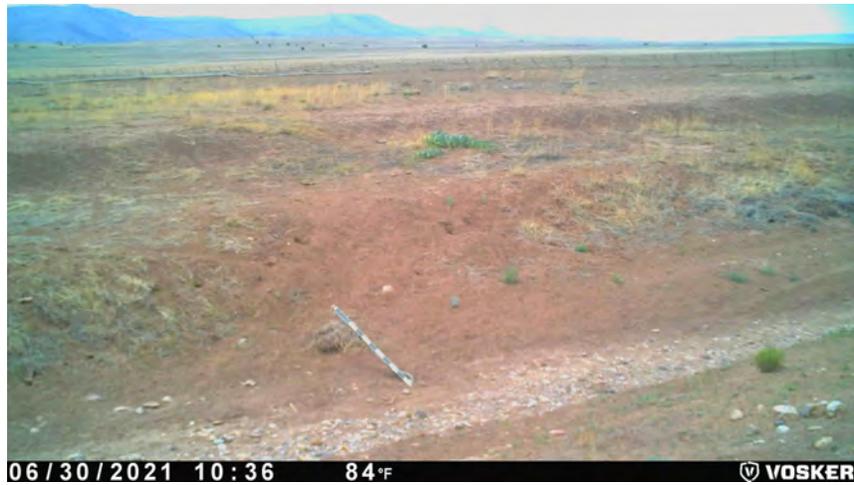
FIGURE 4. UBCW IMAGE DATA

UBCW at the start of the 2021 reporting period:

Peak of 7/3/2020 flow event:

End of 7/3/2020 flow event:

UBCW at the end of the 2021 reporting period:

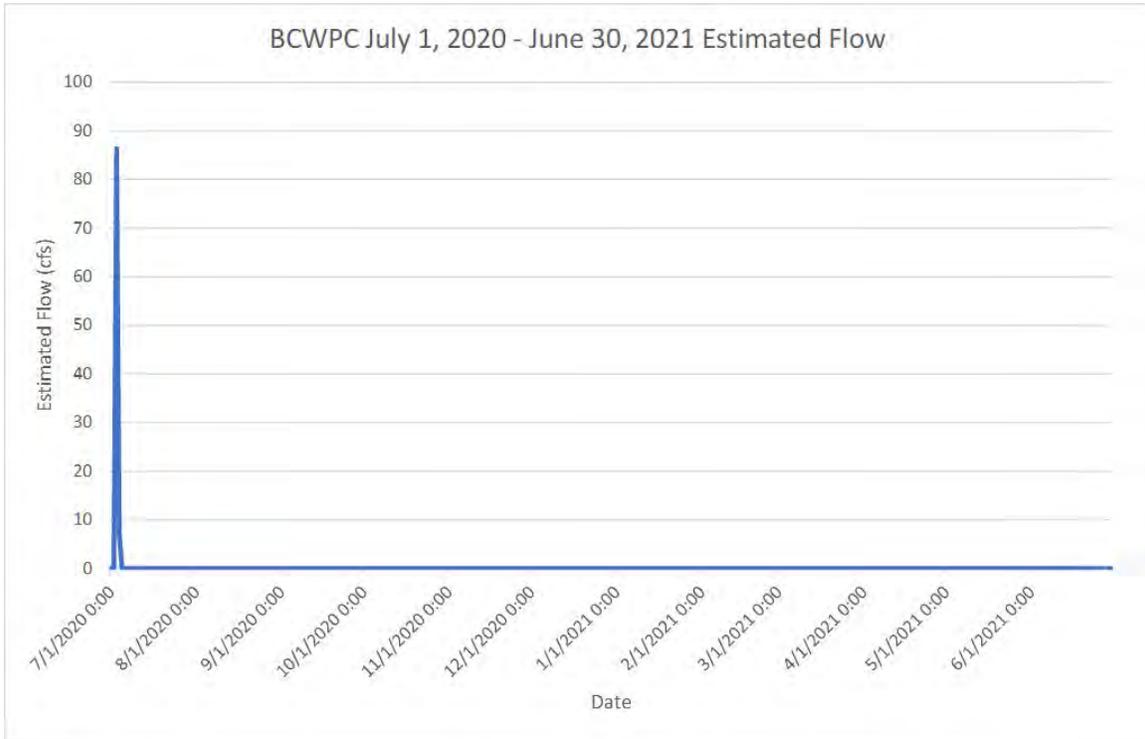
FIGURE 5. BCWPC JULY 1, 2020 – JUNE 30, 2021 ANNUAL FLOW EVENTS

One (1) event with measurable ephemeral flow was observed at BCWPC during the 2021 annual monitoring period. BCWPC responded to one (1) monsoon related precipitation event. Peak discharge for the event was an estimated 86.4 cfs observed on 7/3/2020. The event had a duration of 12.75 hours, resulting in an estimated total flow volume of 26 AF. Because this was the only event observed during the year, the 26 AF is also the estimated volume recorded at the site for the 2021 reporting period. The BCWPC flow event duration and estimated volume for the 2021 reporting period are outlined in Table 3 and Figures 5-7.

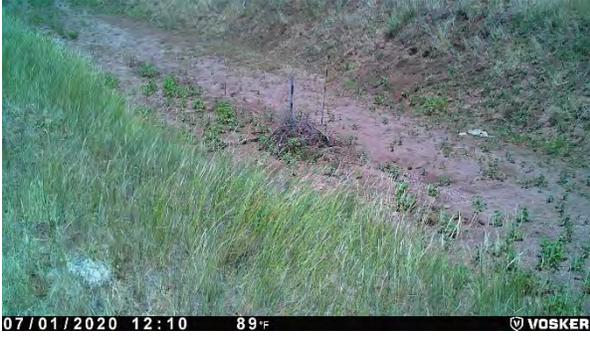
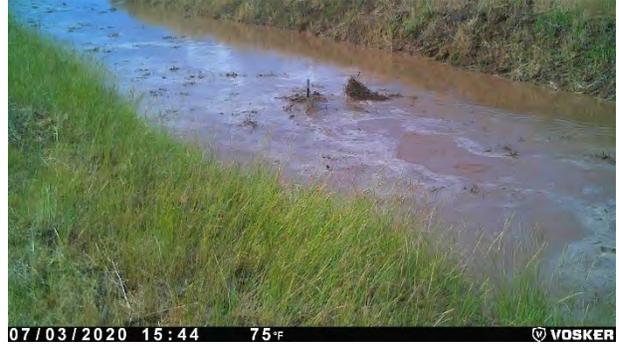
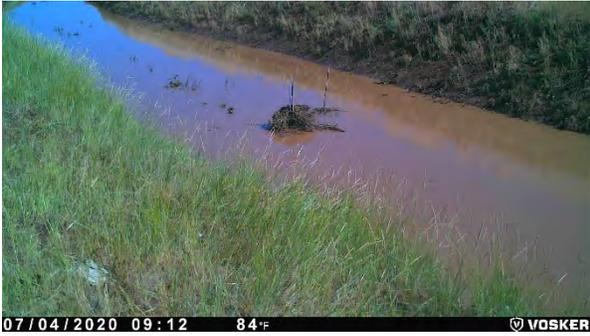
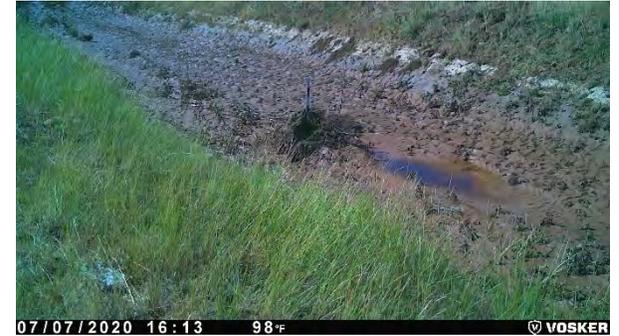
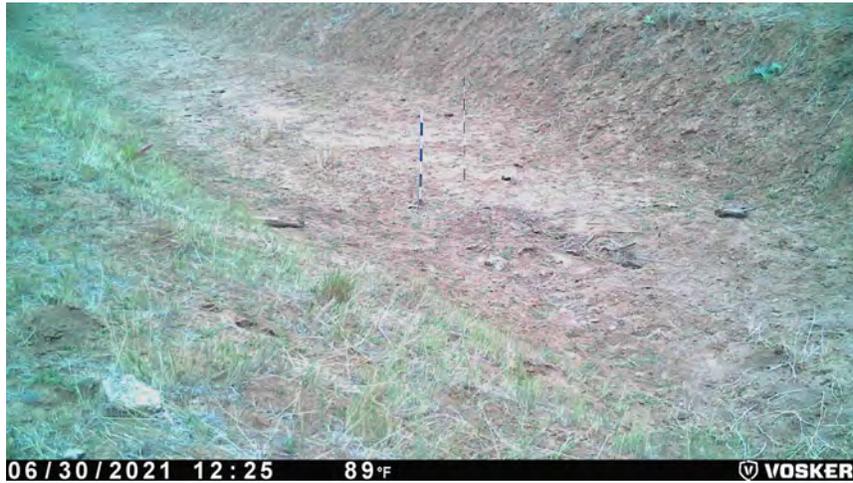
FIGURE 7. BCWPC IMAGE DATA

BCWPC at the start of the 2021 reporting period:

Peak of flow event on 7/3/2020:

Following day after event on 7/4/2020:

Dry channel after flow event on 7/7/2020:

BCWPC at the end of the 2021 reporting period:

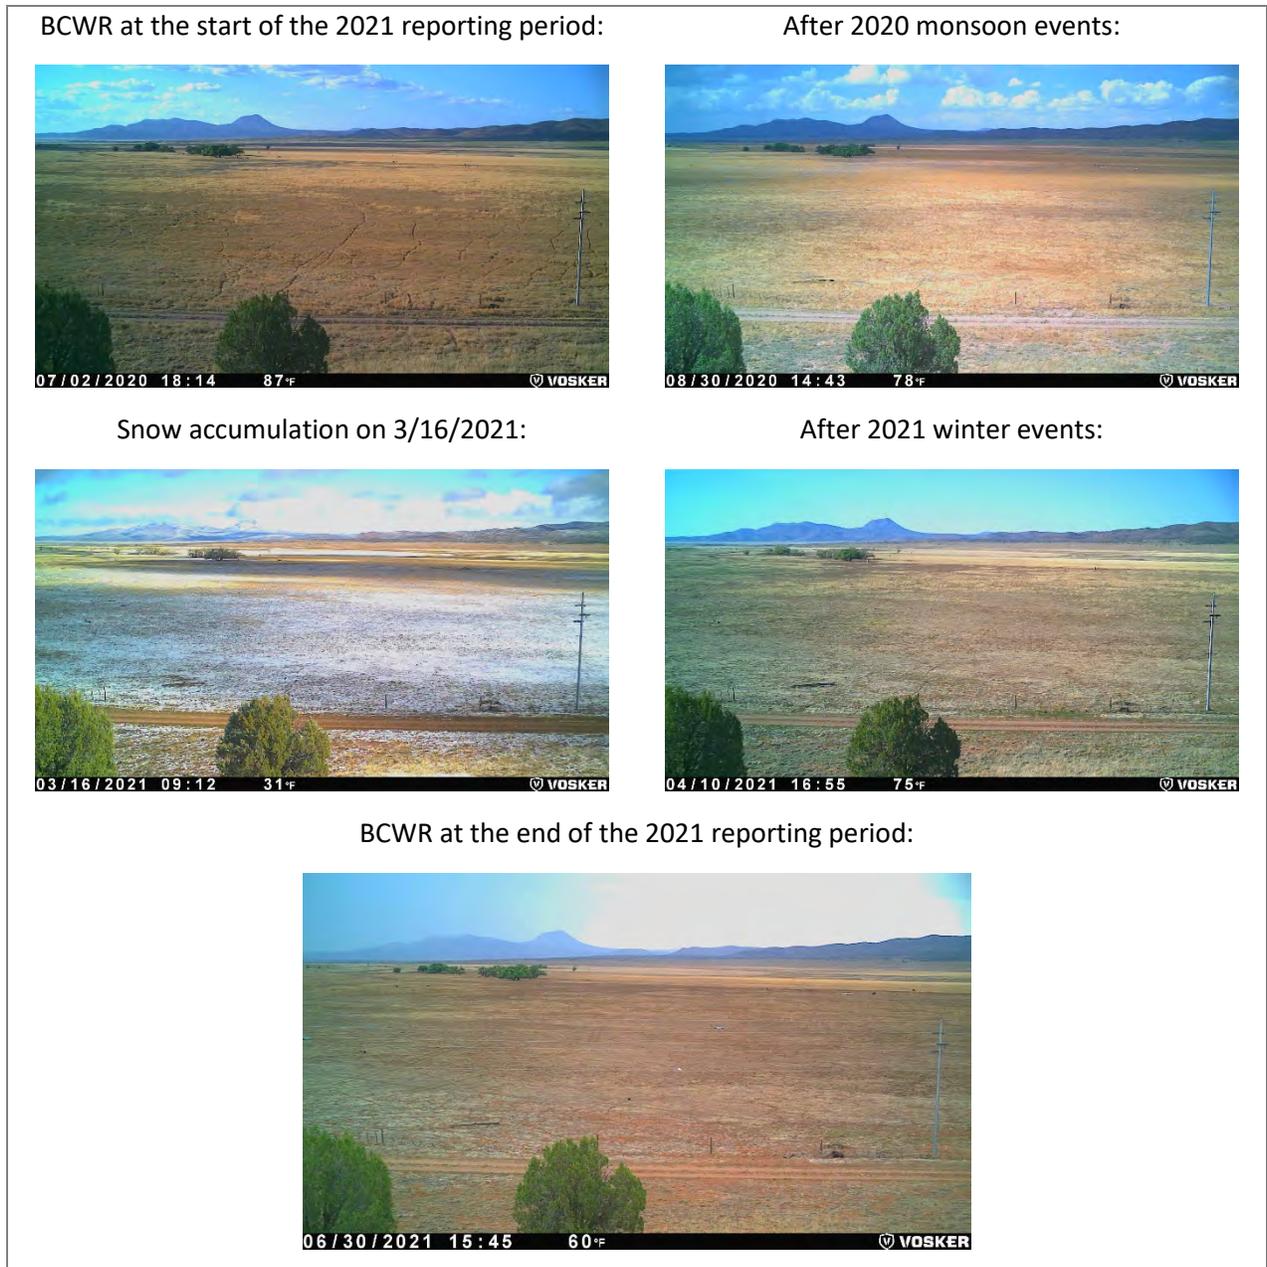
FIGURE 8. BCWR IMAGE DATA

Precipitation was observed in the images at BCWR on six (6) days during the 2021 annual monitoring period. Due to a camera malfunction, images between the middle of October and beginning of March were corrupted. Snow accumulation was visible on two (2) of those days. None of the observed events resulted in water pooling at the surface. BCWR site images for the annual reporting period can be seen in Figure 8 below.

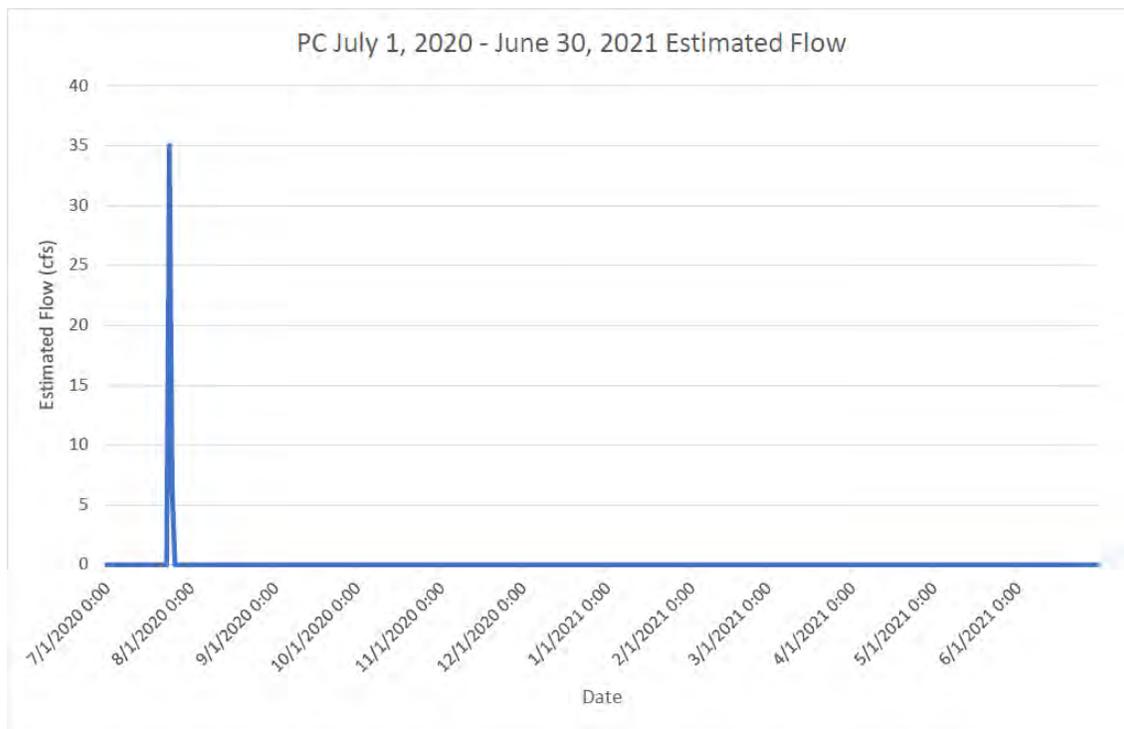
Figure 9. PC July 2020 – June 2021 Annual Flow Events<sup>12</sup>

One (1) event with measurable flow was observed at PC during the 2021 annual monitoring period. PC responded to one (1) monsoon related precipitation event. Peak discharge for the event was an estimated 35 cfs observed on 7/24/2020. The event had a duration of 15.75 hours, resulting in an estimated total flow volume of 13 AF. Because this was the only event observed during the year, the 13 AF is also the estimated volume recorded at the site for the 2021 reporting period. PC flow event duration and estimated flow volume for the annual reporting period are outlined in Table 4 and Figures 9-11.

<sup>12</sup> Discharge is not calculated when flow exceeds the existing site rating. Flow was above the discharge rating for 3 hours.

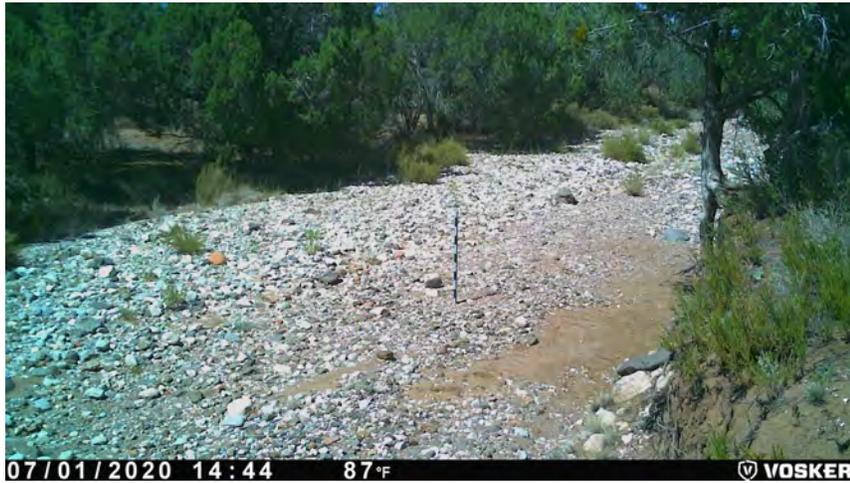
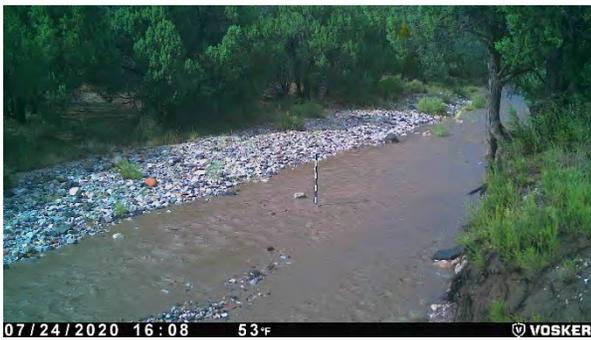
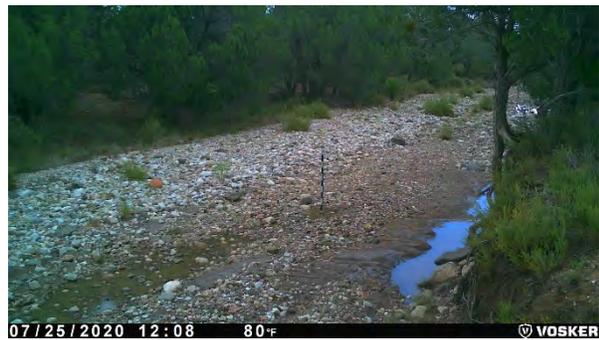
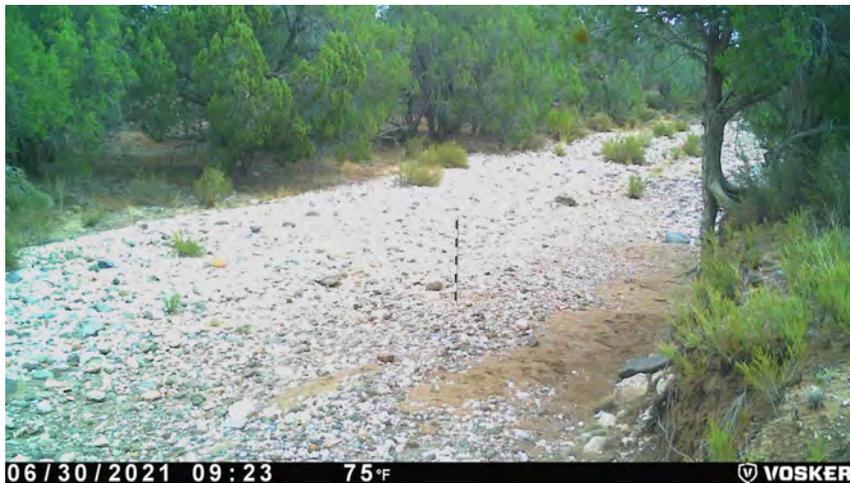
FIGURE 11. PC IMAGE DATA

PC at the start of the 2021 reporting period:

During flow event on 7/24/2020:

End of flow event on 7/25/2020:

PC at the end of the 2021 reporting period:

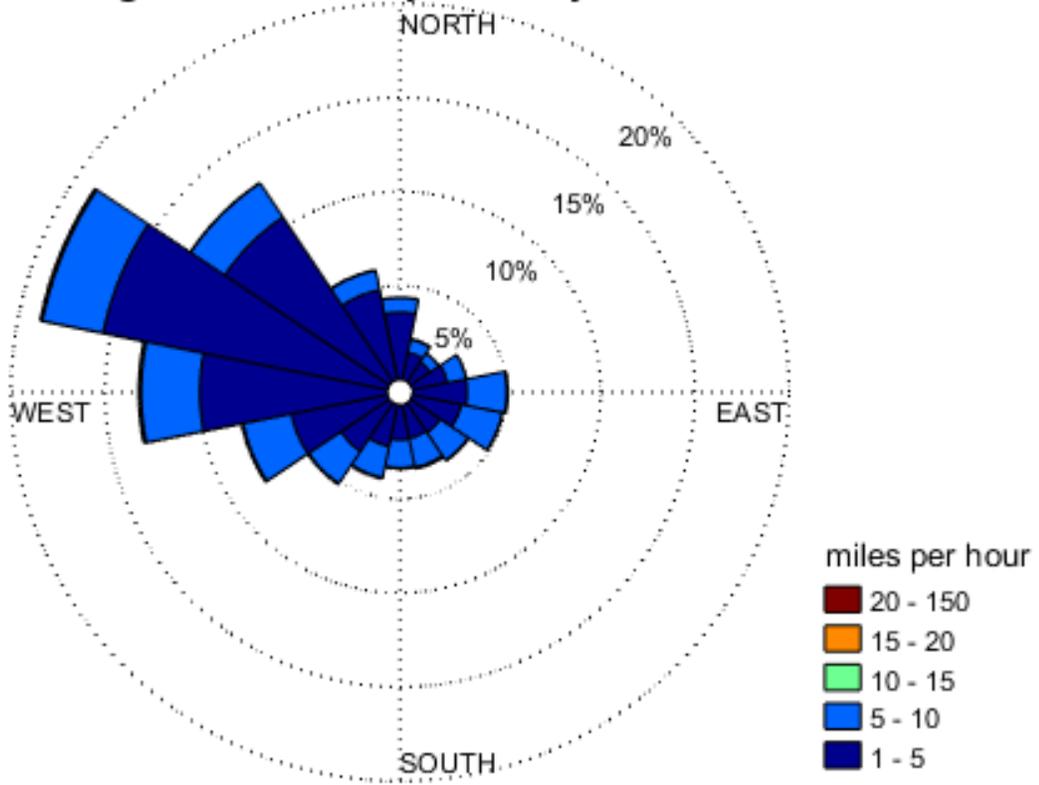
FIGURE 12. GWC JULY 2020 – JUNE 2021 WIND ROSE

The GWC weather station collected precipitation, barometric pressure, air temperature, wind direction, peak gust, relative humidity, wind speed, and SRP Snowtopography™ images of snow depth during the 2021 annual reporting period.

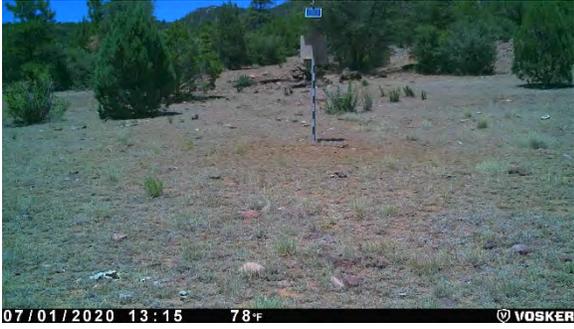
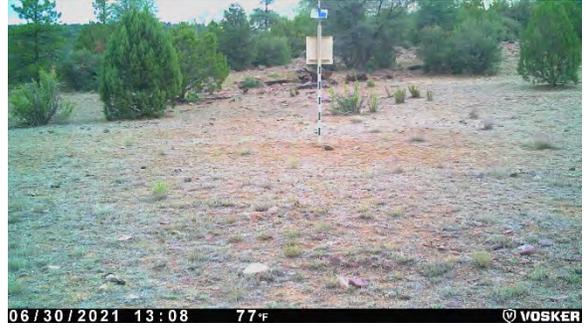
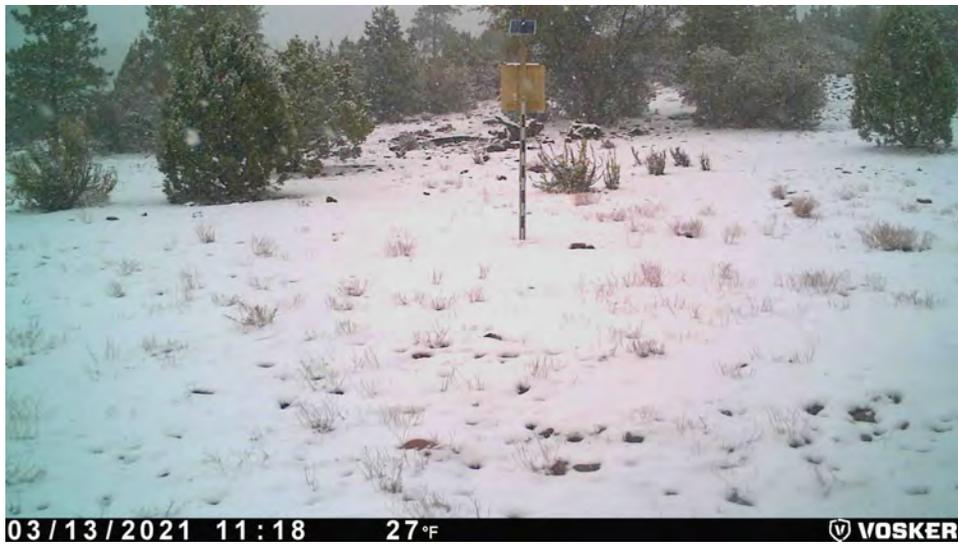
FIGURE 19. GWC IMAGE DATA

GWC at the beginning of the 2021 reporting period:

GWC at the end of the 2021 reporting period:

Snow accumulation event on 3/14/2021:

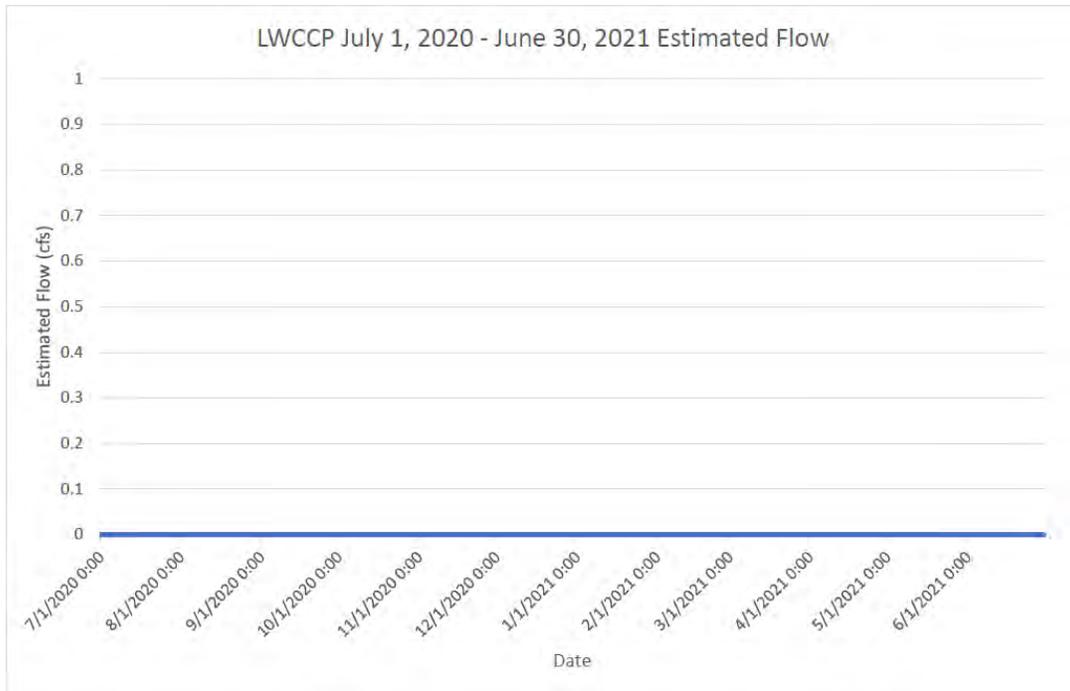
FIGURE 22. LWCCP JULY 2020 – JUNE 2021 ANNUAL FLOW EVENTS<sup>14</sup>

Zero (0) events with measurable flow were observed at LWCCP during the 2021 annual monitoring period Figure 22-23.

<sup>14</sup>Discharge is not calculated when flow exceeds the existing site rating. Flow was above the discharge rating for 2.75 hours.

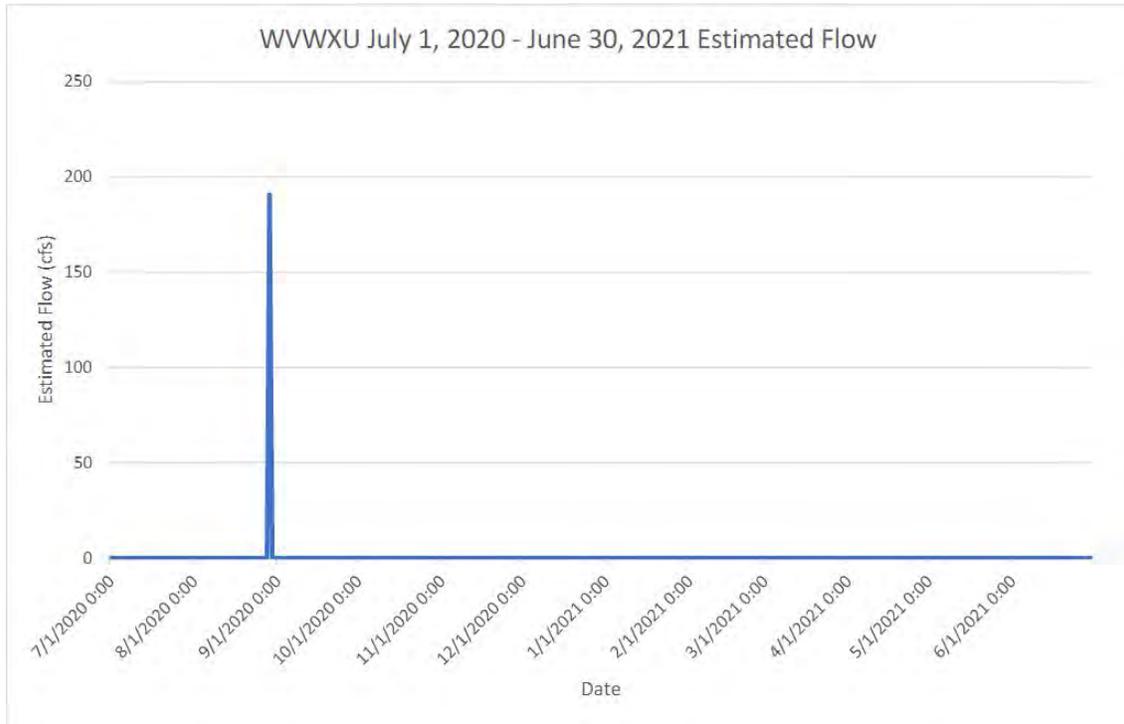
FIGURE 24. WVWXU JULY 2020 – JUNE 2021 ANNUAL FLOW EVENTS

One (1) event with measurable flow was observed at WVWXU during the 2021 annual monitoring period. WVWXU responded to one (1) monsoon related precipitation event. Peak discharge for the event was an estimated 190 cfs observed on 8/29/2020. The event had a duration of 3.25 hours, resulting in an estimated total flow volume of 19 AF. Because this was the only event observed during the year, the 19 AF is also the estimated volume recorded at the site for the 2021 reporting period. WVWXU flow event duration and estimated flow volume for the annual reporting period are outlined in Table 6 and Figures 24-26 below.

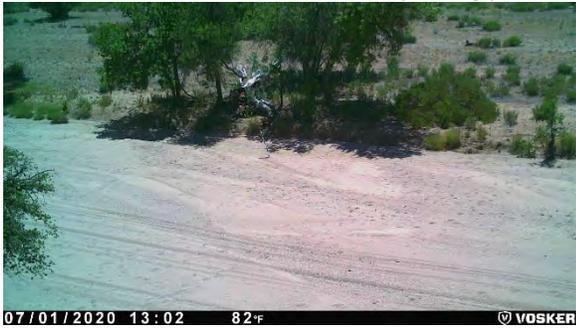
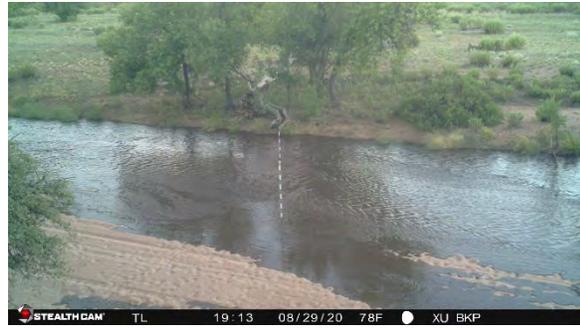
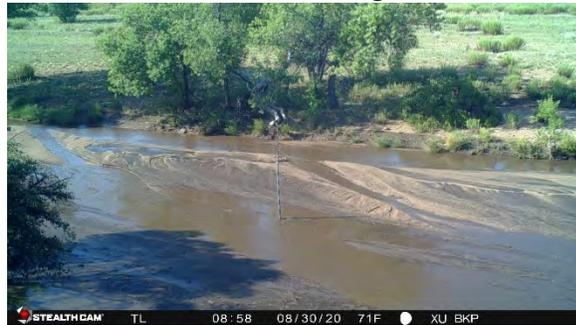
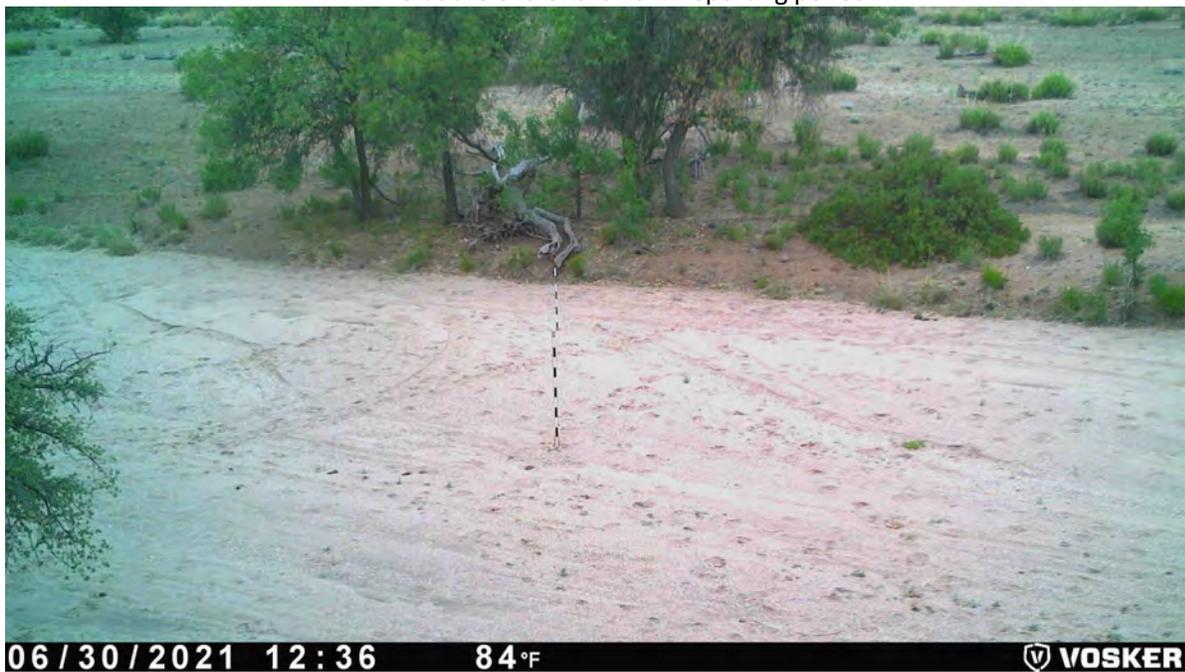
FIGURE 24. WVWXU IMAGE DATA

WVWXU at the start of the 2021 reporting period:

Start of 8/29/2020 flow event:

WVWXU on 8/30/2020 during flow recession:

WVWXU at the end of the 2021 reporting period:

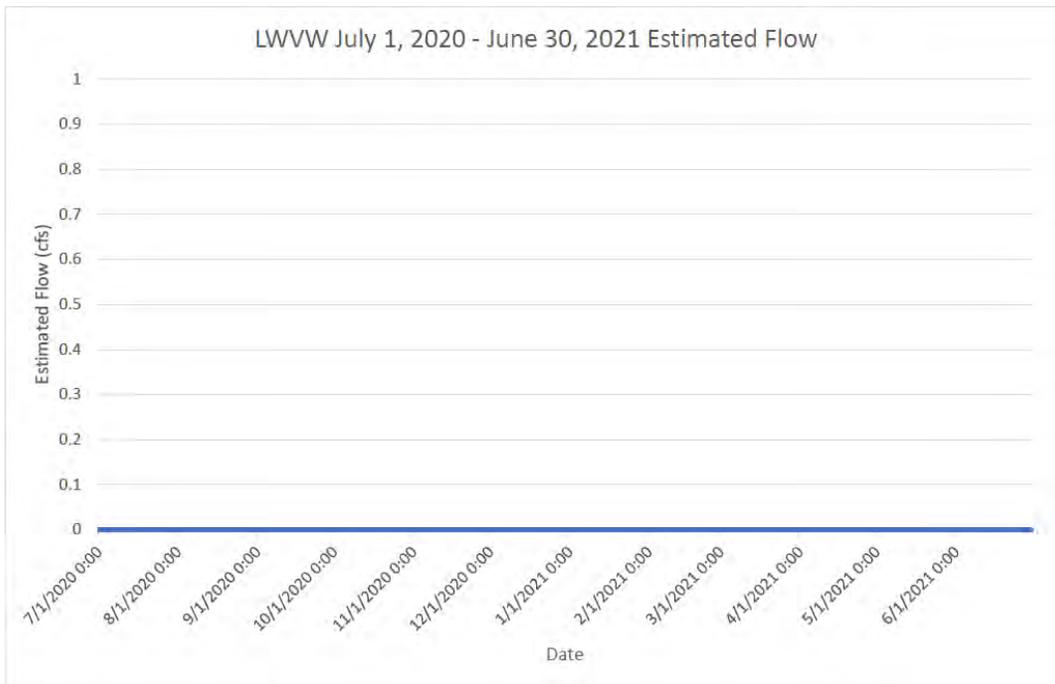
FIGURE 25. LWVW JULY 2020 – JUNE 2021 ANNUAL FLOW EVENTS<sup>17</sup>

Zero (0) events with measurable flow were observed at LWCCP during the 2021 annual monitoring period, as seen in Figures 27-28 below.

<sup>17</sup> Discharge is not calculated when flow exceeds the existing site rating. Flow was above the discharge rating for 10.25 hours.

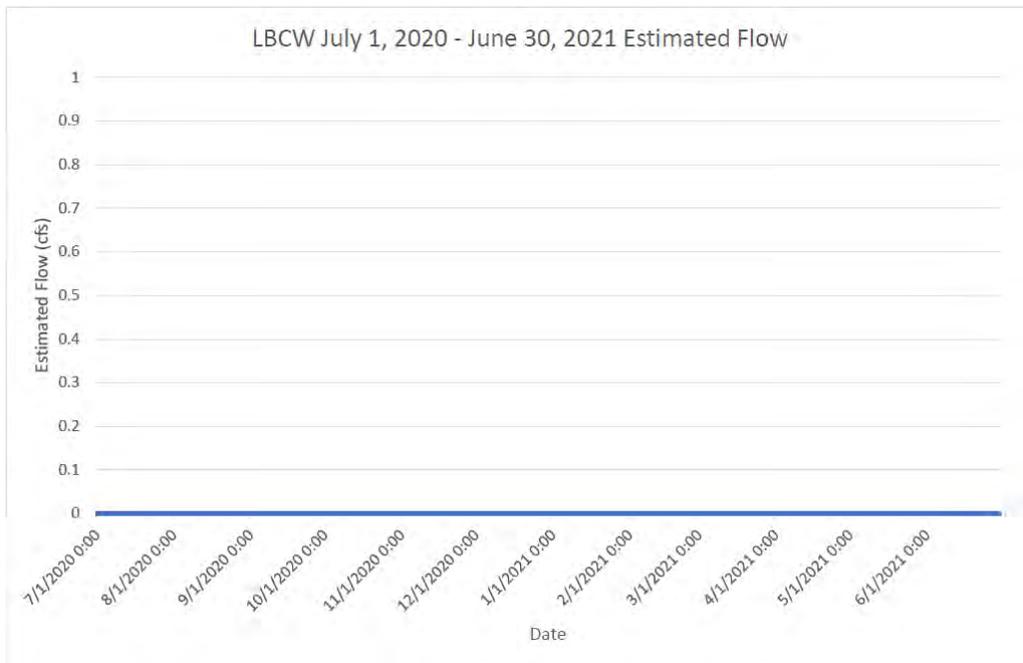
FIGURE 29. LBCW JULY 2020 – JUNE 2021 ANNUAL FLOW EVENTS<sup>18</sup>

Zero (0) events with measurable flow were observed at LWCCP during the 2021 annual monitoring period, as seen Figures 29-30 below.

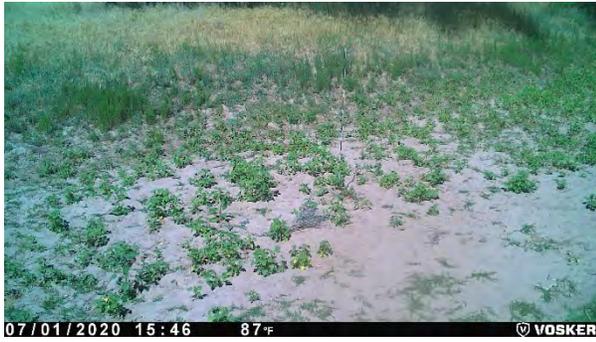
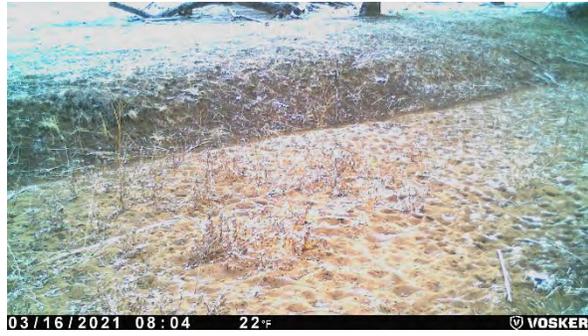
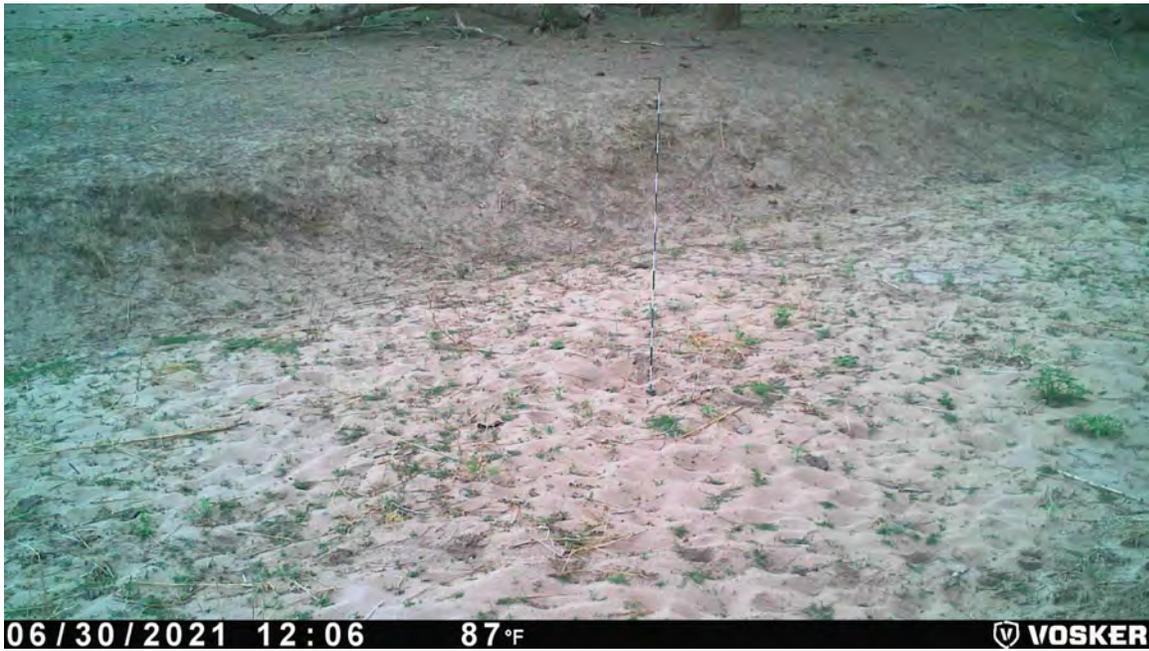
FIGURE 30. LBCW IMAGE DATA

LBCW at the start of the 2021 reporting period:

Snow the LBCW site after a winter event:

LBCW at the end of the 2021 reporting period:

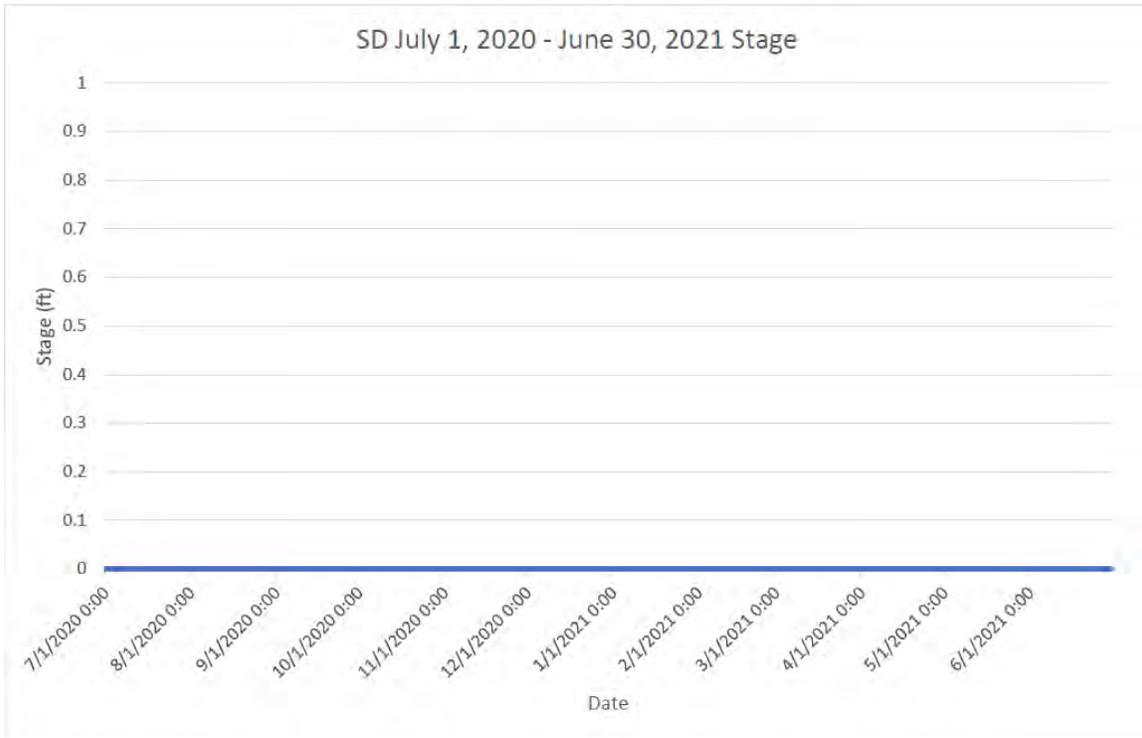
FIGURE 26. SD JULY 2020 - JUNE 2021 STAGE OVER SPILL CREST DATA

Zero (0) events were observed at SD during the 2021 annual monitoring period, as seen in Figures 31-32 below.

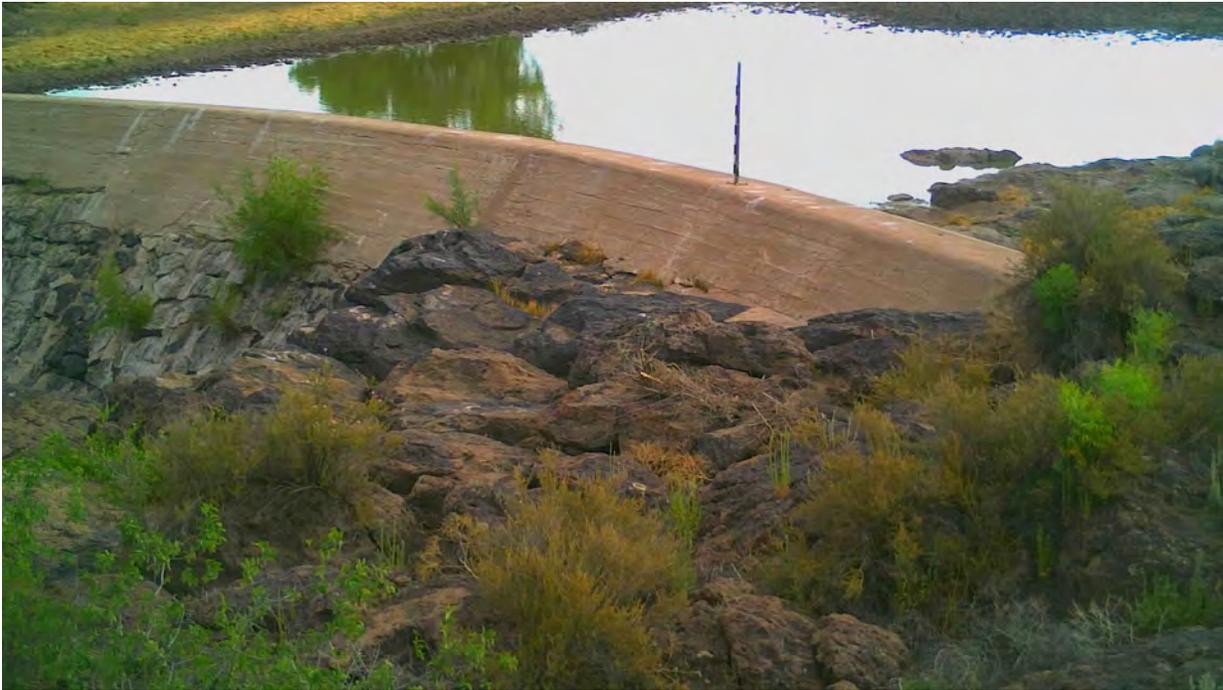
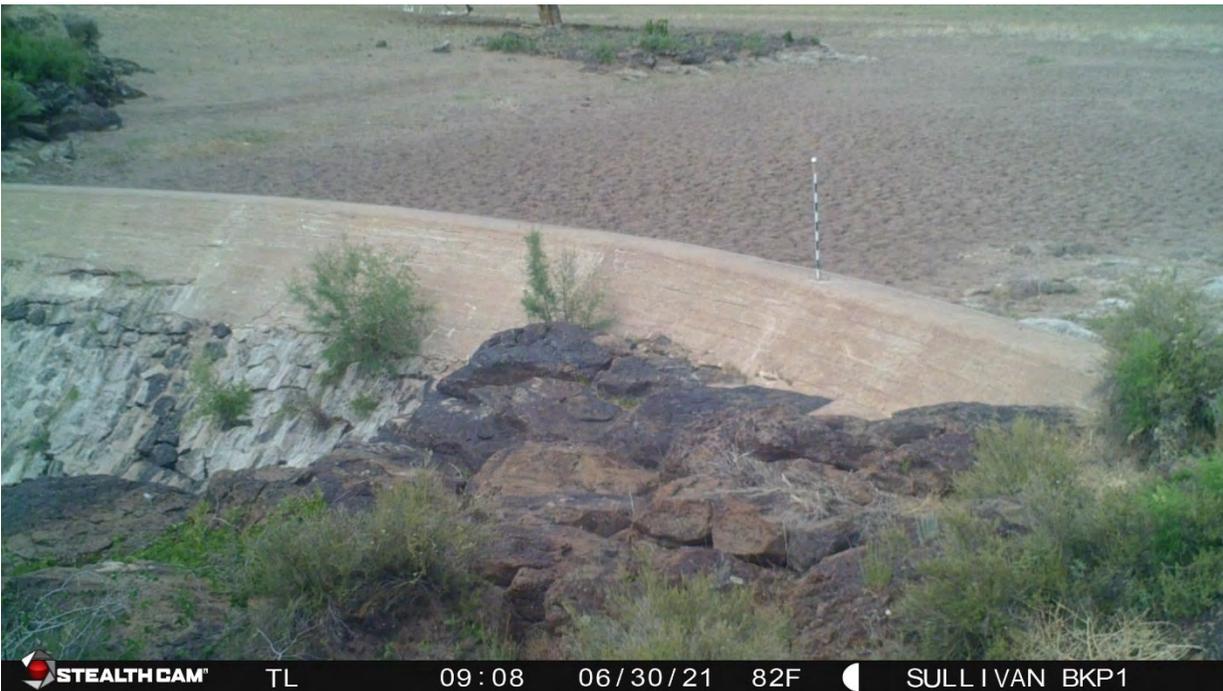
FIGURE 32. SD IMAGE DATA

SD at the start of the 2021 reporting period:

SD at the end of the 2021 reporting period:

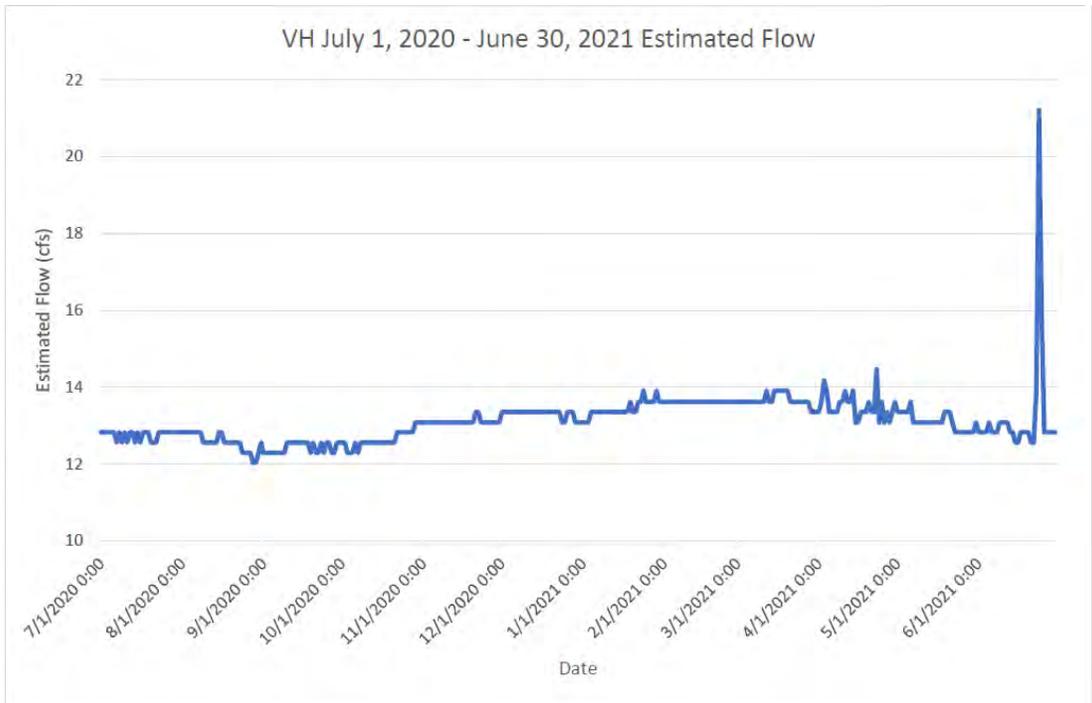
FIGURE 33. VHCR JULY 2020 – JUNE 2021 ANNUAL FLOW EVENTS<sup>19</sup>

One (1) event was observed at VHCR during the 2021 annual monitoring period (for this site and report, a flow event was defined as exceeding a flow rate of over 20 cfs). VHCR flow events for the annual reporting period are outlined in Table 11 and Figures 41-43.

<sup>19</sup> Discharge is not calculated when flow exceeds the existing site rating. Flow was above the discharge rating for 238 hours from January through March 2019.

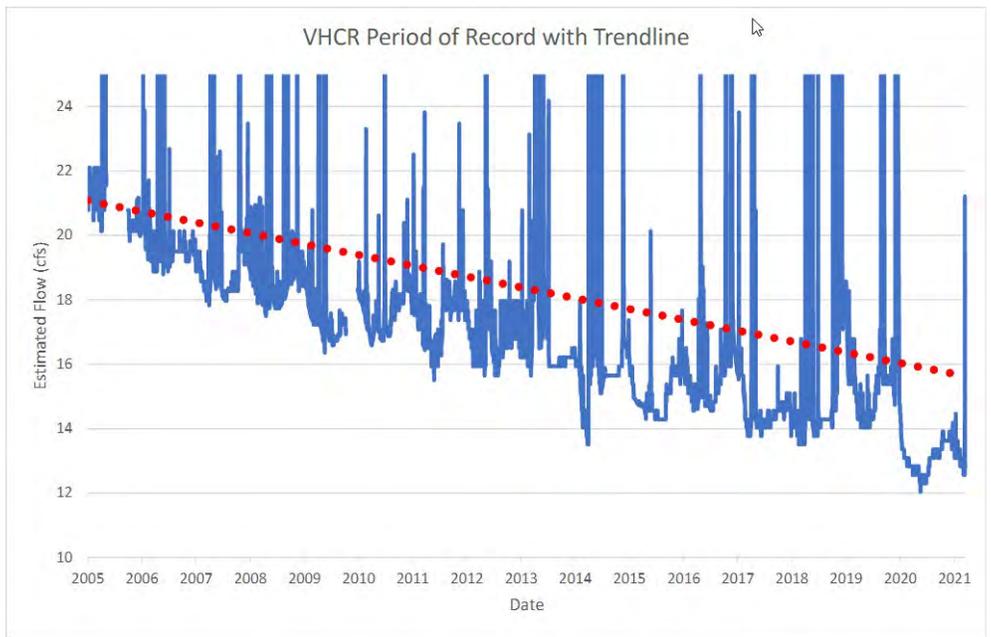
FIGURE 327. VHCR PERIOD OF RECORD FLOW EVENTS<sup>48</sup>

The USGS Verde River near Paulden, AZ stream gage is approximately 6 river miles downstream of VHCR. Flow events observed at VHCR were also observed at the USGS gage (see Table 7 and Figure 33-36 below).
