# Comprehensive Agreement No. 1

## Eighth Annual Report

FY21  
(July 1, 2020 – June 30, 2021)

BIG CHINO SUB-BASIN  
WATER MONITORING PROJECT  
PRESCOTT - PRESCOTT VALLEY - SRP

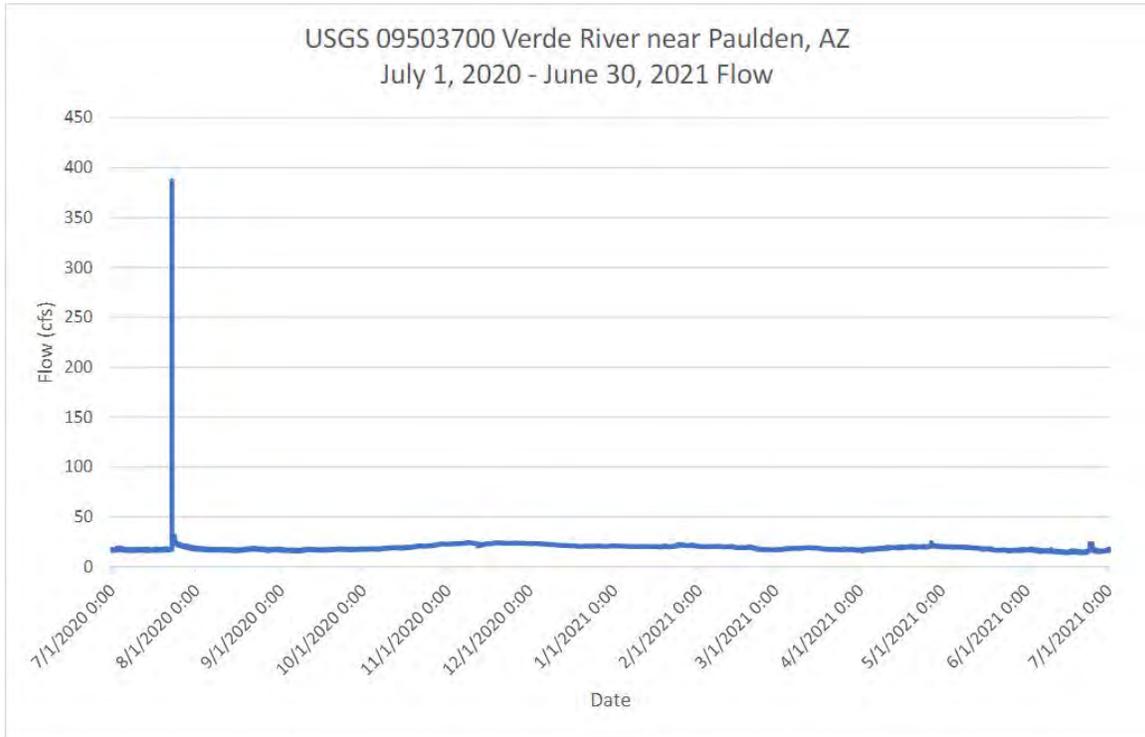
FIGURE 36. USGS VERDE RIVER NEAR PAULDEN, AZ JULY 2020 – JUNE 2021 FLOW EVENTS

The USGS Verde River near Paulden, AZ stream gage is approximately 6 river miles downstream of VHCR. Flow events observed at VHCR were also observed at the USGS gage (see Table 7 and Figure 33-36 below).

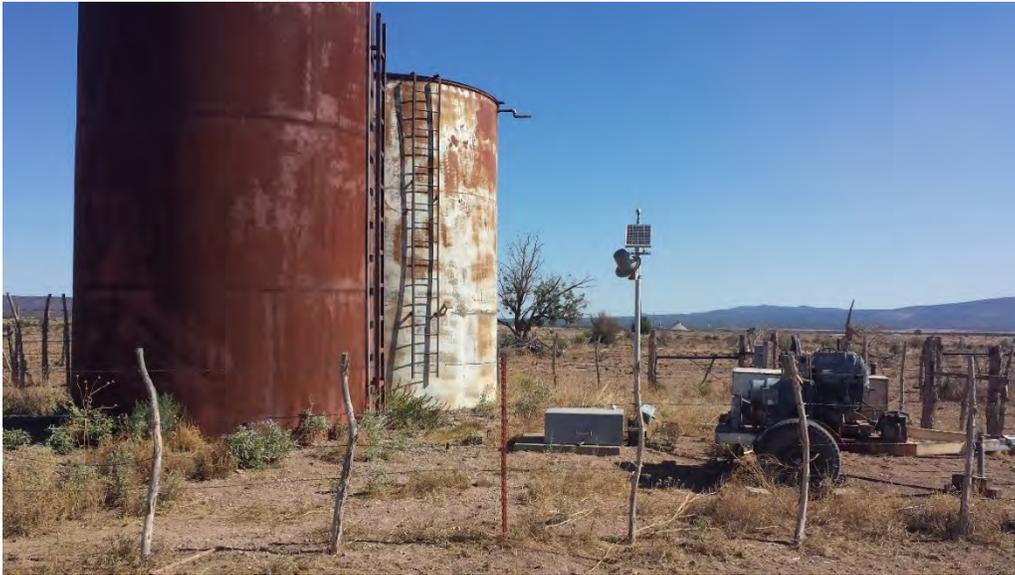
*FIGURE 37. GW SITE IMAGE FOR REFERENCE*

The GW location records the distance from land to water (stage in feet below land surface). Between July 2020 and June 2021, the overall depth to water level increased 1.28 feet (see Figures 37-39 below). It is important to note that due to deteriorated pipe conditions, data can no longer be collected in confidence at this site. After being instructed to stop monitoring at this site by the CA#1 monitoring committee, SRP staff stopped data collection and site visits to Gipe Well in May 2021.

The GW site was visited a total of three (3) times during the 2021 reporting period. All site visits were for routine maintenance and data collection.

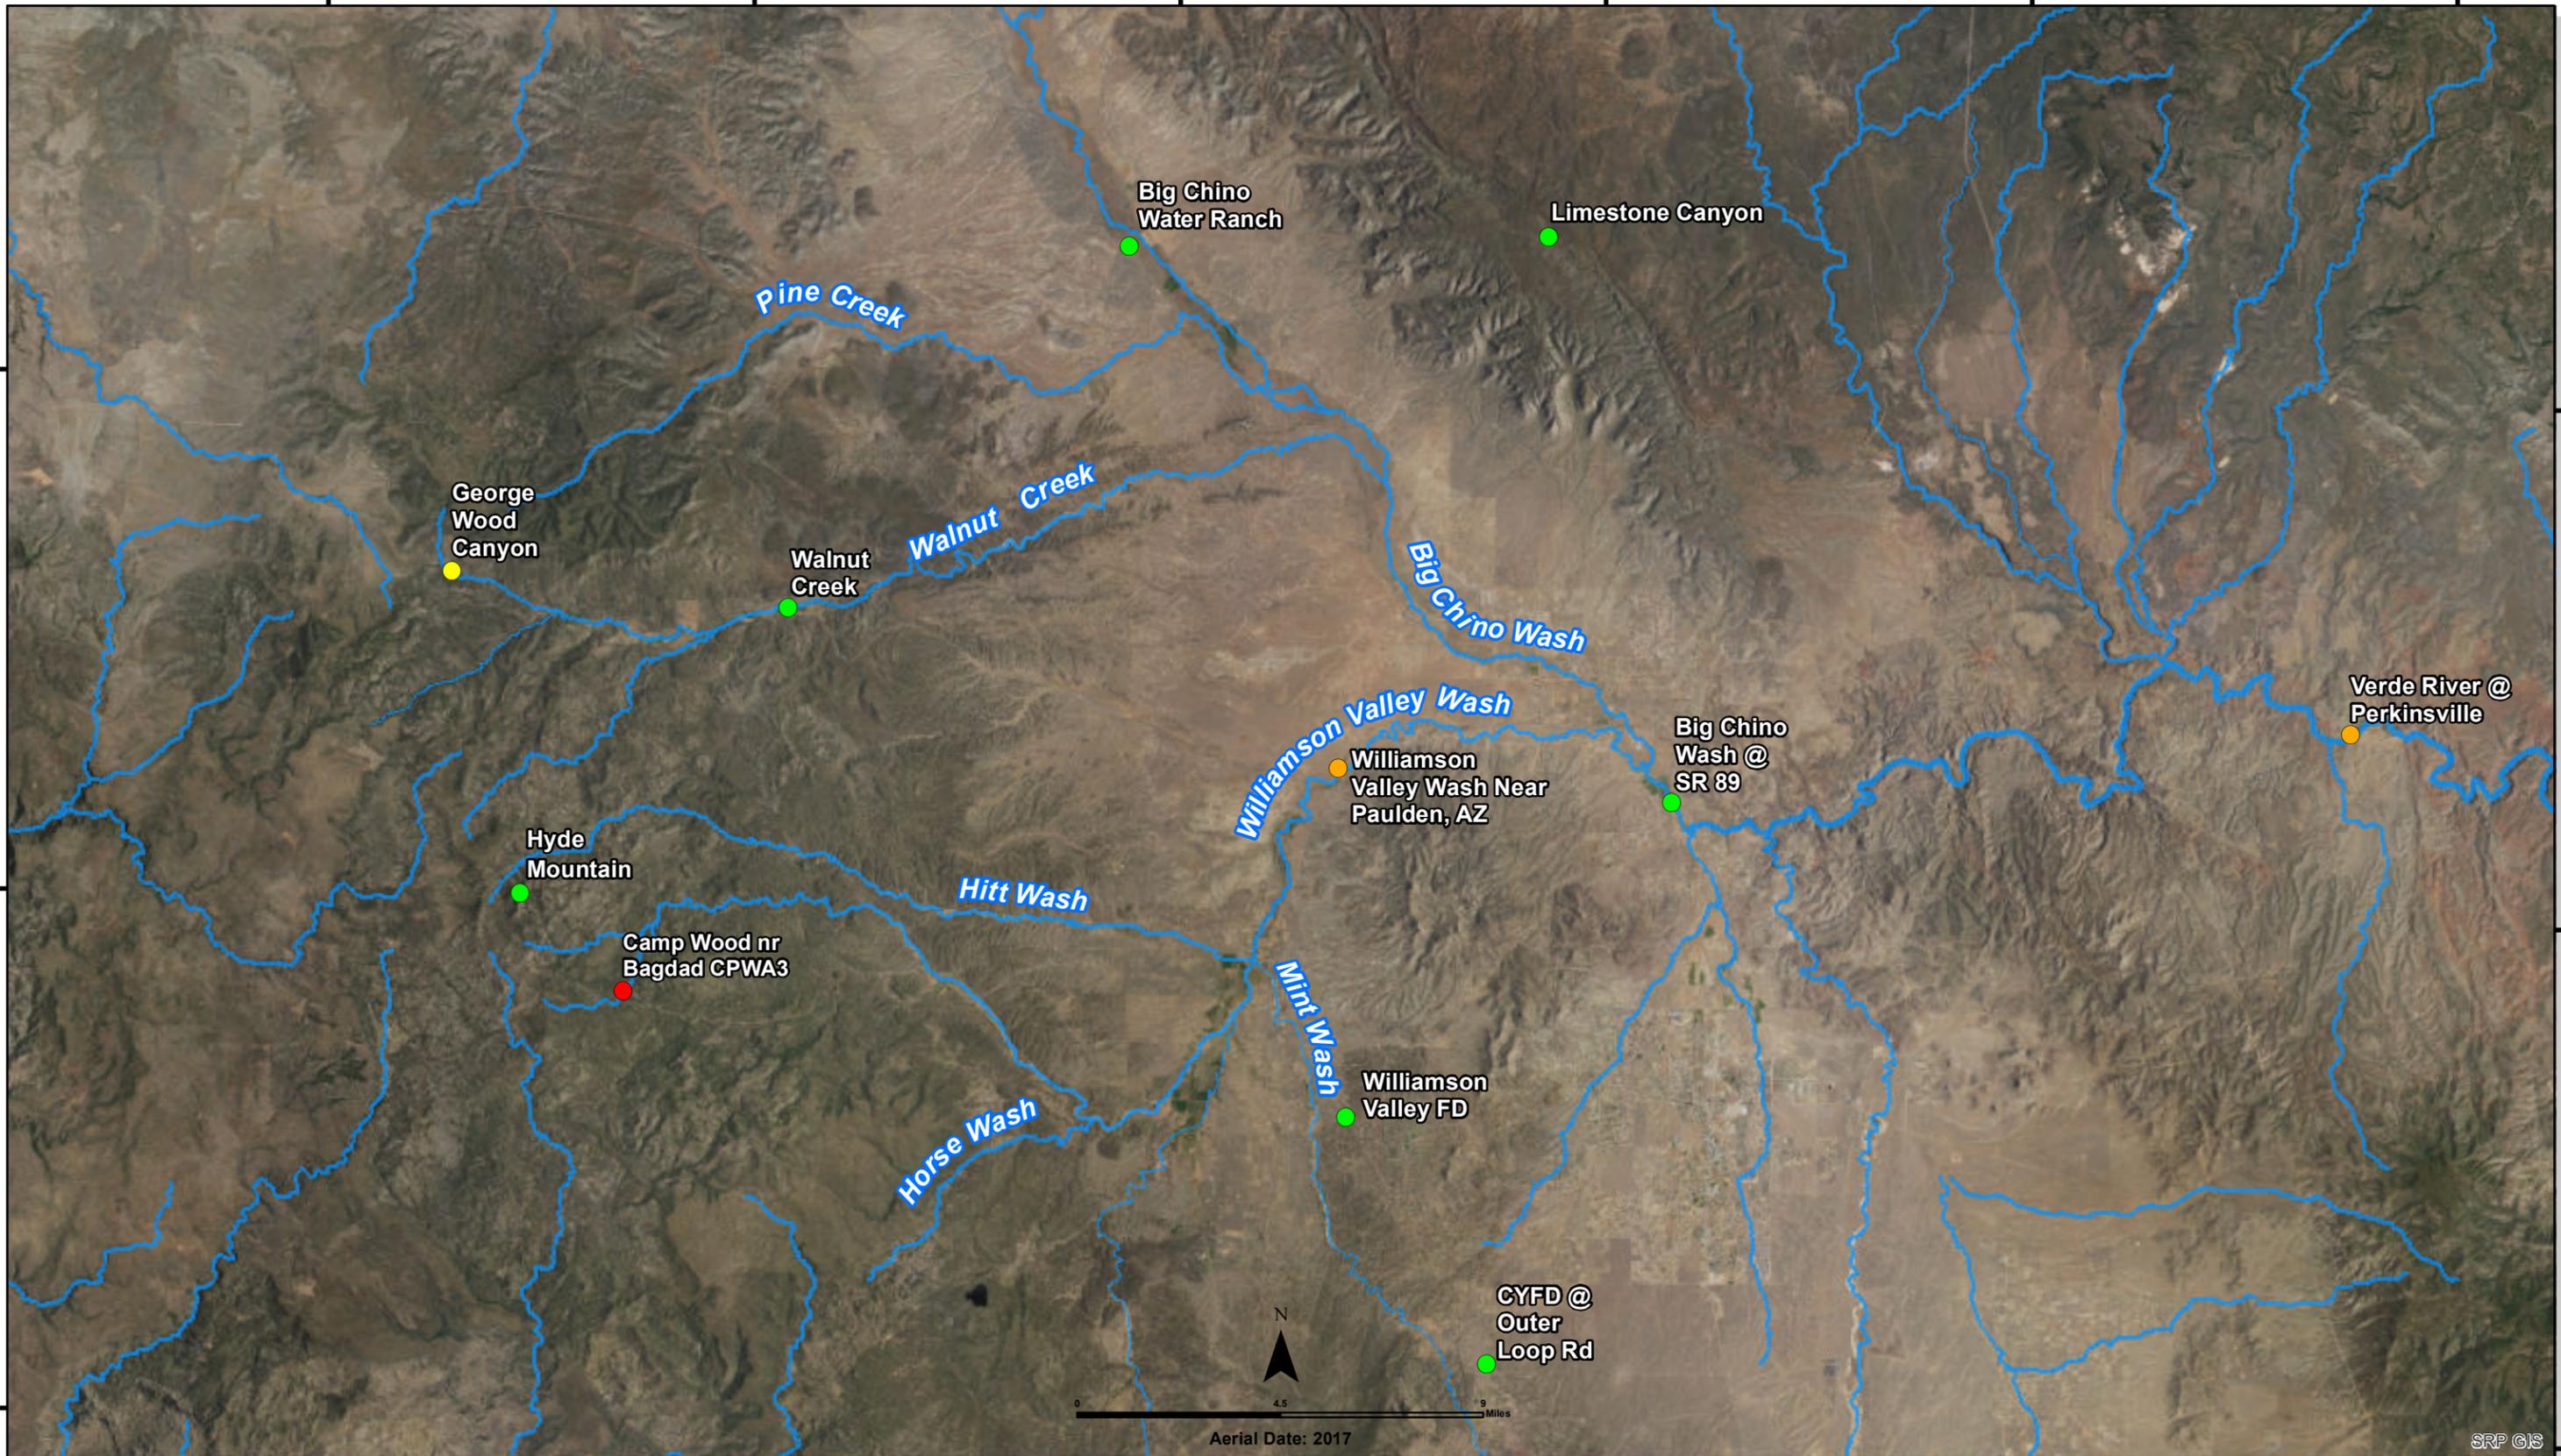
### Map 6 Big Chino Area Weather Stations

- Yavapai County Flood Control District Weather Station
- National Weather Service Hydrometeorological Automated Data System Station
- USGS Weather Station
- SRP Weather Station
